# **Inspection Report**

**River Falls Hydroelectric Project  
FERC Project No. P-10489**

**Powell Falls Dam  
River Falls, Wisconsin**

**December 2009**

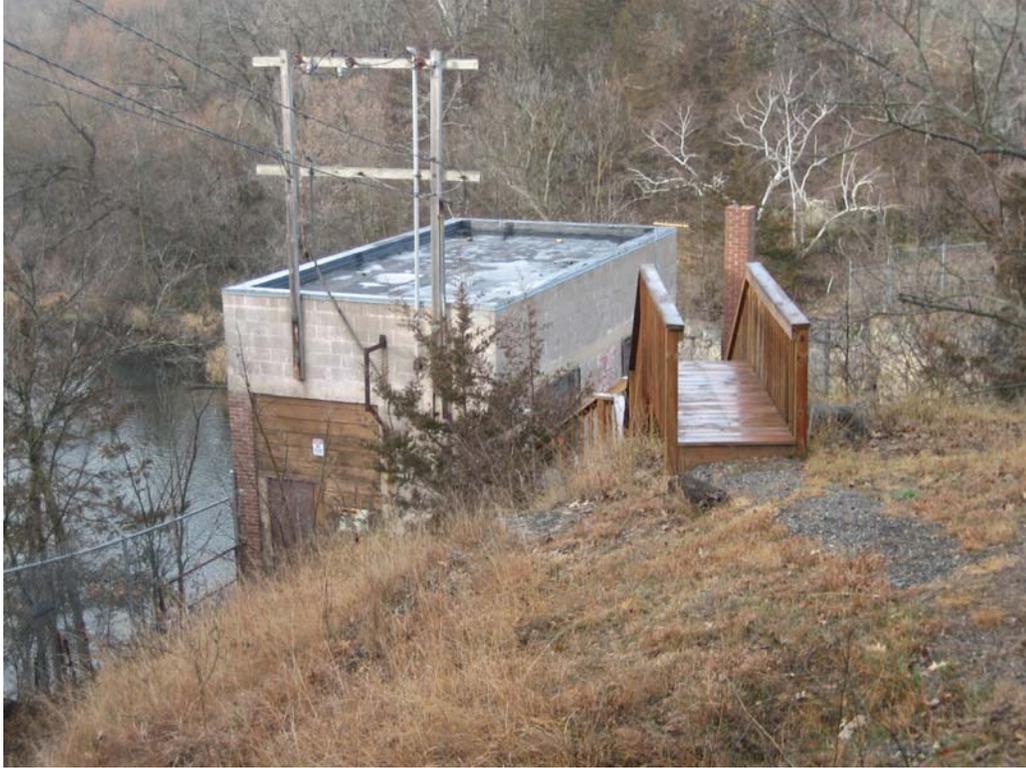
1. Upstream view of powerhouse

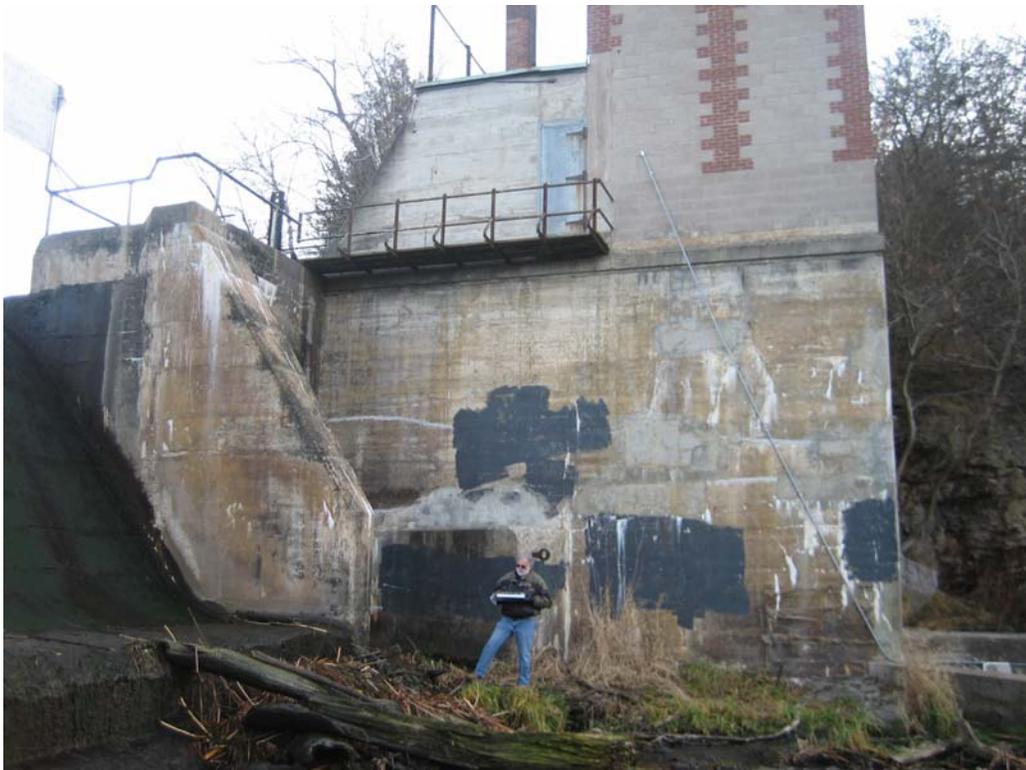
The powerhouse superstructure is generally in good condition. The concrete substructure is in fair condition with cracking, deterioration and efflorescence (Photos 2 and 5). The concrete sluice gate operating deck is in fair condition with cracking and deterioration (Photo 7). The previous left wall crack repairs are in good condition (Photo 9).

2. Left powerhouse wall and left spillway abutment

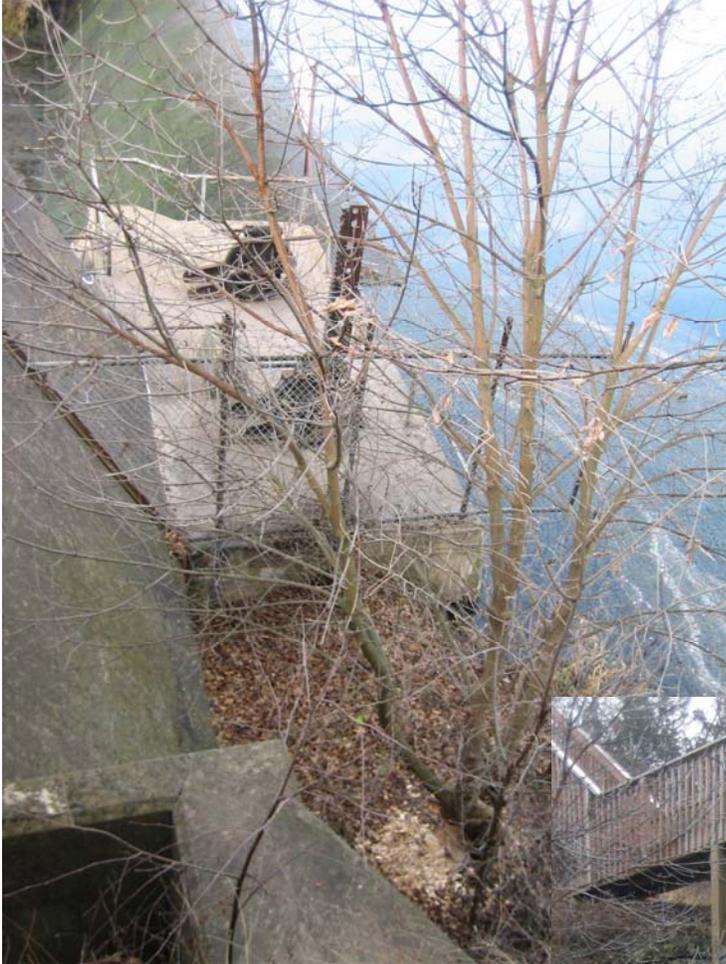
There is vegetation growth around the powerhouse (Photos 3, 5, and 8).

3 (left). Powerhouse upstream face, gate operator deck and spillway (background)

The brush and trees growing around the powerhouse should be removed within one year to facilitate inspection and to eliminate potential seepage paths and concrete damage due to the root systems.

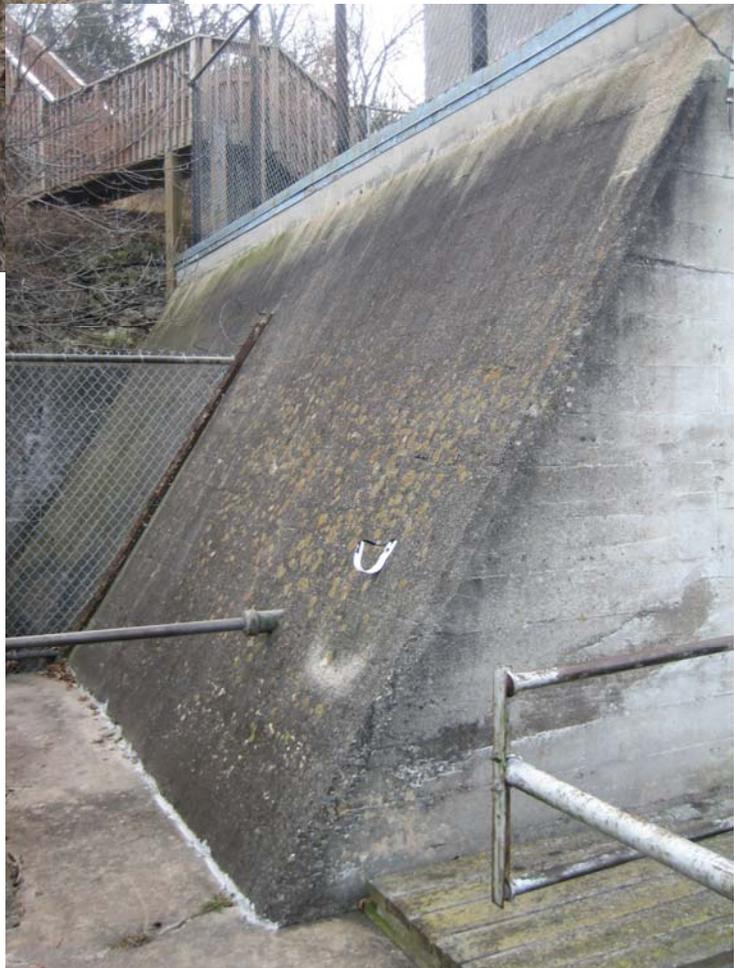
4 (below). Upstream face of powerhouse

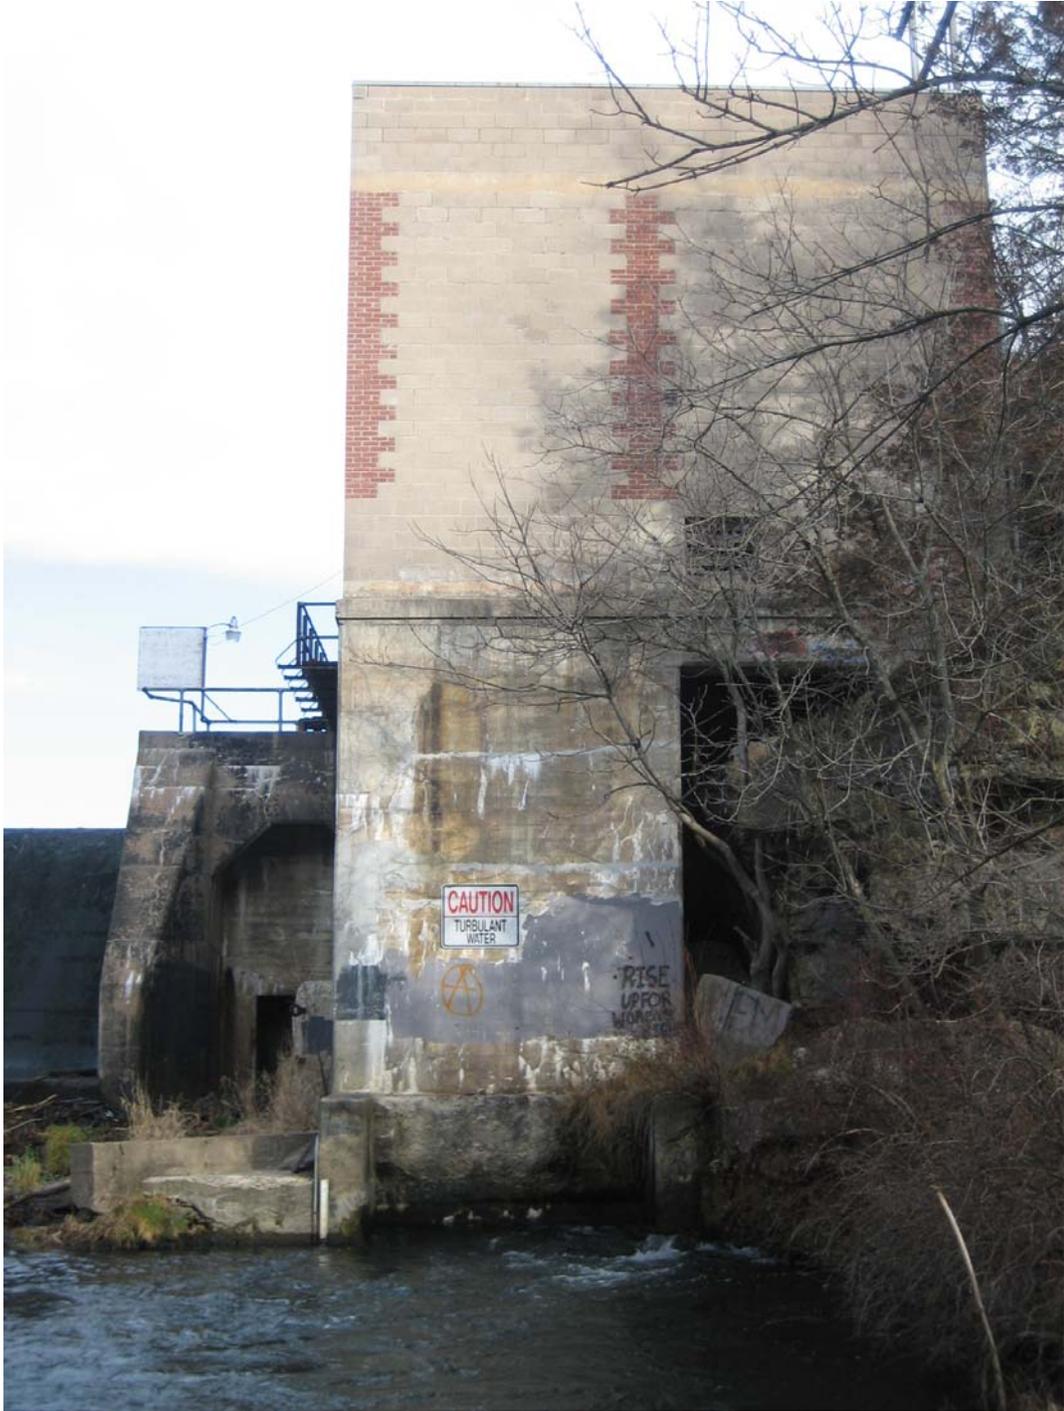
The downstream training wall is in fair condition with minor cracking, deterioration and efflorescence. The end of the wall opposite the powerhouse is undermined (Photo 5).

The downstream stoplog slots are deteriorated at the waterline (Photo 6). The massive concrete access walk is deteriorated (Photos 5 and 6).

The wasteway is in fair condition with cracking, deterioration and efflorescence (Photos 5, 8, and 10).

5. Downstream face of powerhouse and wasteway

The downstream training wall undermining should be repaired within three years to prevent concrete damage.

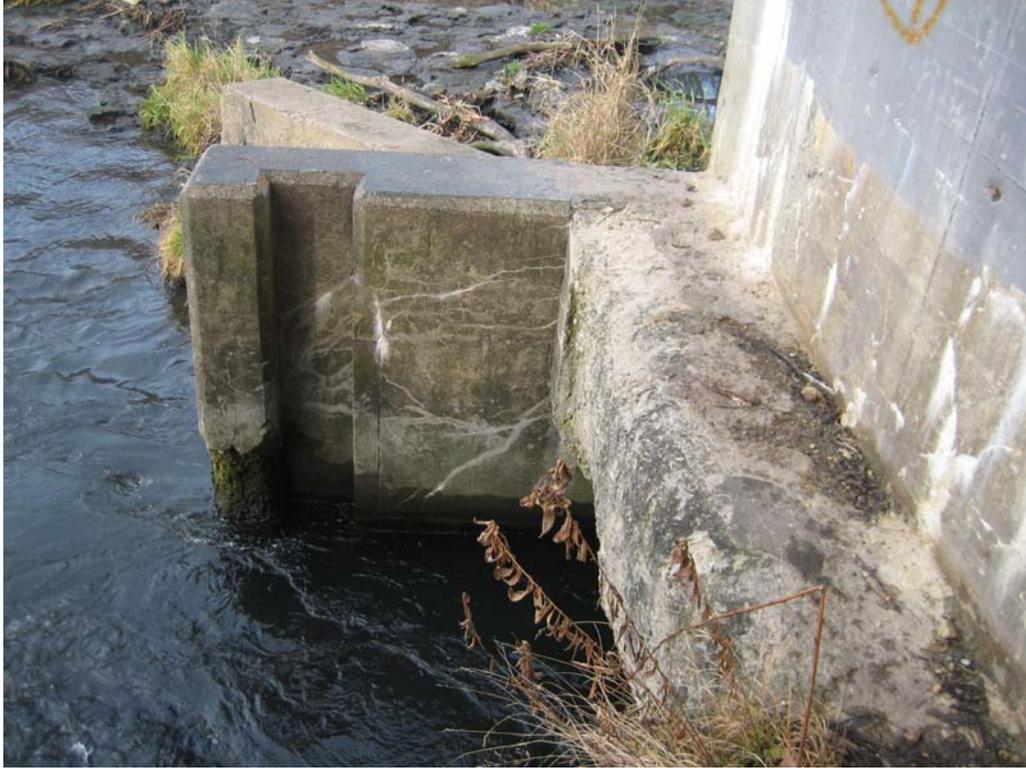
6. Typical slot downstream of powerhouse

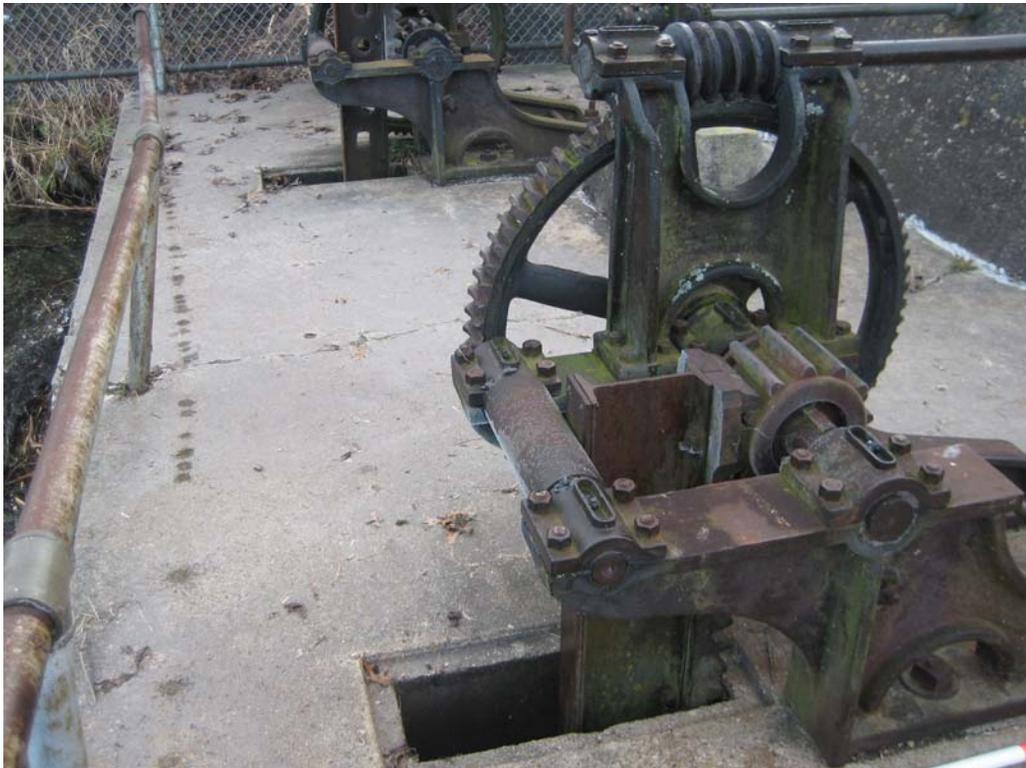
The concrete sluice gate operating deck is in fair condition with cracking, deterioration and efflorescence (Photos 7 and 11).

7. Operating deck for gates

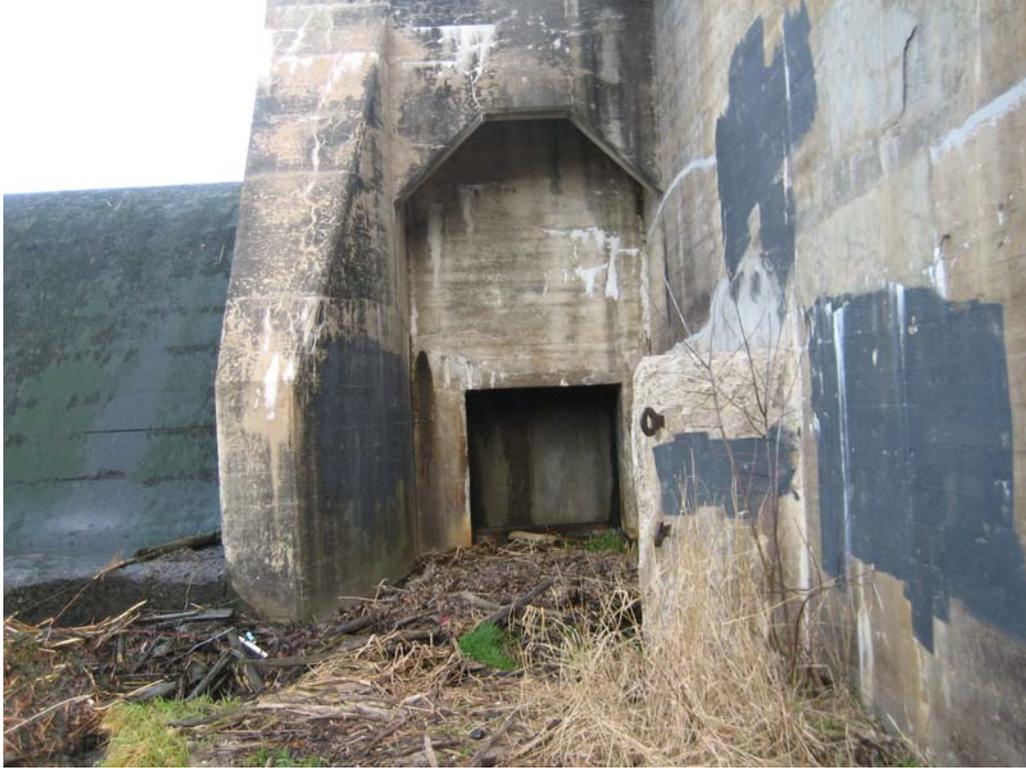
8. Downstream view of wasteway

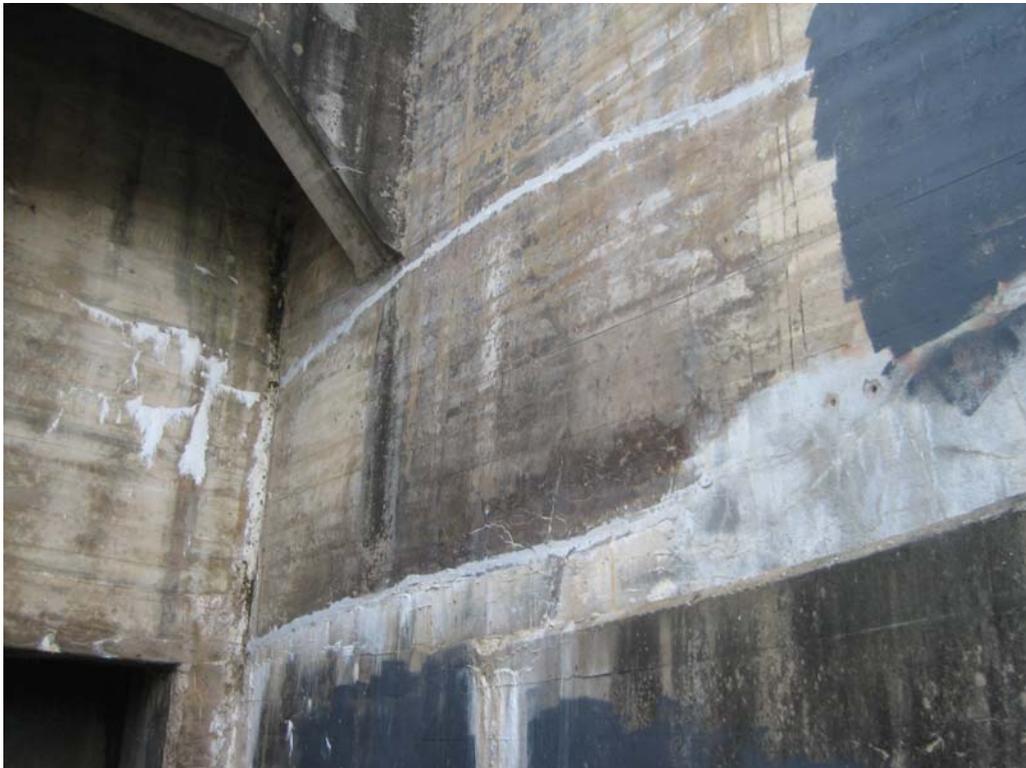
9. Left powerhouse wall (note previous crack repairs)

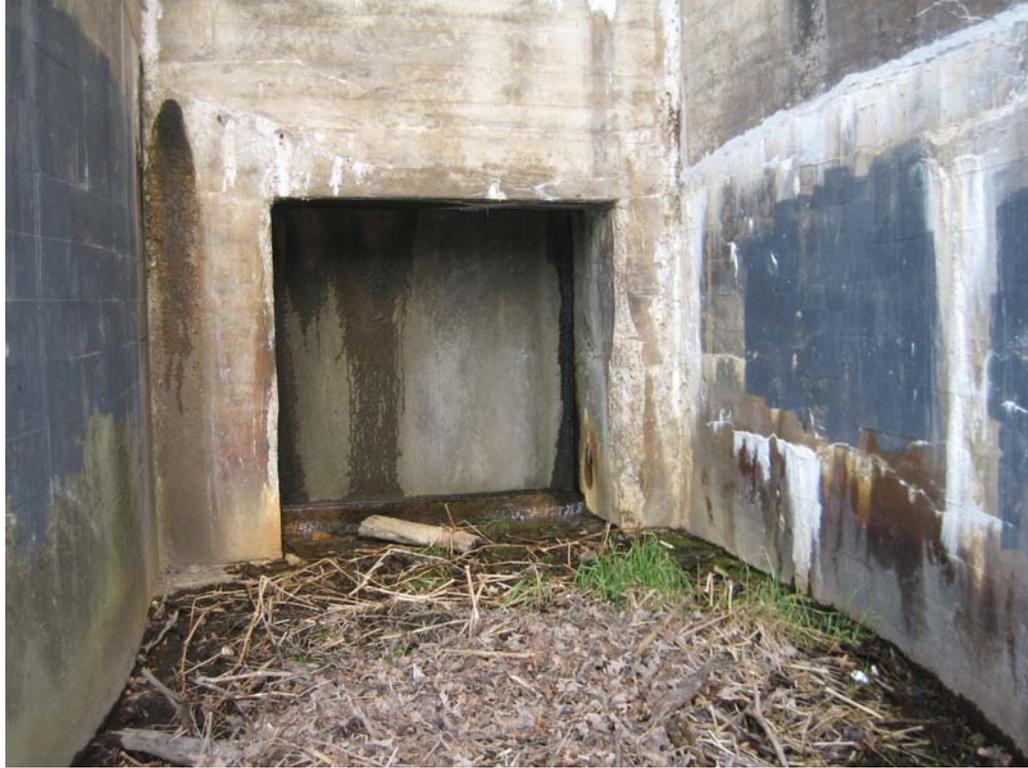
Minor gate leakage was observed (Photo 10).

10. Closed sluice gate

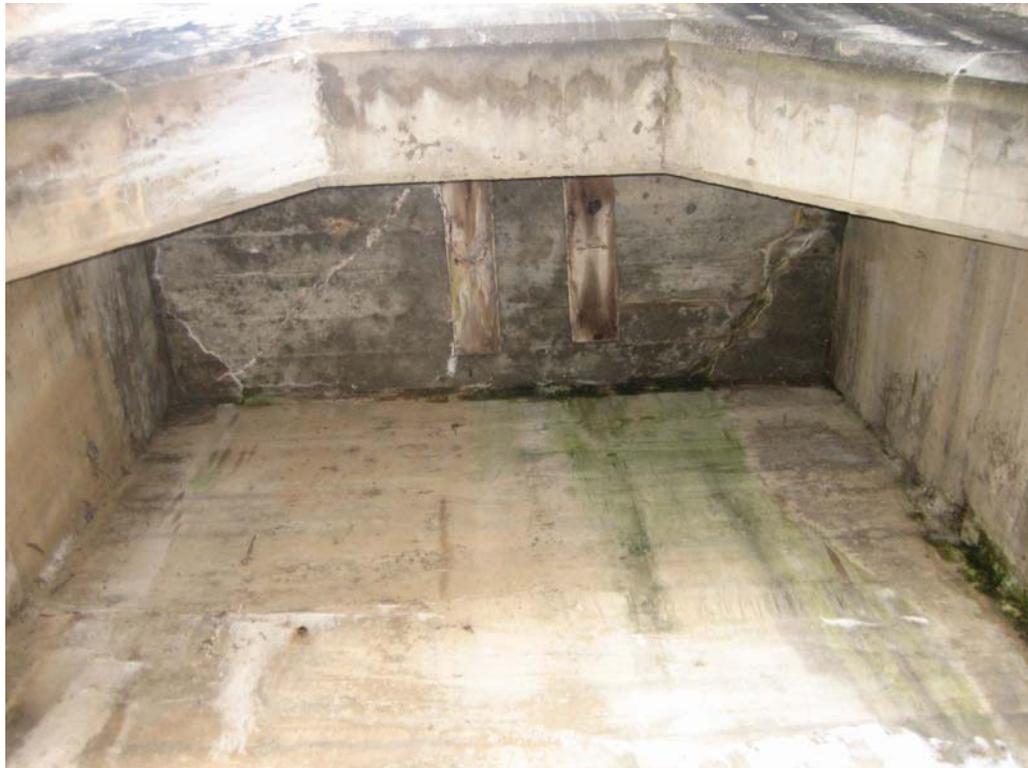
11. Underneath operator's deck

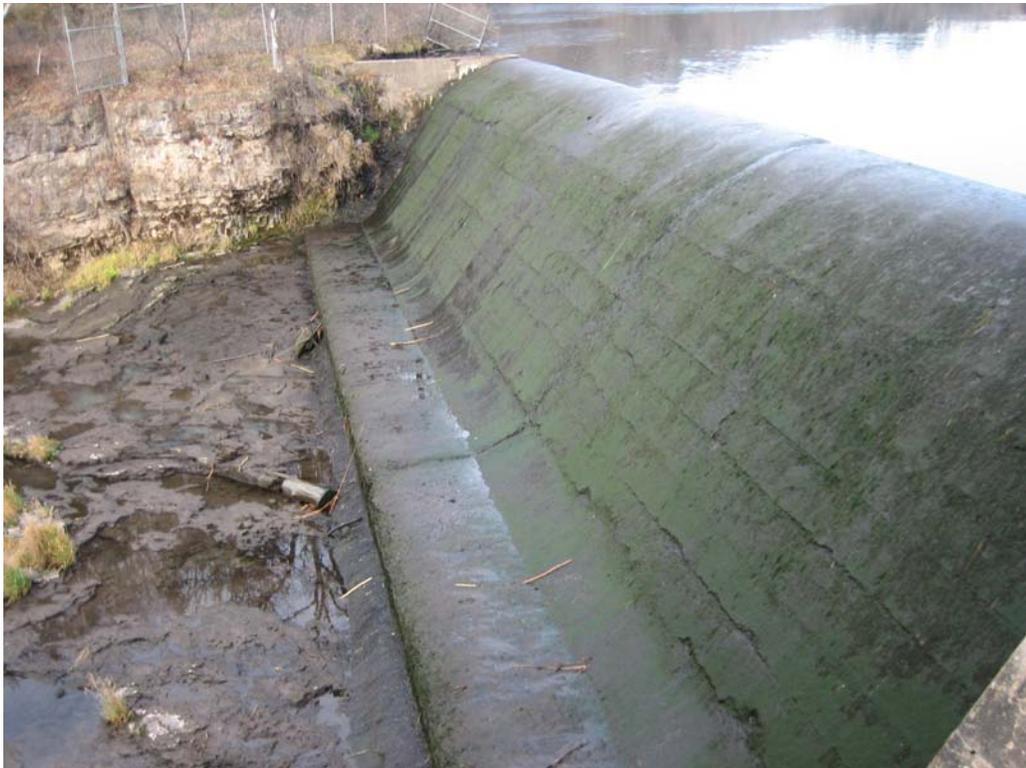
The spillway is in good condition, however, the algae growth limited the inspection. There were no visible signs of structure undermining. The horizontal lift joints were visible (Photos 14 and 15) and there was minor deterioration and spalling. Minor flow was observed from the weep holes.

14. Downstream view of spillway and right abutment

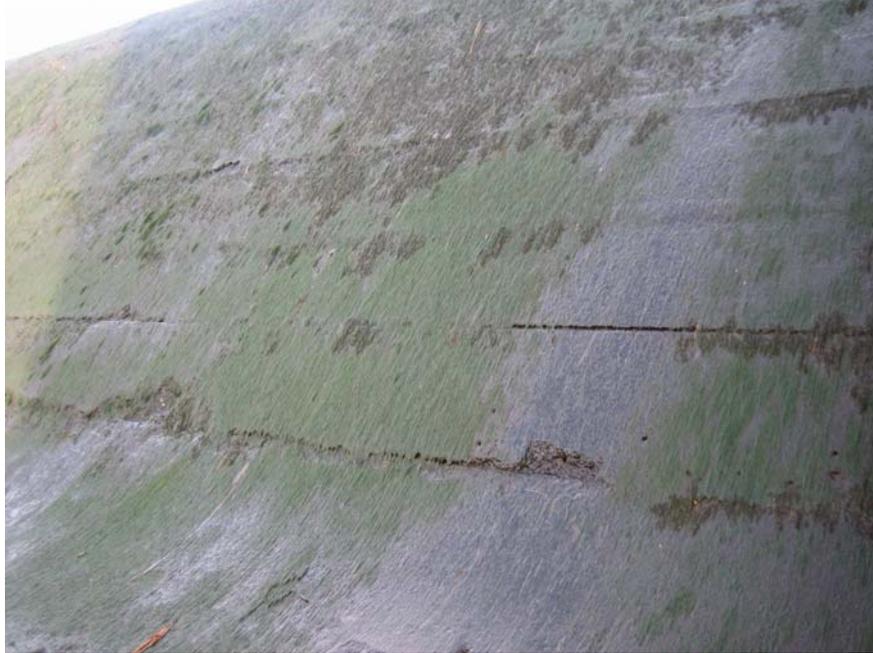
15. Typical spillway downstream joints

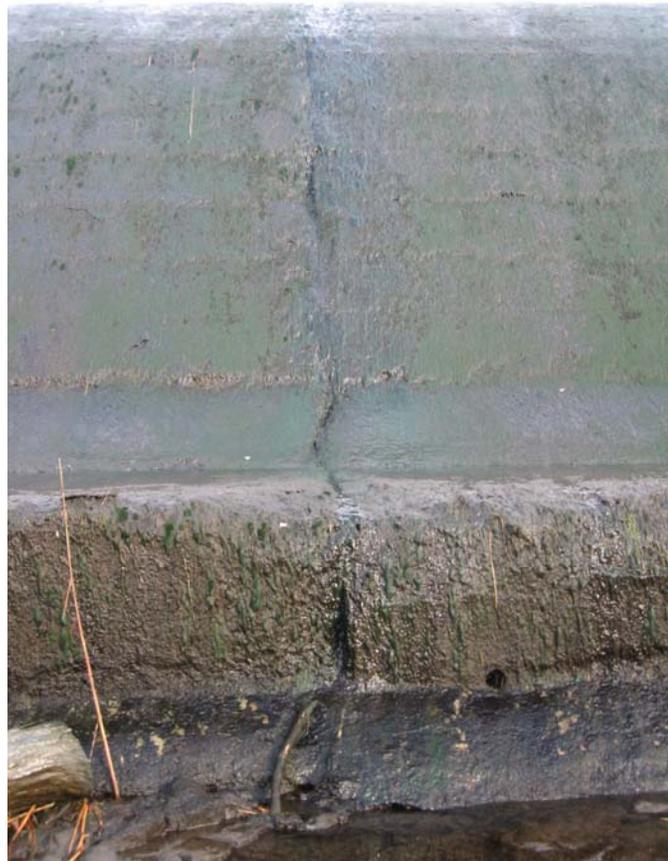
There was minor deterioration and spalling at the vertical joints (Photo 16).

16. Typical vertical joint in downstream of spillway

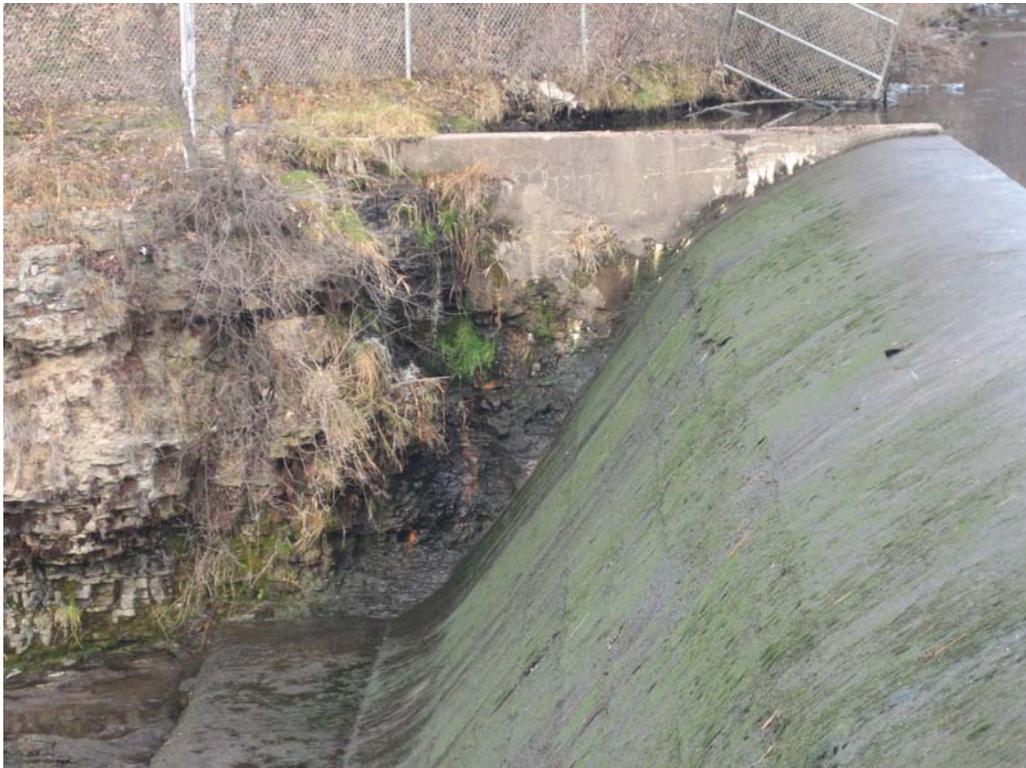
The right abutment is in fair condition with cracking, deterioration and efflorescence (Photo 18). There is vegetation growth in the cracks and spalls. There is seepage through the cracks, spalls and at the wall/ bedrock interface (Photos 19 and 20). Water is also seeping through the rock joints.

18. Right abutment

The vegetation around the abutment should be removed within one year to facilitate inspection and to eliminate potential seepage paths and concrete damage due to the root systems.

When vegetation removal has been completed, an inspection (with photographic record) of the right abutment downstream face should be performed at least two times per year. The inspections should be performed at least three months apart during non-freezing months and the water should not be flowing over the spillway. The purpose is to observe and document the concrete condition and seepage locations to aid a future structural assessment.

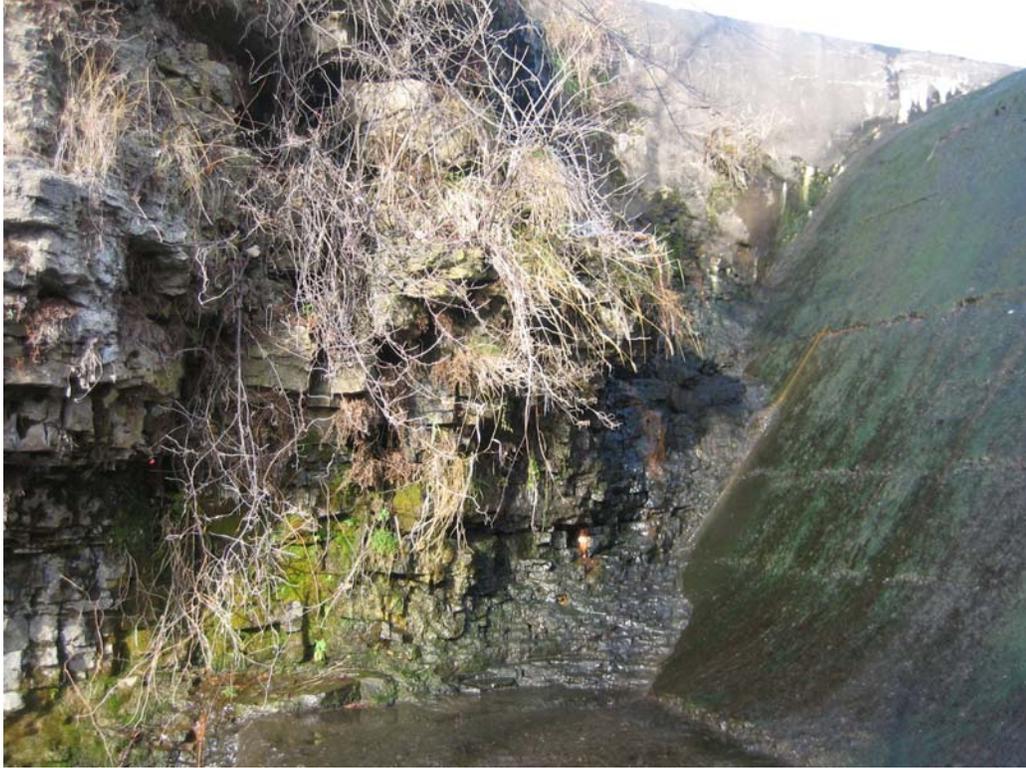
19. Right abutment (note seepage through rock)

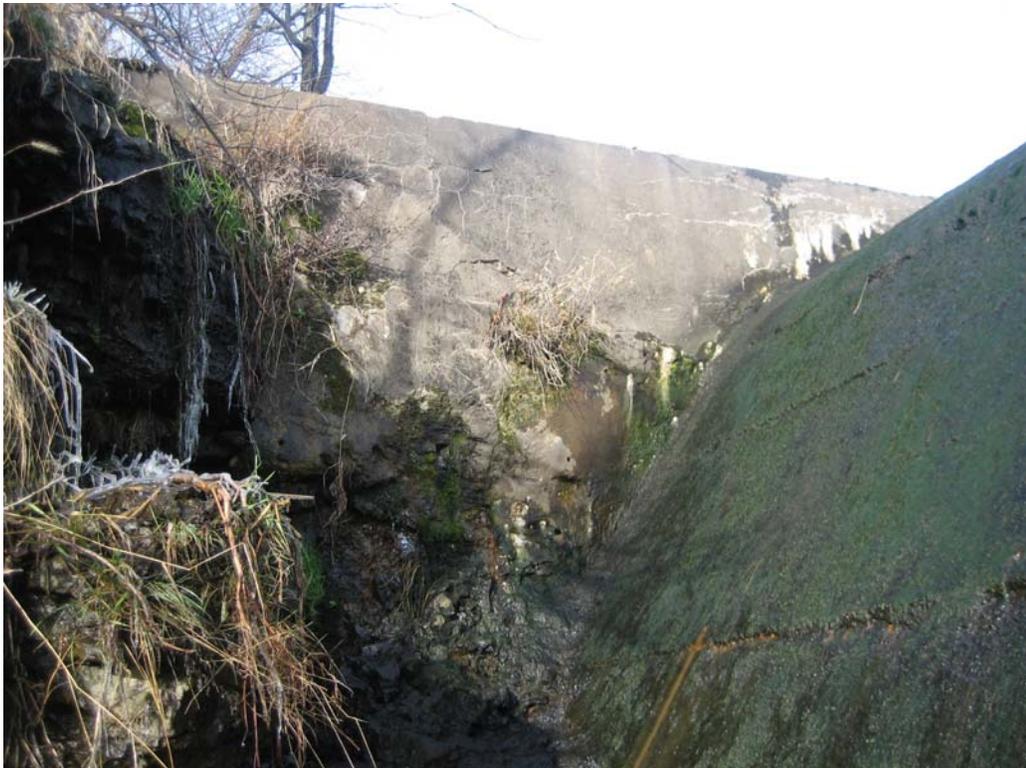
20. Right abutment (note seepage through rock)
