City of River Falls Hydroelectric Project FERC Project P-10489

Powell Falls
Decommissioning Plan

January 30, 2021

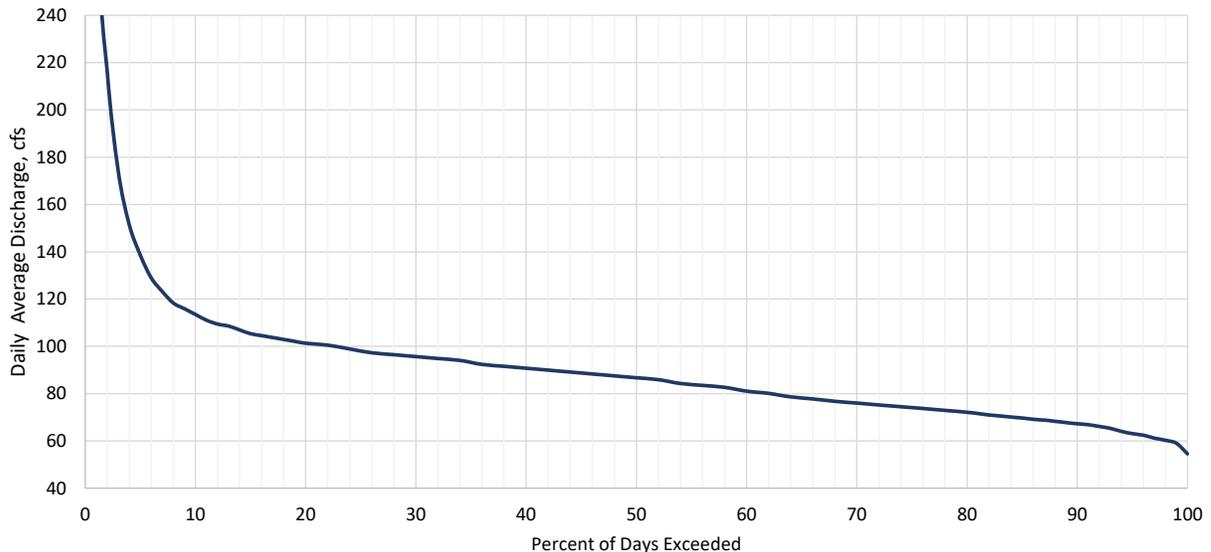
Figure 2. Flowrate-duration curve for Powell Falls Dam

One definition of base flow is average daily flowrate for which half the records exceed and half the records are less than this value. Based on the USGS gage records for the Kinnickinnic River and adjusted for drainage area and flowrate ratios, the annual flow duration curve at Powell Falls was computed as shown in Figure 2 and the baseflow computed as 86 cfs.

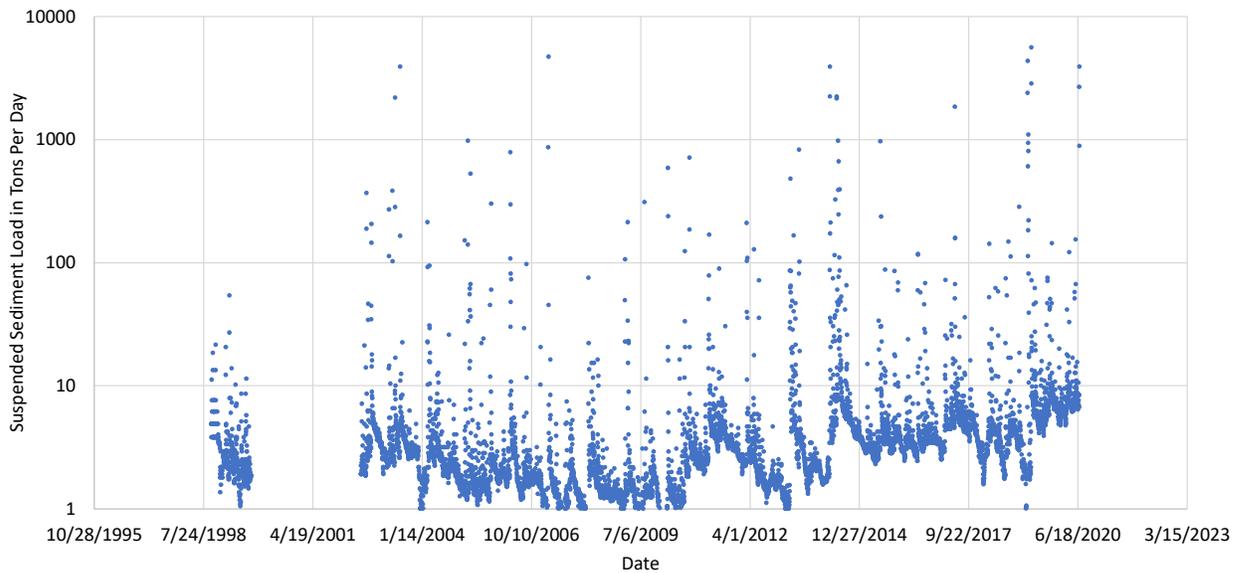
Figure 5. Variability in daily suspended sediment load for the Kinnickinnic River

While Figure 5 is only as accurate as Figure 4’s trendline’s accuracy, it is important to understand that suspended sediment transport (and associated turbidity) is extremely variable for the Kinnickinnic River. Since data shown in Figure 5 is predicted at the USGS gage location, the suspended sediment load must be reduced to account for the watershed area difference (Powell Falls has only 71% of the drainage area that the USGS gage has). Therefore, the average suspended sediment transport at Powell Falls Dam is 17.4 tons per day or 6,400 tons per year. For dams with shallow or drawn down impoundments, the suspended load is not likely to be reduced by the dam. For the same river flowrate, the post-removal suspended load during floods is expected to exceed that shown in Figure 5 because bank instability will augment suspended sediment levels passed through the dam.

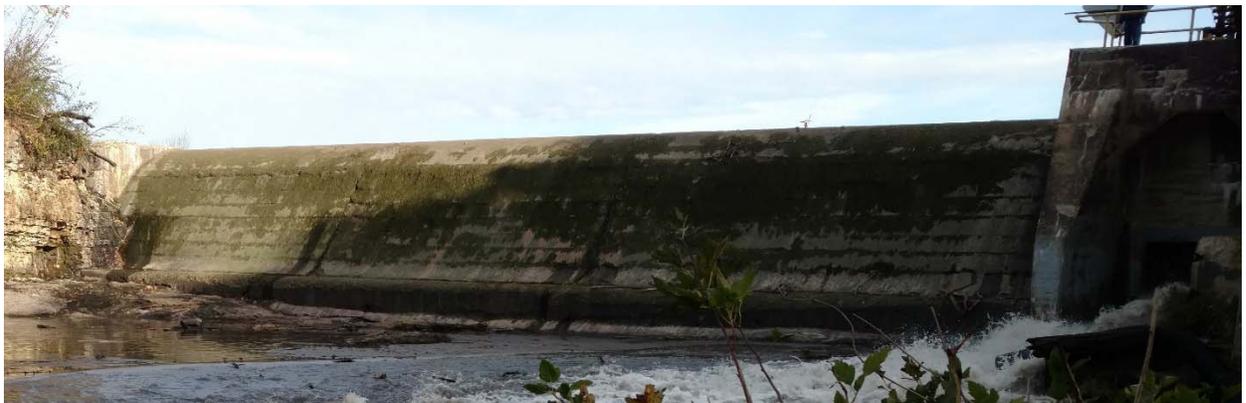
Figure 6. Right abutment bedrock (left side of figure) and main spillway (right side of figure)

Photographs shown in Figures 6 to 12 show various features discussed in the Decommissioning Plan. In Figure 6, note the variable bedrock height along the downstream end, or “toe” of the spillway. Note that “left” and “right” when referring to dam structures typically take the perspective of a viewer facing downstream.

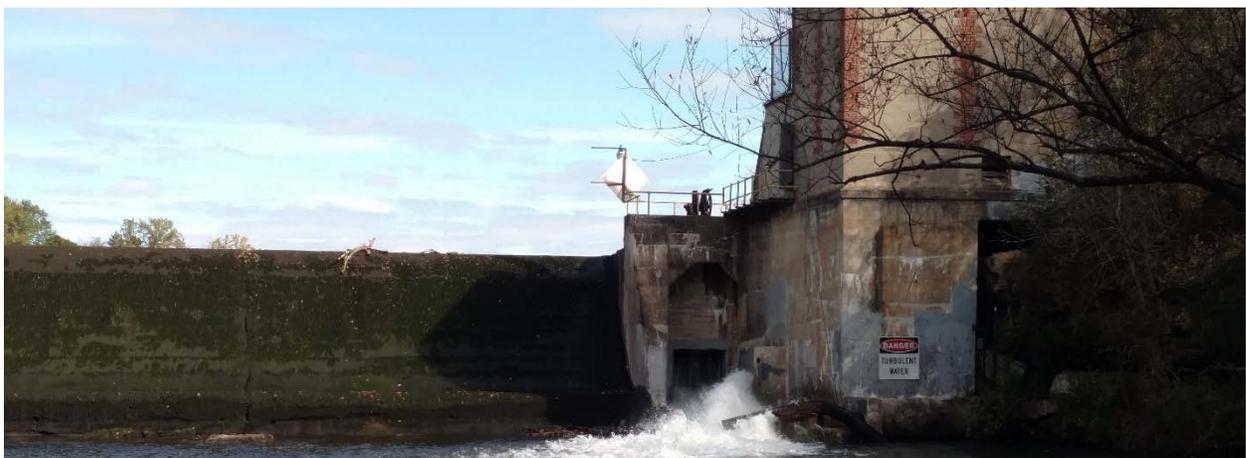
Figure 7. Left abutment (far right side of figure), powerhouse draft tube discharge (lower right, under the sign), powerhouse generating bay (upper right, above sign), and sluice or “waste” gate (lower center).

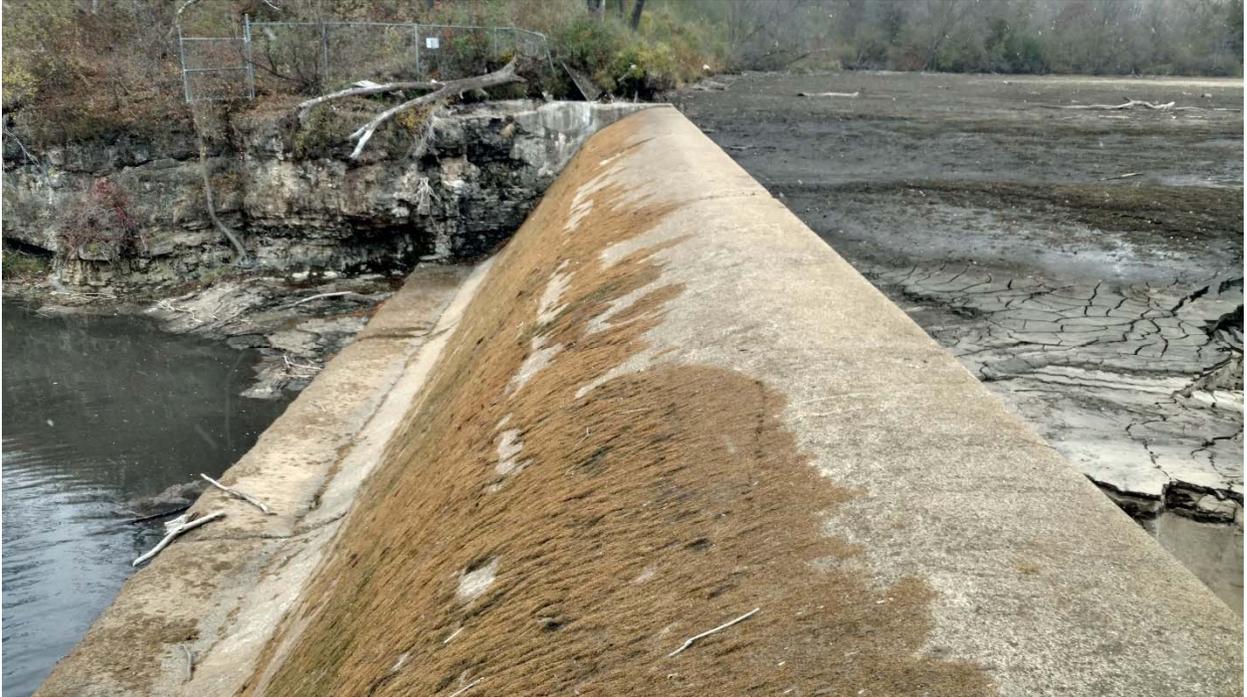
Figure 8. Looking west along dewatered spillway

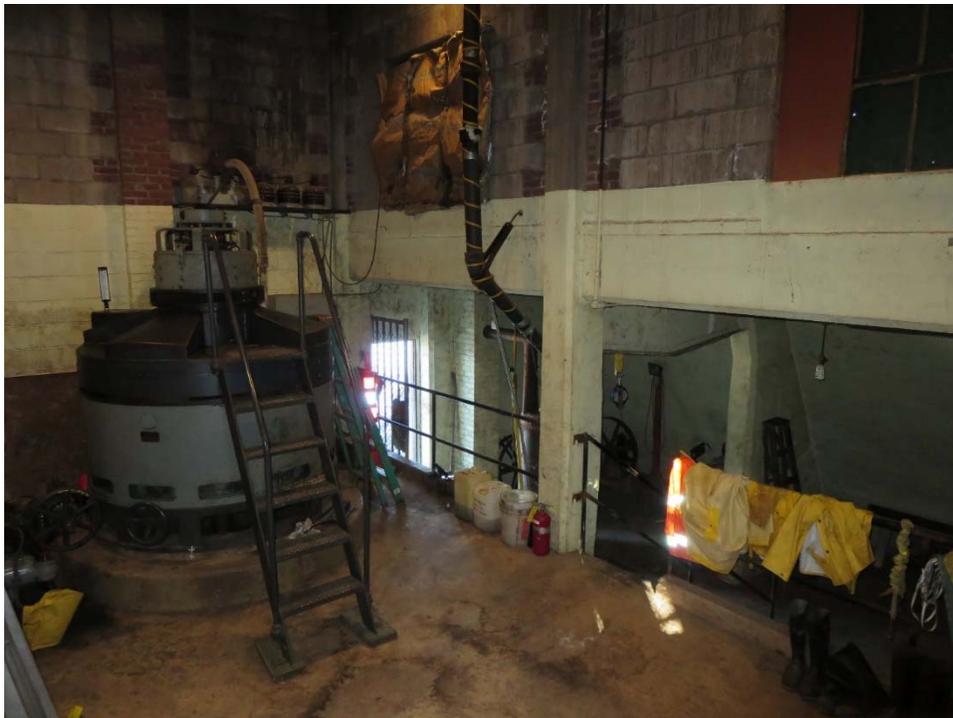
Figure 9. Interior of powerhouse generating bay, showing generator (left)

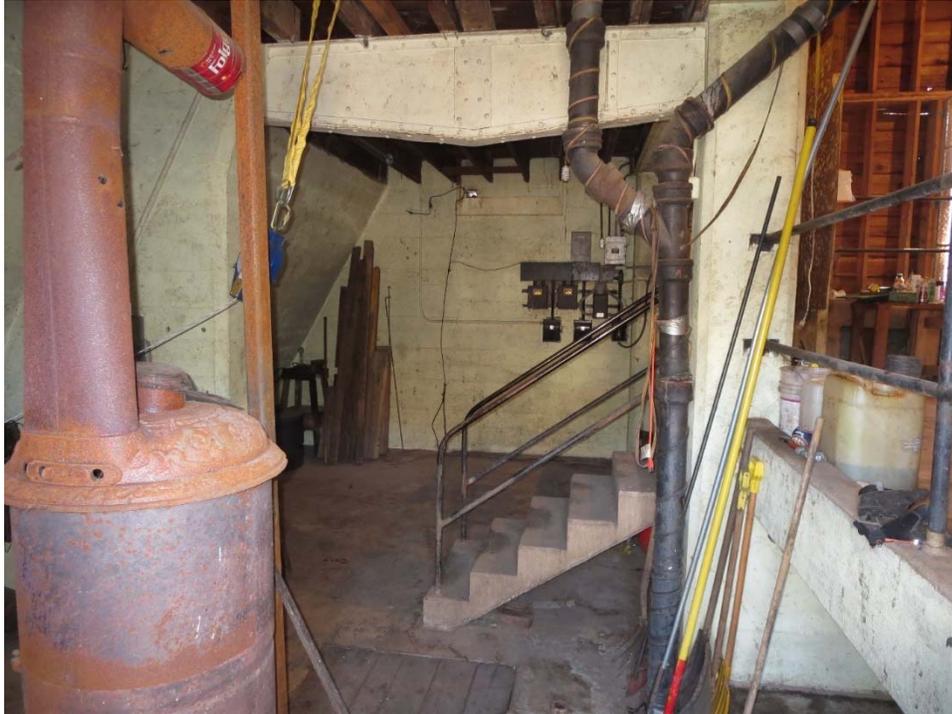
Figure 10. Interior of powerhouse, showing typical lubricant containers (right side of figure), slug fuse cutouts (center) and camp stove (left)

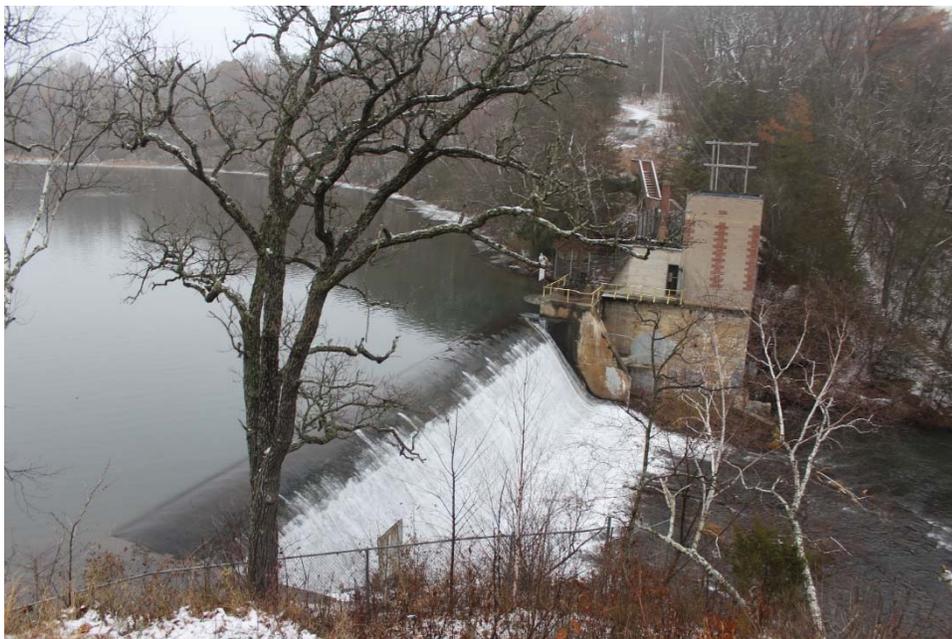
Figure 11. Looking east toward dam at typical normal pool conditions with 107 cubic feet per second of discharge (71% of the recorded flowrate at <https://waterdata.usgs.gov/usa/nwis/uv?05342000>)

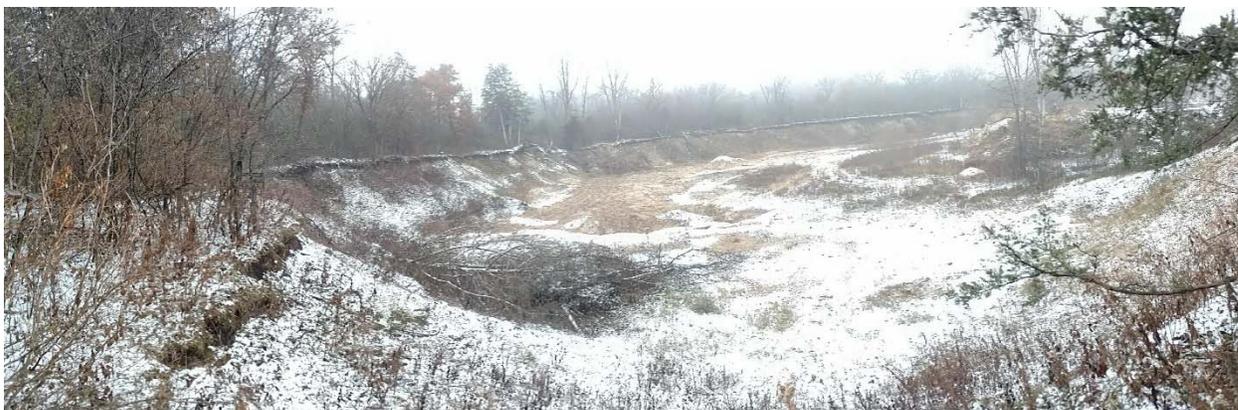
Figure 14. Proposed disposal site for concrete and sediments

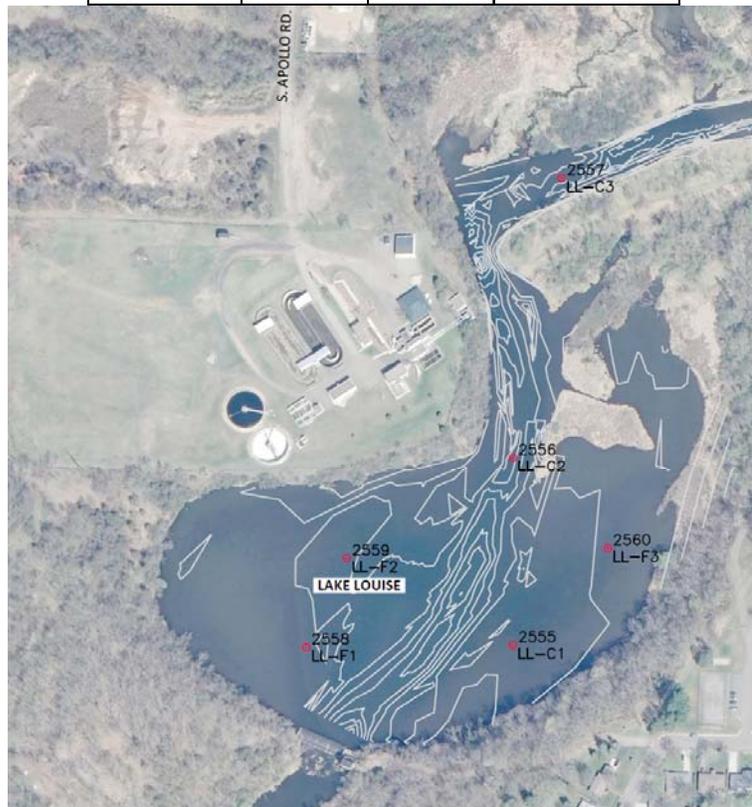
Table 4 (top) and Figure 13 (bottom). Dewatering Time Estimated for 6 Sediment Samples

Core (2016)	k (ft/min)	Distance (ft)	Days to Dewater
LL-C1	5E-04	100	131
LL-C2	1E-01	10	0.05
LL-C3	5E-02	5	0.1
LL-F1	2E-03	200	81
LL-F2	1E-02	290	15
LL-F3	5E-04	280	366

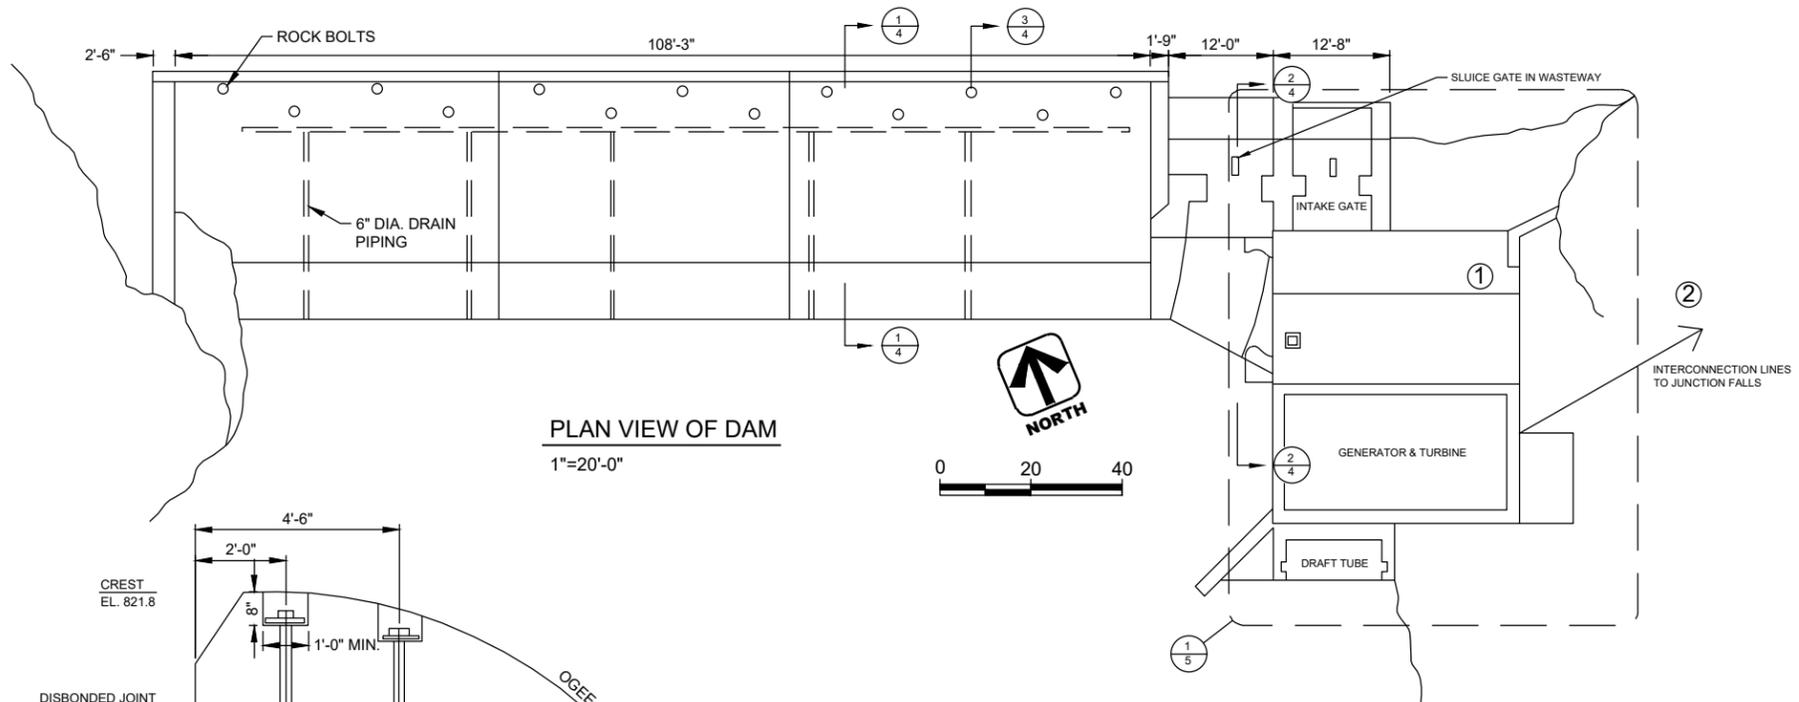
PLAN VIEW OF DAM
1"=20'-0"

- ① PRIOR TO START OF PROJECT: RMFU TO REMOVE SLUG FUSE CUTOFFS TO DE-ENERGIZE GENERATOR AND CEASE GENERATION.
- ② CITY TO ADD 2400 TO 240 V POLE TRANSFORMER WITH METER FOR CONTRACTOR CONNECTION.

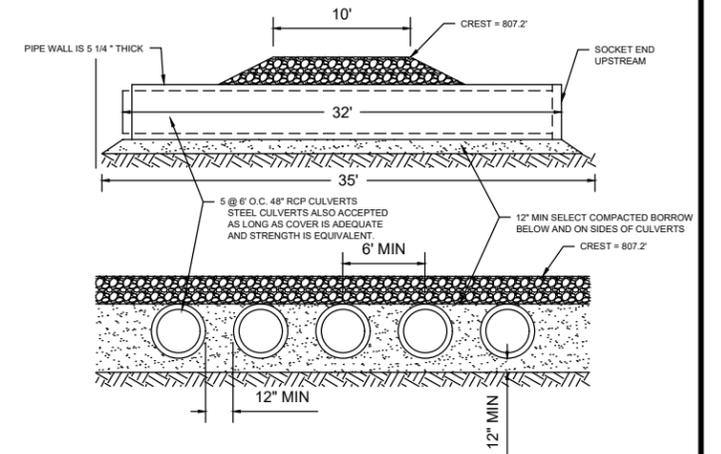
ROCK CAUSEWAY DETAIL
 N.T.S.

CHANCE	FLOW	HW	TW
1%	12800	830.7	814.0
2%	11000	829.9	813.1
10%	6800	827.9	810.5
50%	2500	824.9	806.7

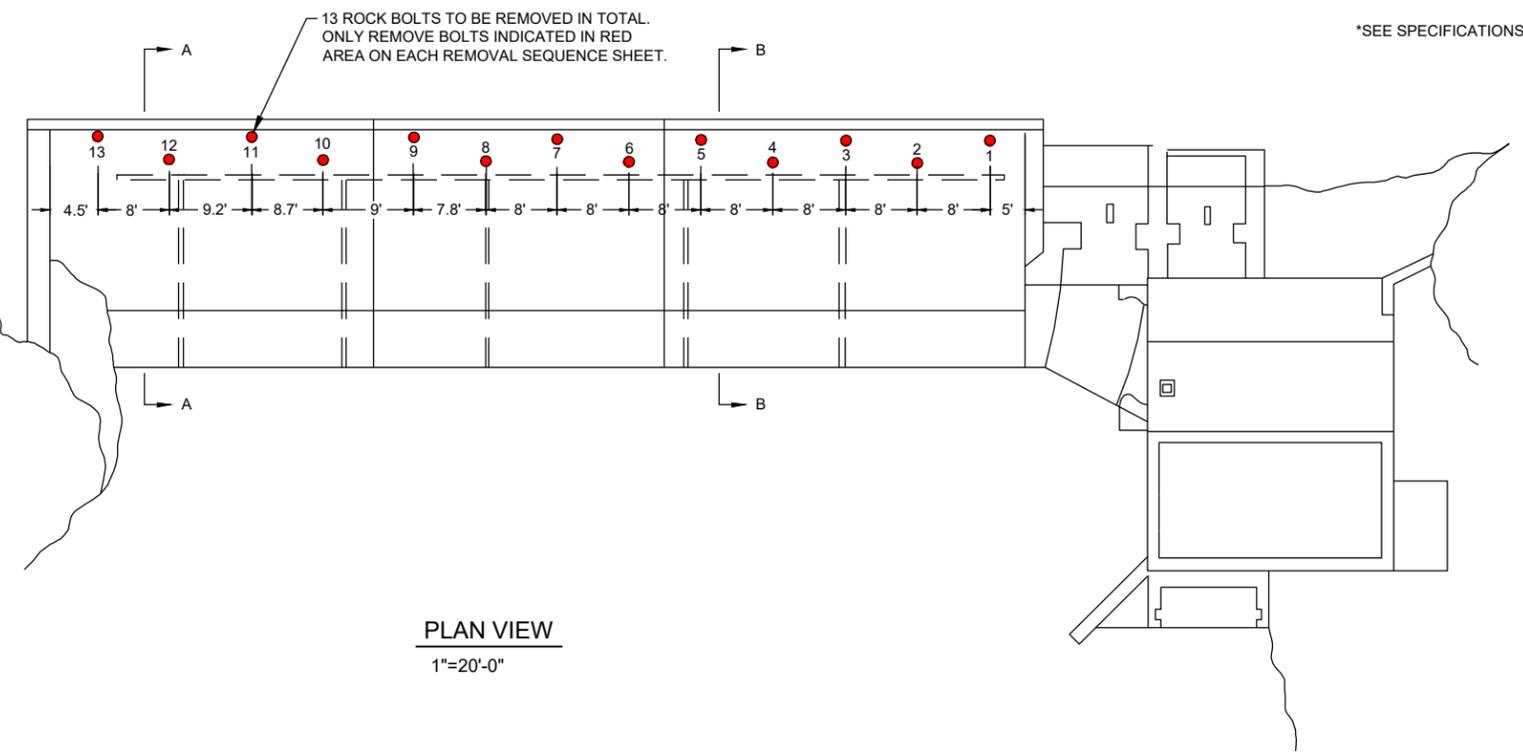
PLAN VIEW
1"=20'-0"

Rock Bolt	Crest EL	Bedock EL	Cored EL
1	821.80	807.97	806.22
3	821.81	808.56	806.81
5	821.83	808.16	805.16
7	821.81	807.64	805.64
9	821.82	805.97	804.32
11	821.81	806.35	805.31
13	821.80	807.40	805.59

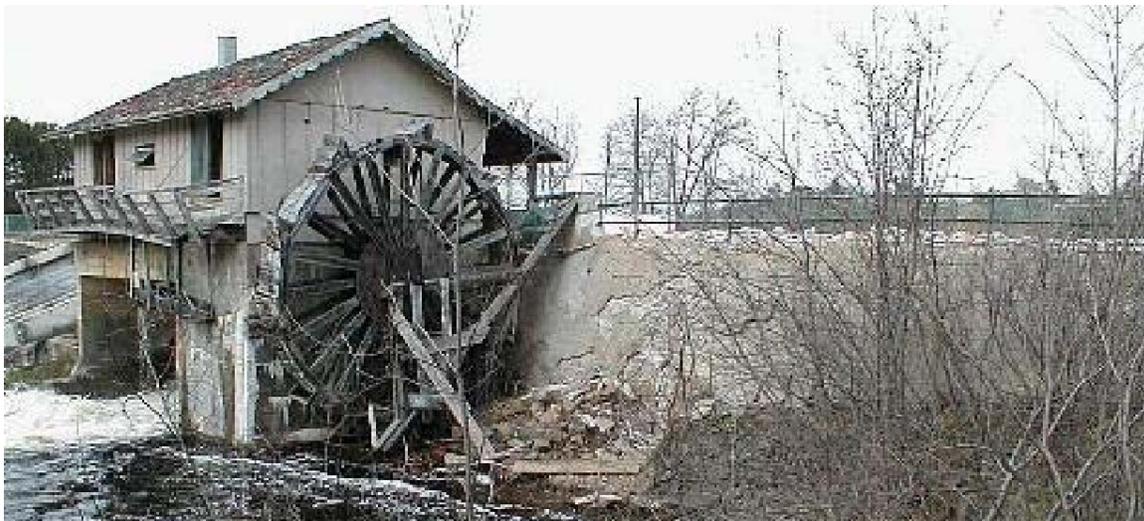
Figure 2. Woodley Dam, prior to 2002 (photo courtesy²⁰ of Woodley Dam Front)

Polk County's Woodley Dam (45.39636°, -92.36385°) is 40.0 miles north-northeast of Powell Falls. In 2001, Woodley Dam's embankment nearly overtopped during a large flood event, and the Wisconsin DNR soon ordered a mandatory drawdown until repairs could be completed.

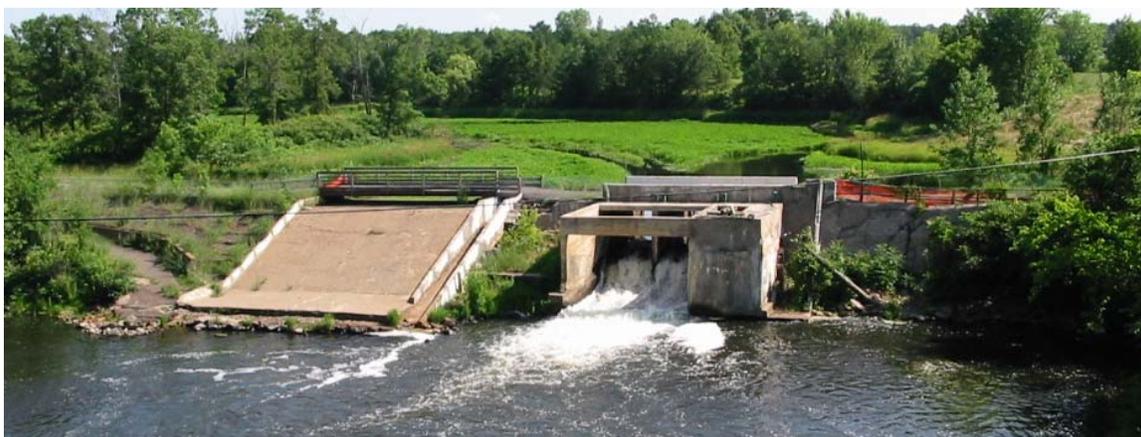
Figure 3. Woodley Dam in 2007 (powerhouse removed in 2003 and reservoir drawn down in 2001).

Citing excessive repair expenses, the grist mill building (last producing hydroelectric power in 1994 but never licensed under FERC jurisdiction) was removed in 2003 with little opposition (Figure 3), but the County's subsequent application for dam removal in 2003 was met with opposition.

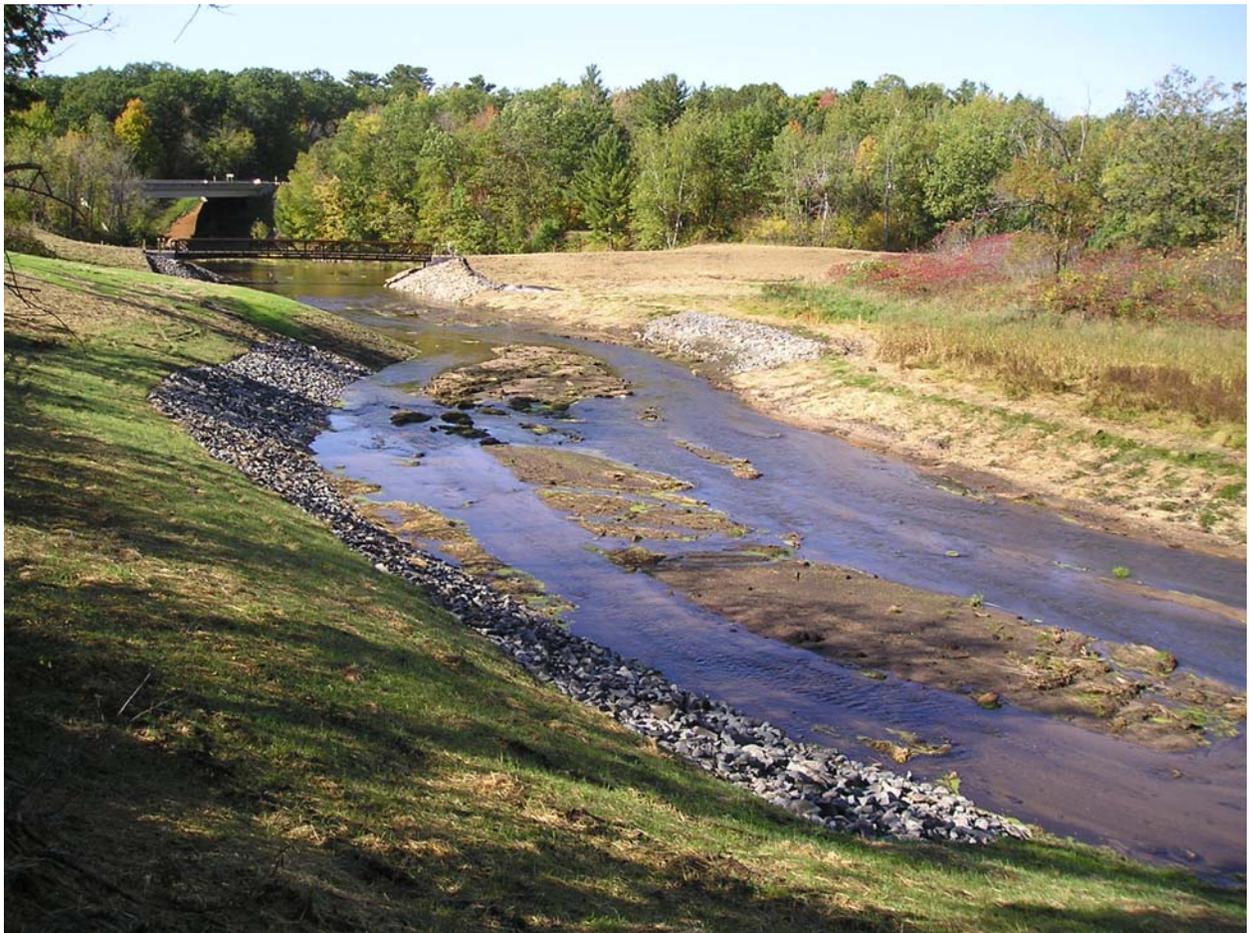
Figure 4. Woodley Dam in fall of same year as removal, note active sediment transport (bedload)

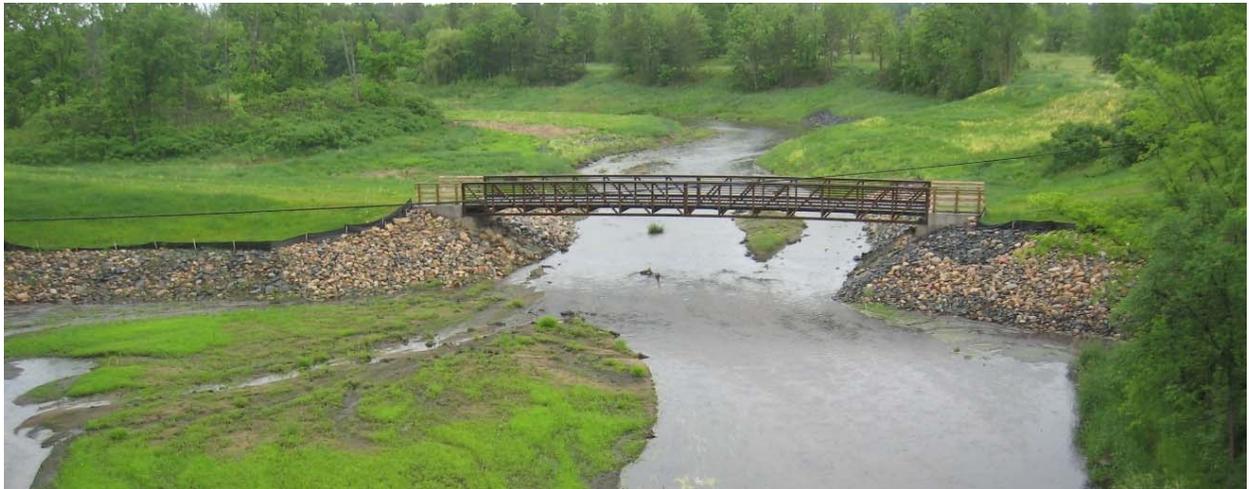
Figure 5 shows the site, two years after removal. The revised design (outer bend riprap and re-grading) successfully stabilized lateral bank stability, and the former scour hole below the dam had refilled with silt without leading to upstream migrating headcuts. The disposal site was stable and well vegetated.

Figure 5. Woodley Dam two years post-removal (same view as Figure 3), note little sediment transport

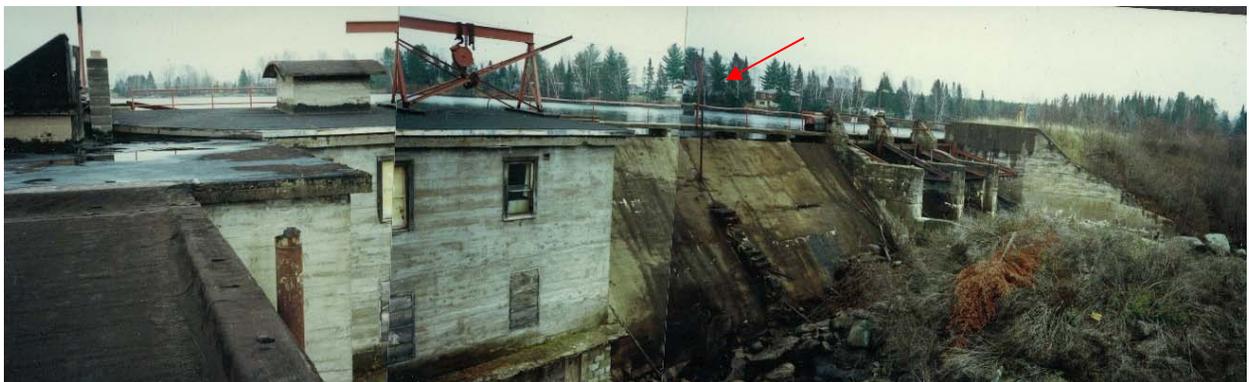
Figure 6. Grimh Dam in 1990, Pre-Removal

Sawyer County's Grimh Dam (45.760986°, -91.220336°) is 93.4 miles northeast of Powell Falls. When North Central Power Company decided to remove the 30-foot-high, 1200-foot-long Grimh Dam (Figure 6) in a sparsely populated region of northern Wisconsin, few anticipated the legal, environmental, and public safety challenges ahead. Grimh Dam originally supplied power to a local shingle factory, and the resulting Village of Radisson expanded around the Grimh Dam impoundment. As the shingle business faded, the dam was raised nine more feet to produce hydroelectricity for the region's wood-products industries and surrounding communities. By 1997, the dam required significant repairs to meet the Federal Energy Regulatory Commission (FERC) standards, so rather than complete the FERC licensure process, the owner published a legal notice to abandon the dam. The removal process was delayed during attempts to sell the dam to the community and other hydropower producers.

Figures 6 and 10 show, respectively, the before and after removal photographs (note the same house under the red arrow, though 15 years later).

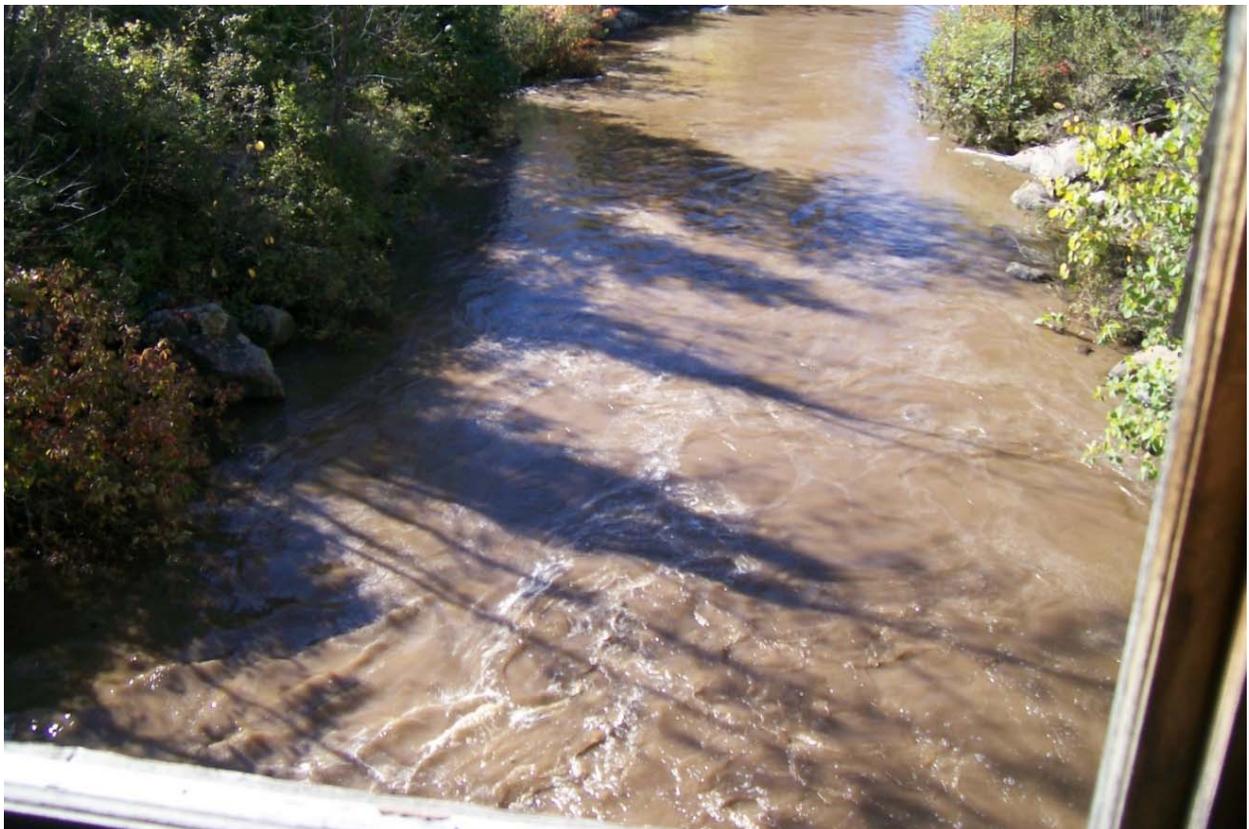
Figure 7. Couderay River below Grimh Dam during September 2010 flood event

Even after a decade of the lake drawn down halfway and a slow methodical drawdown and removal sequencing plan, sediment management was a significant challenge when compounded with high water events. For dam safety reasons, the WDNR permit restricted any work done onsite during high water, and this permit condition was implemented twice. Grimh Dam’s cofferdam overtopped as four inches of rainfall fell in seven hours on September 25, 2010. An unknown quantity of sediment (possibly 5,000 to 10,000 cubic yards) was released during this single event to the Couderay and Chippewa Rivers. Consultation with DNR dam safety and permitting staff was frequent, and all parties agreed that dam safety was the highest priority throughout the flood. Turbidity was high for three days (Figure 7), but then the river returned to normal color. Since the lake had refilled during the flood, the WDNR and Ayres waited for the lake to return to a drawn down condition for inspections of the remnant site. Within two weeks, Ayres’ inspections of the rivers below the removal site found no evidence of new sandbars, no change in bedforms, and little evidence that a large volume of silt had been released. However, the reservoir clearly showed signs that up to three feet of channel bed incision had occurred during this single event. The contractor was allowed to resume work once the high water period had passed.

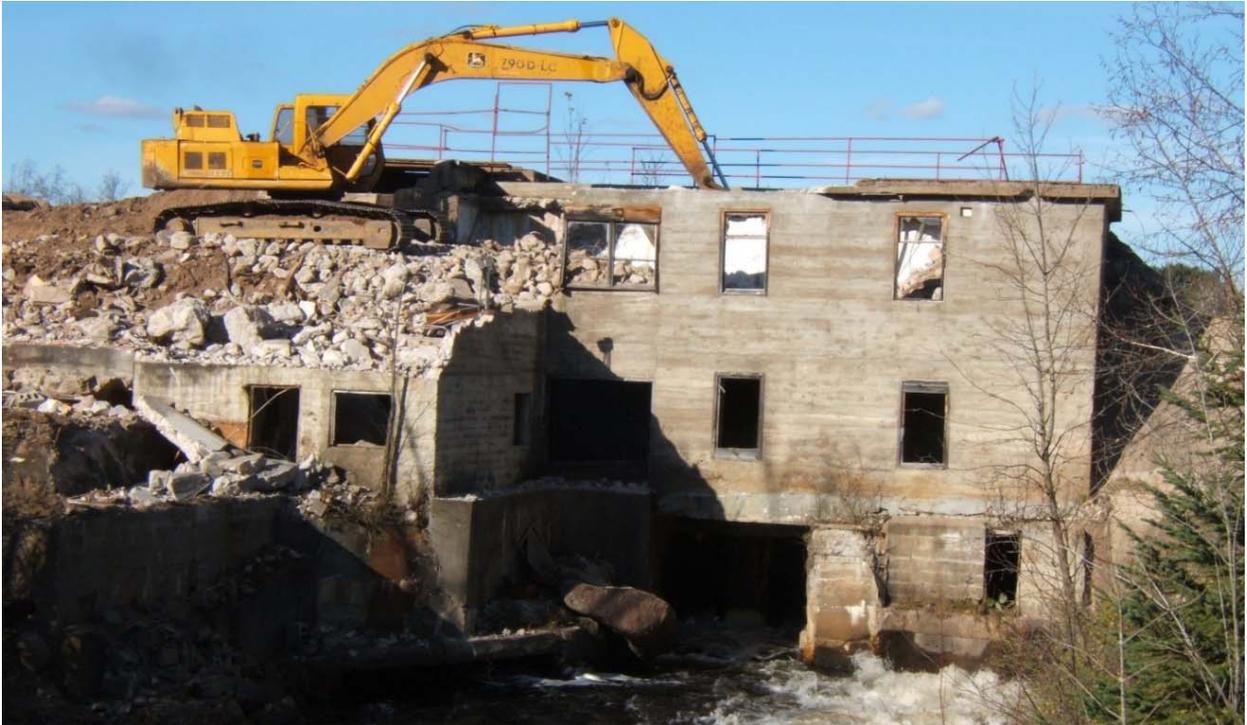
Figure 8 shows how difficult construction access was, because protected wetlands downstream of the dam and fifteen feet of muck upstream of the dam limited contractor access to slowly working from dam ends toward the dam's middle.

Figure 8. Difficult site access at Grimh Dam, looking upstream at powerhouse

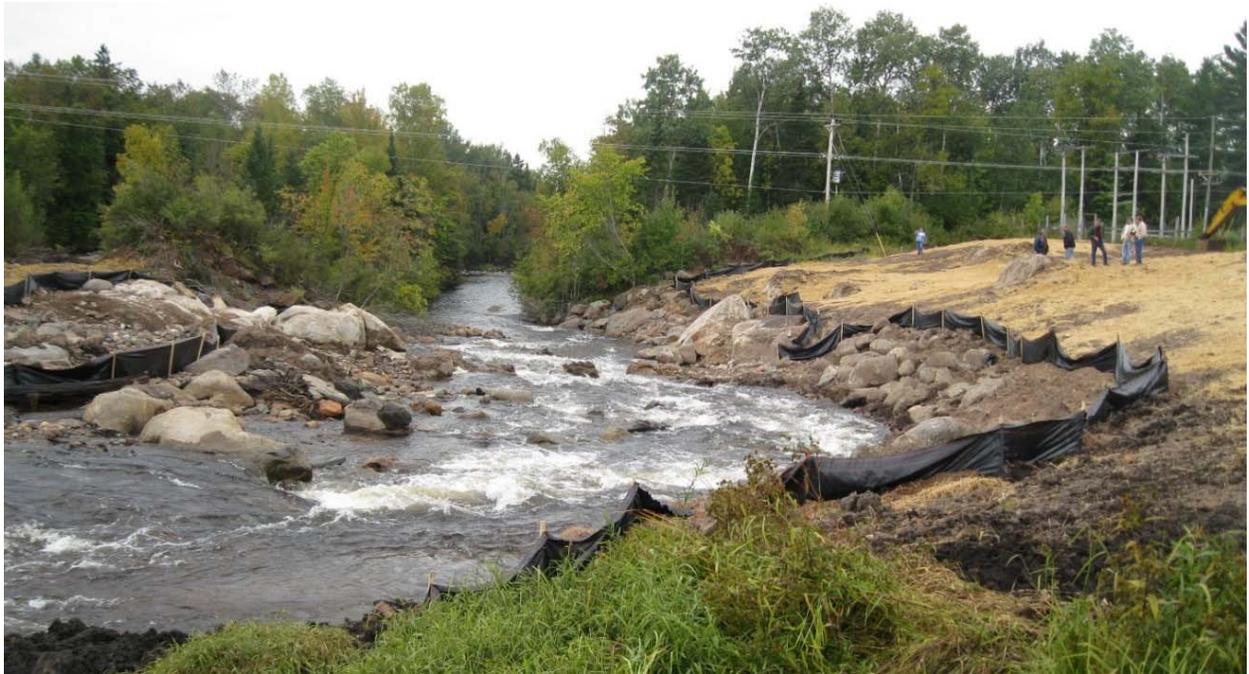
Figure 9. Complete removal of powerhouse by end of 2011, looking downstream at powerhouse site.

Figure 9 shows the site, looking downstream at the previous powerhouse location during the substantial completion inspection. This project was a highly collaborative project and also highly regulated with frequent DNR visits to the site. Figure 9 shows 4 DNR staff onsite during substantial completion and in the two years after completion many DNR upper management staff visited the site to see the results.

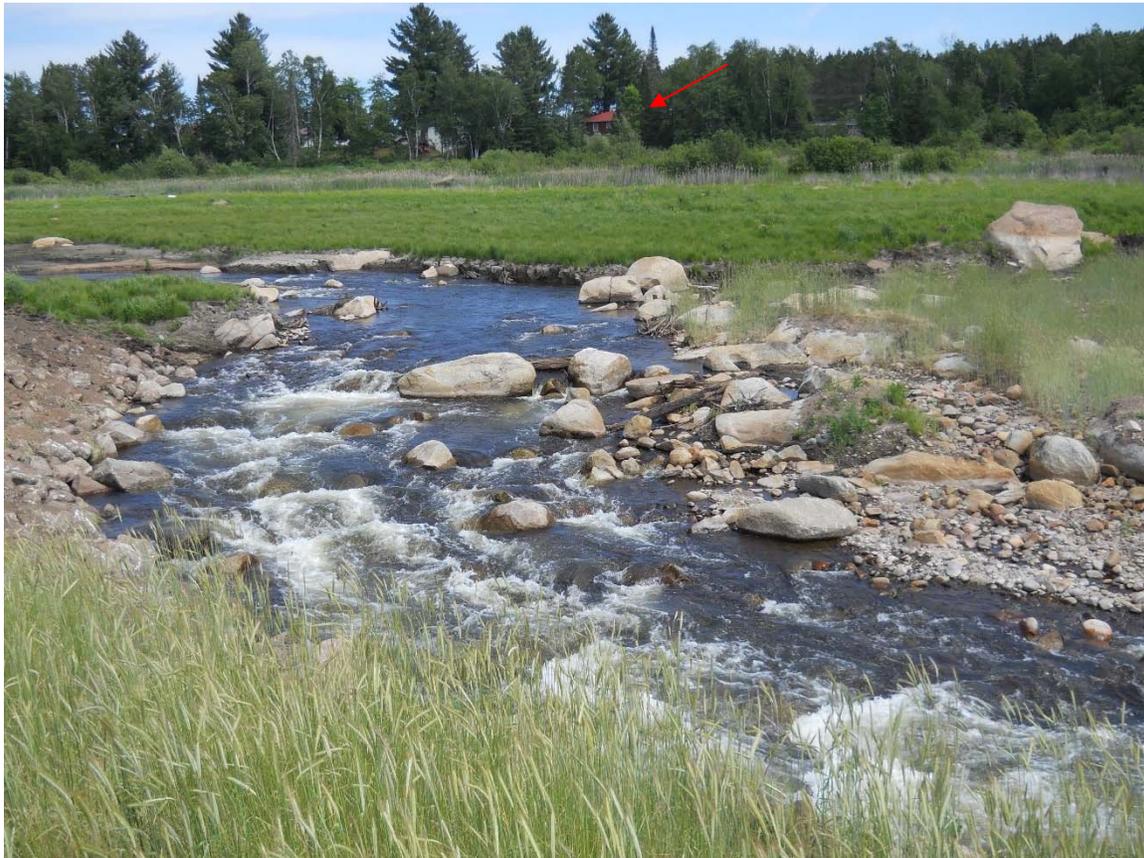
Figure 10. Grimh Dam site three years post-removal

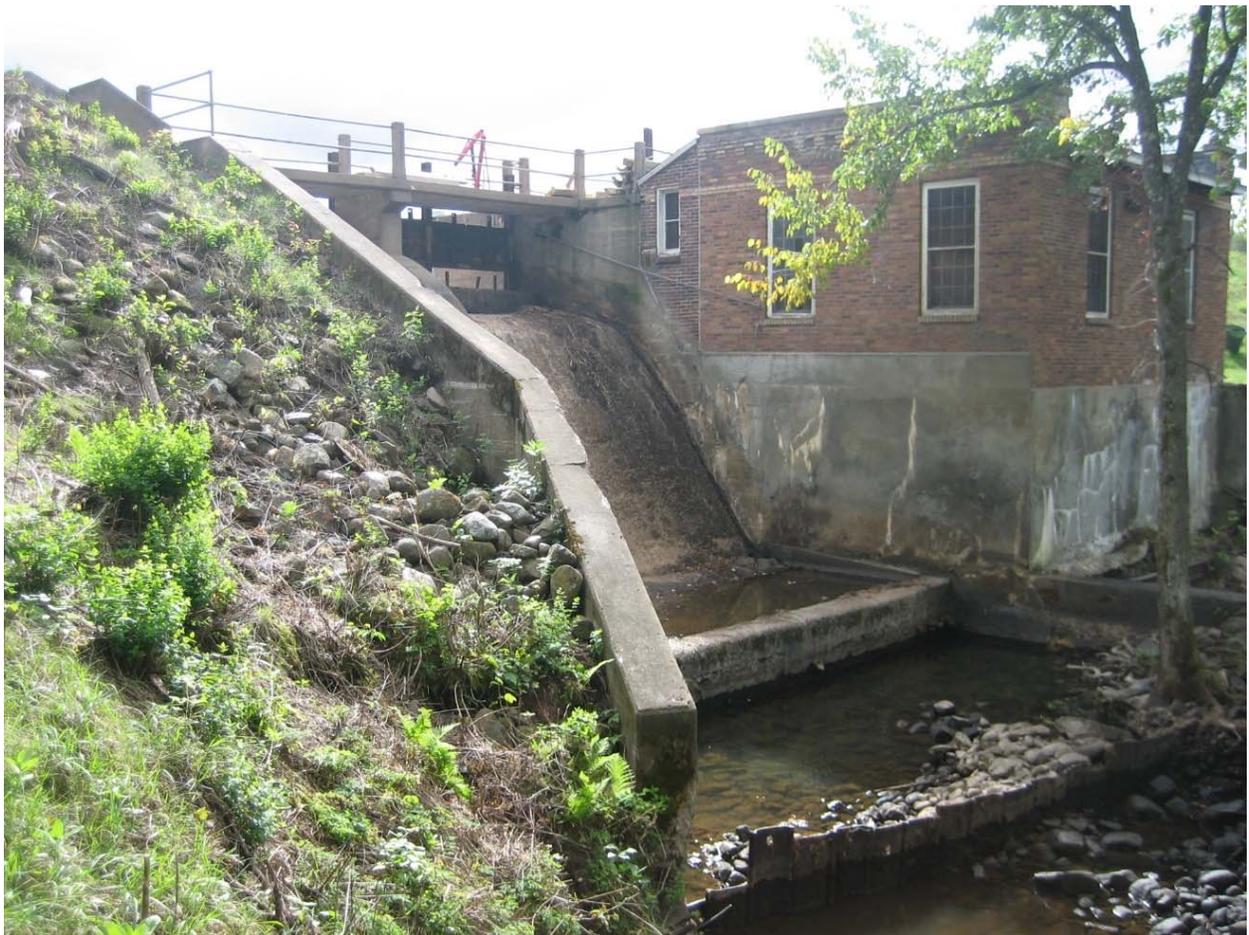
Figure 11. Gordon Dam Pre-Removal

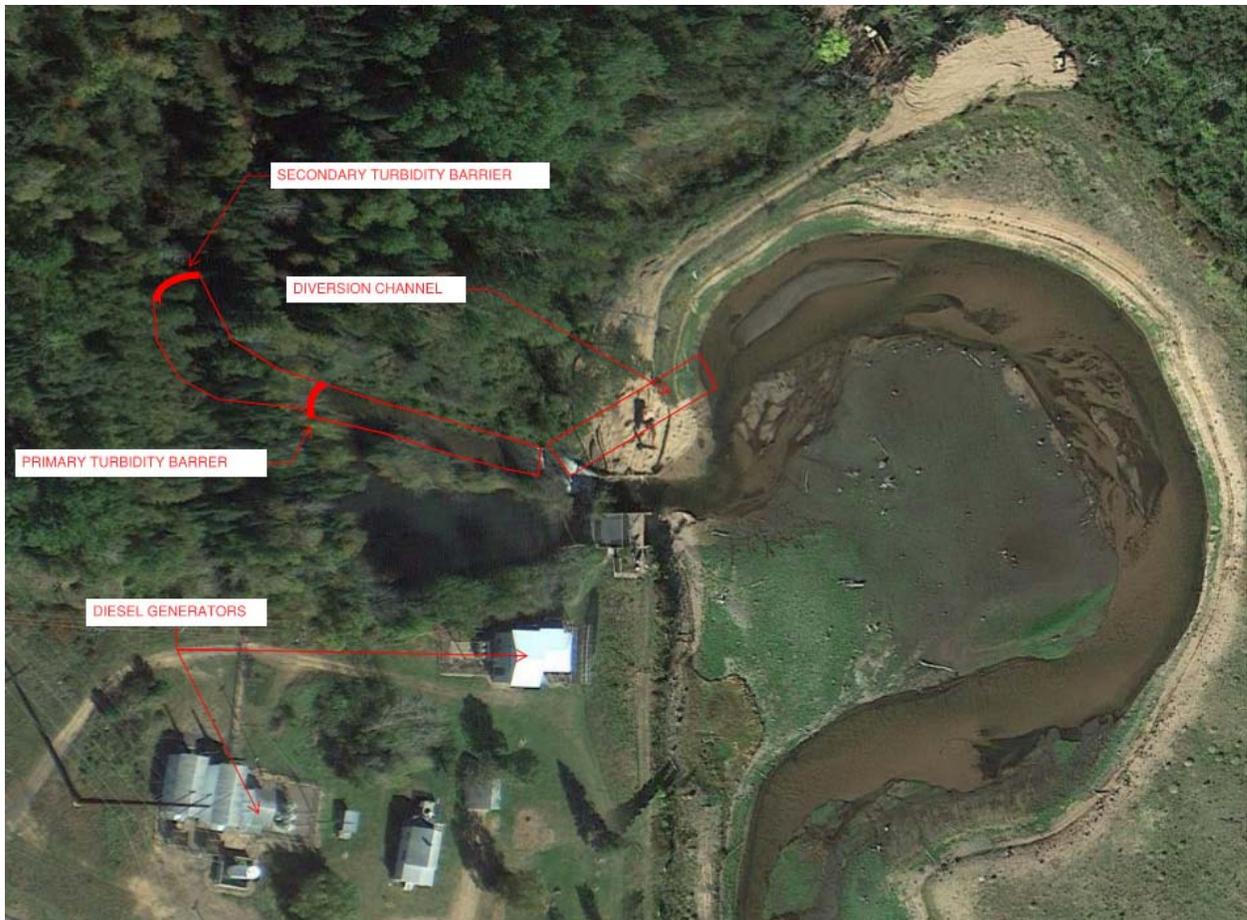
Figure 12. Gordon Dam removals' double turbidity containment system and diversion channel (image courtesy of and used under license of Google Earth Pro, 2020)

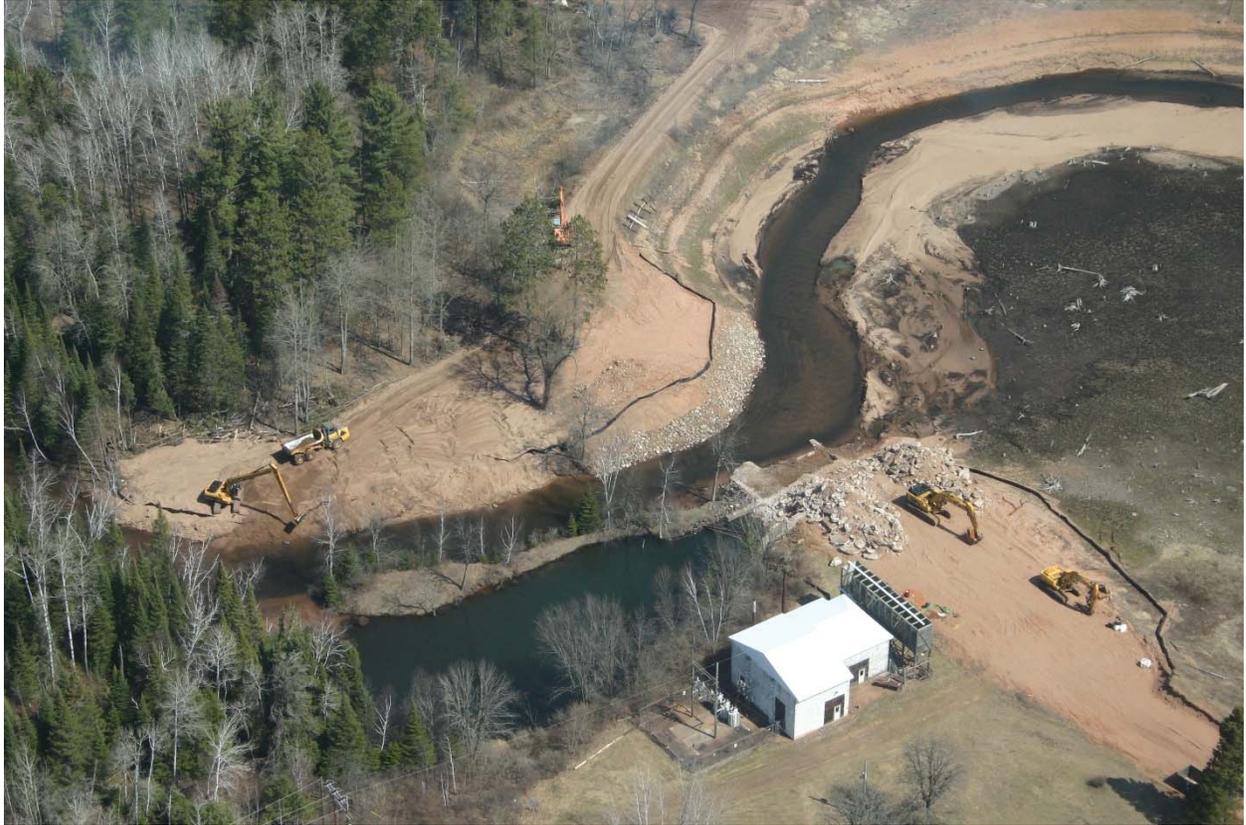
Figure 13. Gordon Dam during second year of removal (image courtesy of Frank Dallam, DNR)

Figure 13 shows the second-year removal (powerhouse foundation still shown), and this view shows the channel is carrying a significant bedload of sand nearly ten months after the full drawdown was completed.

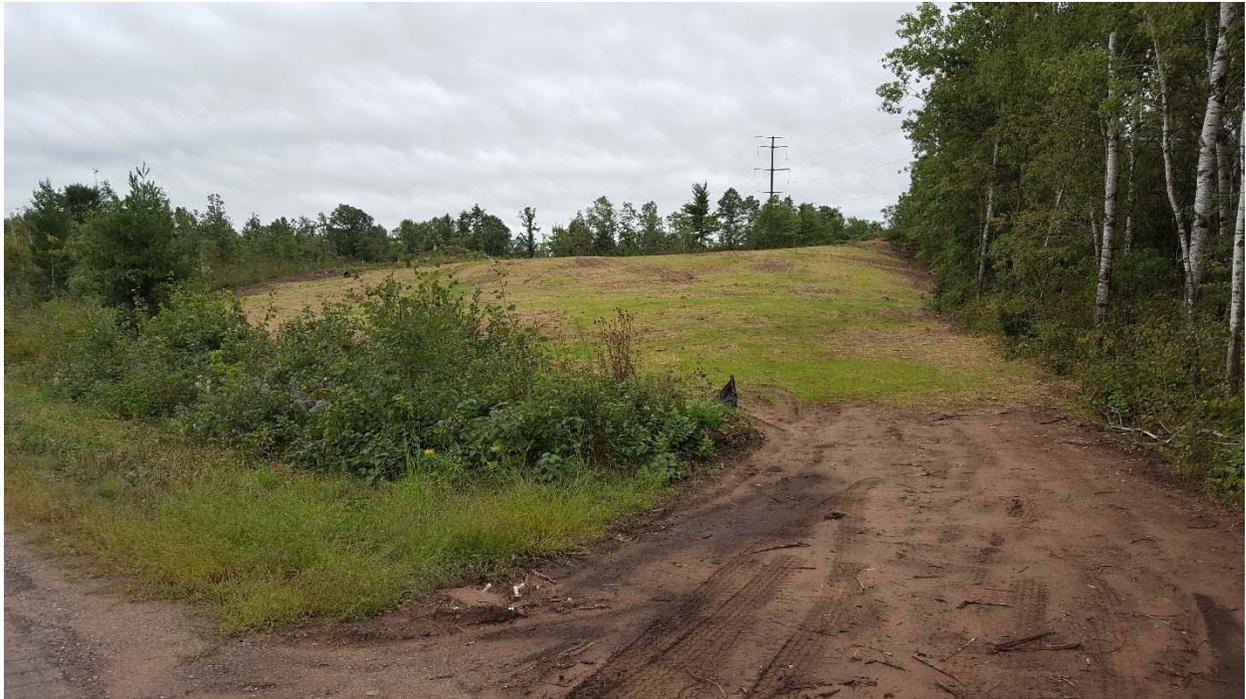
Figure 14. Gordon Dam's onsite permanent stockpile for removal materials

To remove the 13,500 cubic yards of embankment fill and clean concrete chunks, Ayres requested and received permits to store the removed materials onsite. Figure 14 shows the berm built into the hillside, capped with topsoil and seeded. The relatively silt-less sands collected by the turbidity barriers were donated to the local township's borrow pit for possible reclamation as future road sand.
