City of River Falls Hydroelectric Project FERC Project P-10489

Powell Falls
Decommissioning Plan

January 30, 2021

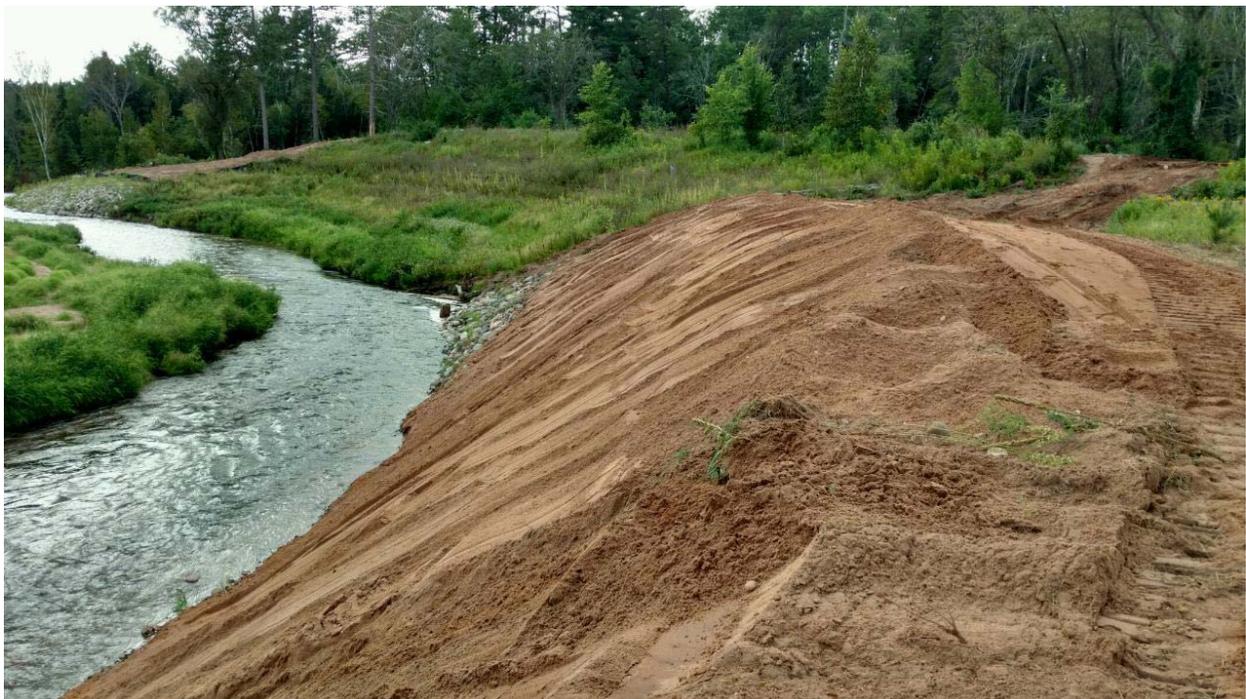
Figure 15. Bank restoration efforts at Gordon Dam

Figure 15 shows bank restoration efforts at two cut banks within the former flowage. The contractor used riprap and filter sand along the toe and regraded slopes to 3H:1V (horizontal to vertical; the site's round glacial sands required flatter than normal grades for stability).

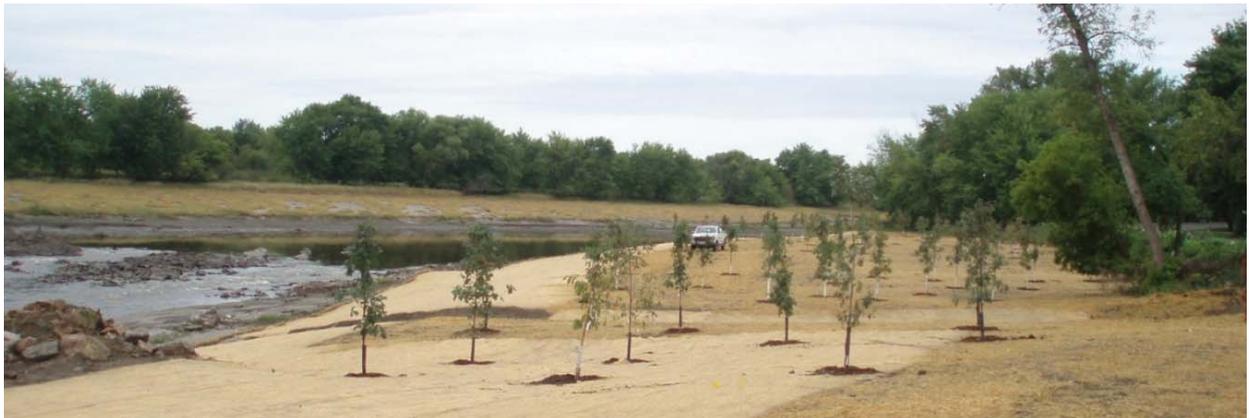
Figure 17. Post-removal view of Minnesota Falls Dam (photo courtesy of Xcel Energy³²)

After expiration of the FERC license, the timeline of the Minnesota Falls Dam Removal project was typical. Plans²⁹ to remove the dam were submitted to regulating agencies in January 2010 and the dam was removed³⁰ in February 2013 (Figure 17). The construction was completed during low river flow conditions in mid-winter, and turbidity was monitored downstream of the worksite for most of the 62-day construction period. Construction was completed by equipment working in water to hydraulically hammer and demolish the structure in place. Once demolished, crews hauled sediment and clean concrete fragments to an onsite disposal location and other materials to approved landfill or recycling centers. The winter drawdown and dam removal efforts were successful at meeting the turbidity standards set by the state reviewers. Vegetation at the removal site was stabilized by September 2013, and the construction report (including post-construction monitoring provisions) was issued in December 2013.³¹
