**Summary Report
River Falls Hydroelectric Project
Lake George Shoreline Habitat Assessment
River Falls, Wisconsin**

**Contract No.: W912ES20D0001
Delivery Order: W912ES20F0062**

December 2020

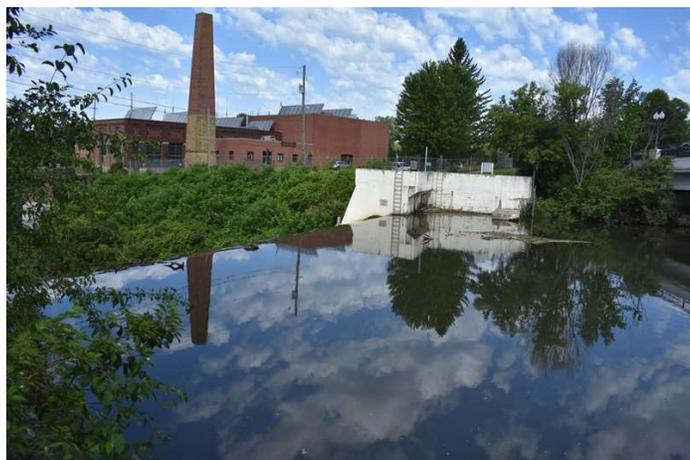
Photograph 1. View of Junction Falls Dam and the adjoining powerhouse, facing northwest.

Around Lake George, as well as the adjacent upper reach of the Kinnickinnic River to the north and Lake Louise to the south, public use areas including biking/walking trails, benches, and water-access infrastructure have been developed for use by residents of the City of River Falls. Paved bike trails run along both sides of Lake George. While most of the parcels around the lake are maintained as a public recreation opportunity, parcels along the upper reach of the Kinnickinnic River are owned by private individuals and contain both businesses and residences. The City of River Falls surrounds the lake, including the city's downtown to the east/northeast of the lake and neighborhoods to the west. The Junction Falls powerhouse is located immediately west of Junction Falls Dam (Photograph 1).

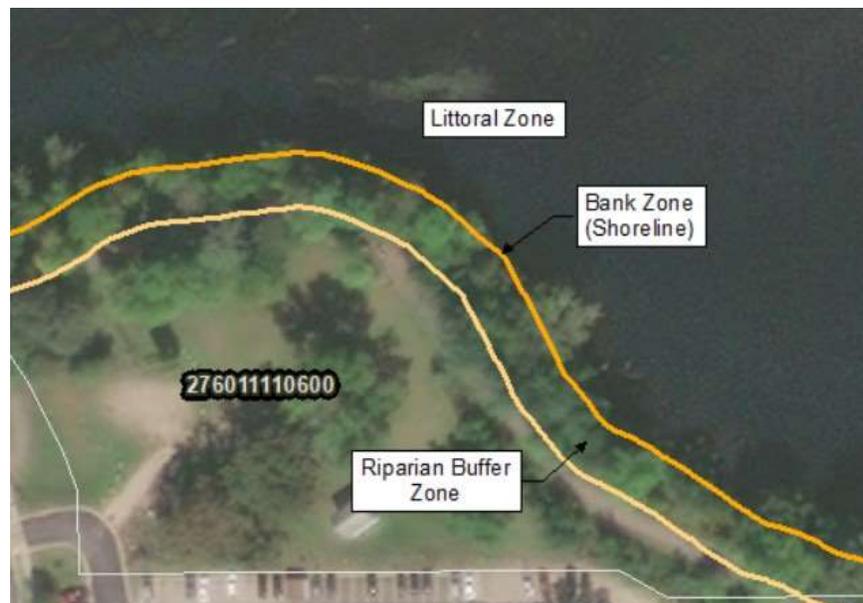
Figure 3. Assessment Zones for Lake George SHA

An example of these zones shown over aerial imagery for a single parcel along Lake George is provided in Figure 3.

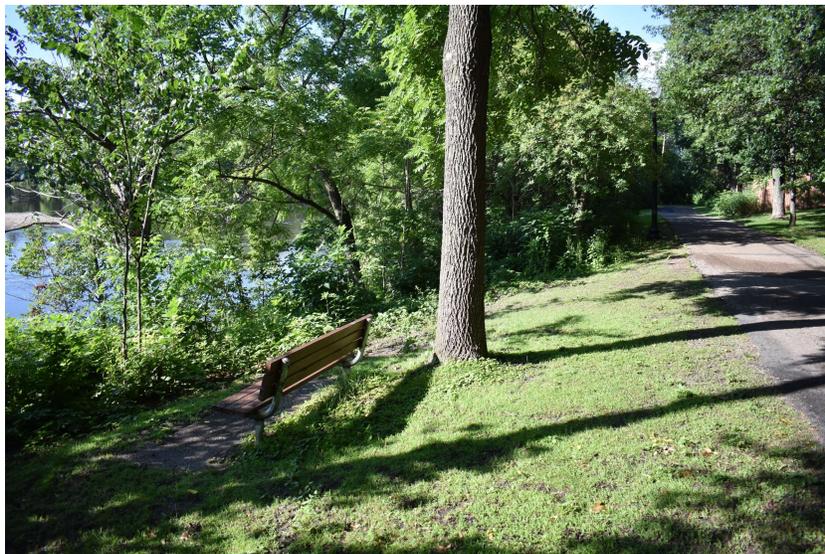
Approximately one quarter of the riparian buffer zone exhibited significant disturbance or anthropogenic modifications. Typical disturbed areas include maintained lawns along Lake George intended for public use and paved trails used by bicyclists and pedestrians (Photograph 2).

Photograph 2. Typical forms of vegetated cover, manicured lawn, and impervious surface found in the Riparian Buffer Zone.

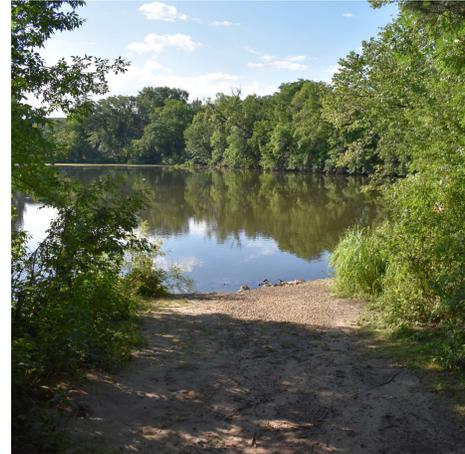
Though primarily lacking development more extensive than trail systems, the Lake George and upper Kinnickinnic River riparian buffer zone contains sporadic structures as presented in Table 4 and Figure 9. None of the five buildings recorded in the 35-foot buffer were located along the Lake George shoreline. Rather, four buildings are located on the eastern side of the upper Kinnickinnic River, and the other building recorded was a portion of the Junction Falls Development’s powerhouse which is found downstream (south) of the dam. Additional buildings are located in the parcels assessed but are found outside (i.e., further inland) of the designated riparian buffer zone. The boat ramp located on the western shoreline of Lake George is a gravel takeout with rip rap at the base (Photograph 3).

Photograph 3. Boat ramp on west side of Lake George.

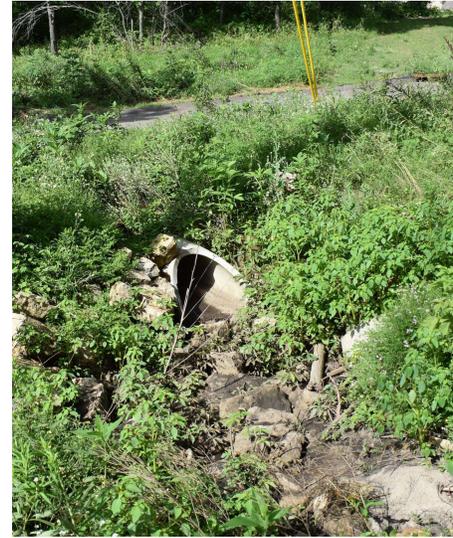
Runoff concerns and other inputs of water to the impoundment and river were considered for both the riparian buffer zone and the rest of the parcel outside of the buffer zone (i.e., further inland). Typical runoff concerns recorded were trails or roads leading to the lake and lawns or exposed soil sloping towards the lake (Table 5). Point sources, defined as specific identifiable sources of water or pollution input into the lake (e.g., storm water outflows), were found consistently around the lake. Due to the often hidden or obscured nature of point sources observed, it is possible that more exist along the lake and river edge that have been covered by debris, vegetation, or soil erosion (Photograph 4).

Photograph 4. Typical point source in riparian buffer zone.

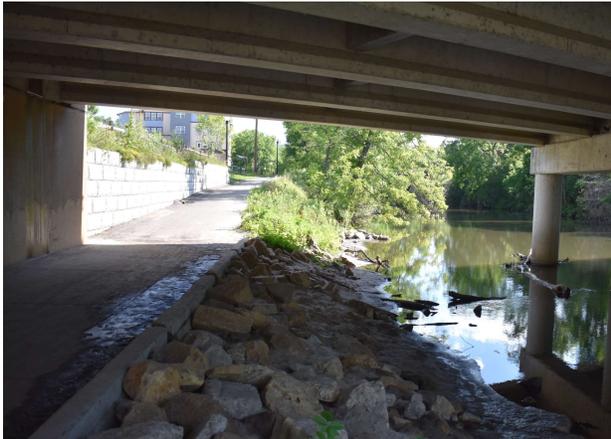
Photograph 5. Top left – Paved path sloping to lake showing collected water.

Other examples of types of runoff concerns are provided in Photographs 5 through 7. Channelized water flow was minimal and on average less than 2 feet wide when found in the Project Area. Trails or designated paths leading to the lake were either portions of the walking path installed by the City or pedestrian-made dirt trails leading to fishing spots or lookouts along the Lake George bank.

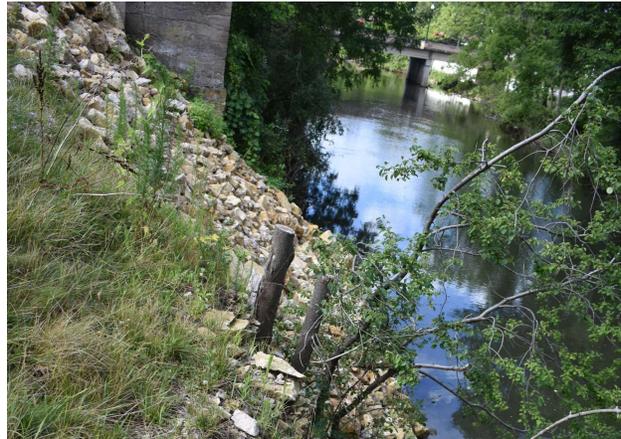
Photograph 6. Top right – steep slope with maintained lawn and rip rap behind.

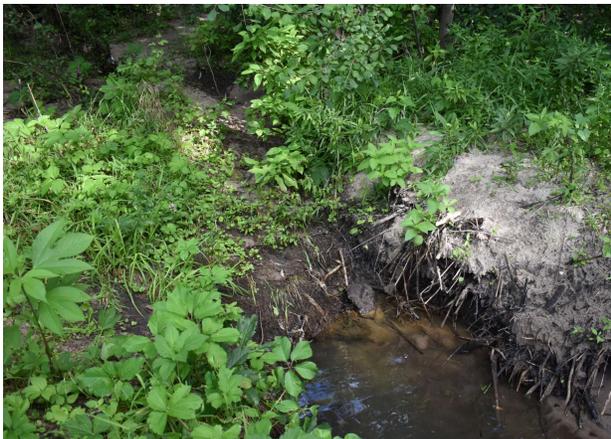
Photograph 7. Bottom left – signs of minor channelized (ephemeral) water flow coming from uphill.

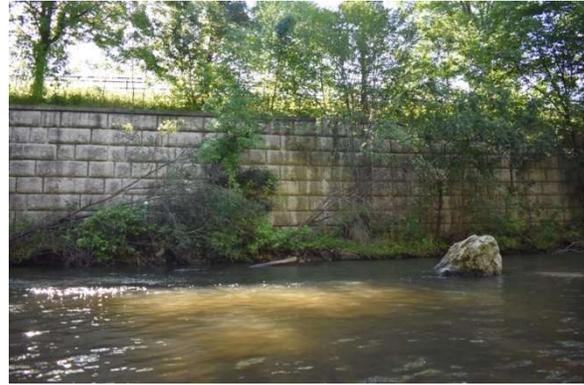
Within the bank zone, which is the portion of shoreline between the upper bank lip and lower bank toe that typically contains the OHWM, anthropogenic modifications consisted of vertical retaining wall along two stretches and rip rap (Table 6). A retaining wall has been installed along the western bank of the dam and powerhouse (Parcel No. 276011040400) as well as a stretch of the eastern bank of the upper Kinnickinnic River (Photograph 8). Rip rap was found commonly associated with bridges, retaining walls, or steep portions of shoreline along the upper reach of the river. A short stretch of shoreline containing natural vegetation on the east bank of the river showed signs of erosion.

Photograph 8. Retaining wall along upper Kinnickinnic River.

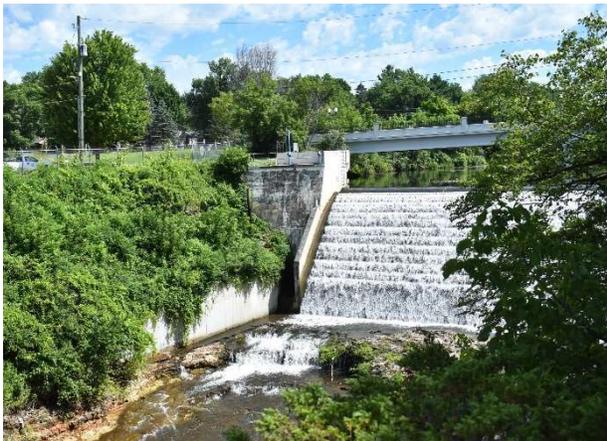
Photograph 9. Junction Falls Dam.

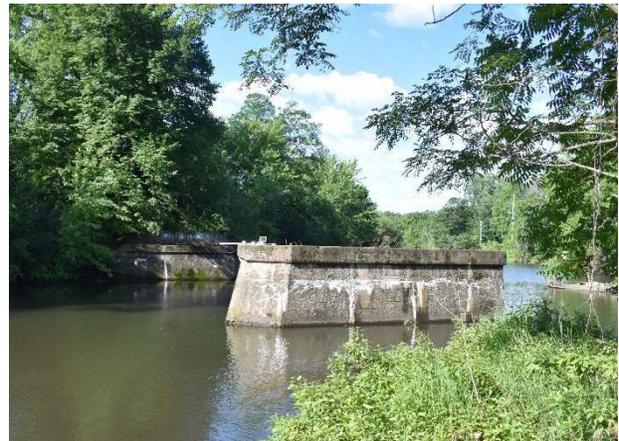
Photograph 10. Old bridge abutments.

Two large road bridges (West Maple Street and Winter Street) are located between parcels and not noted in the list above, but these bridges are present in the littoral zone of the overall Project Area. Photographs 9 through 12 present examples of the human structures found in the littoral zone.

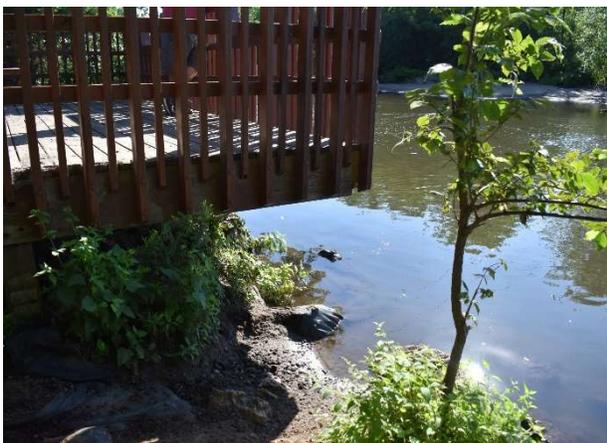
Photograph 11. Fishing pier.

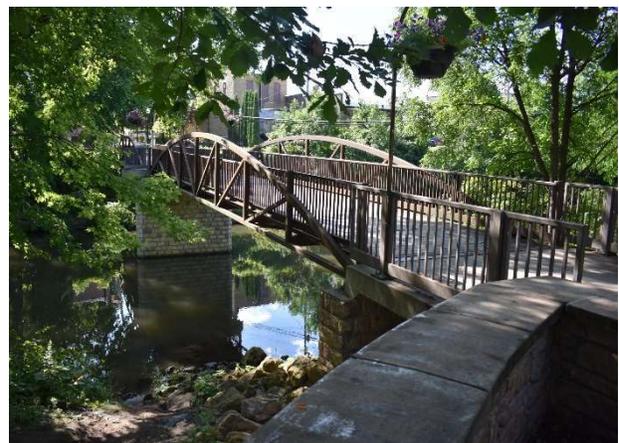
Photograph 12. Riverwalk foot bridge.

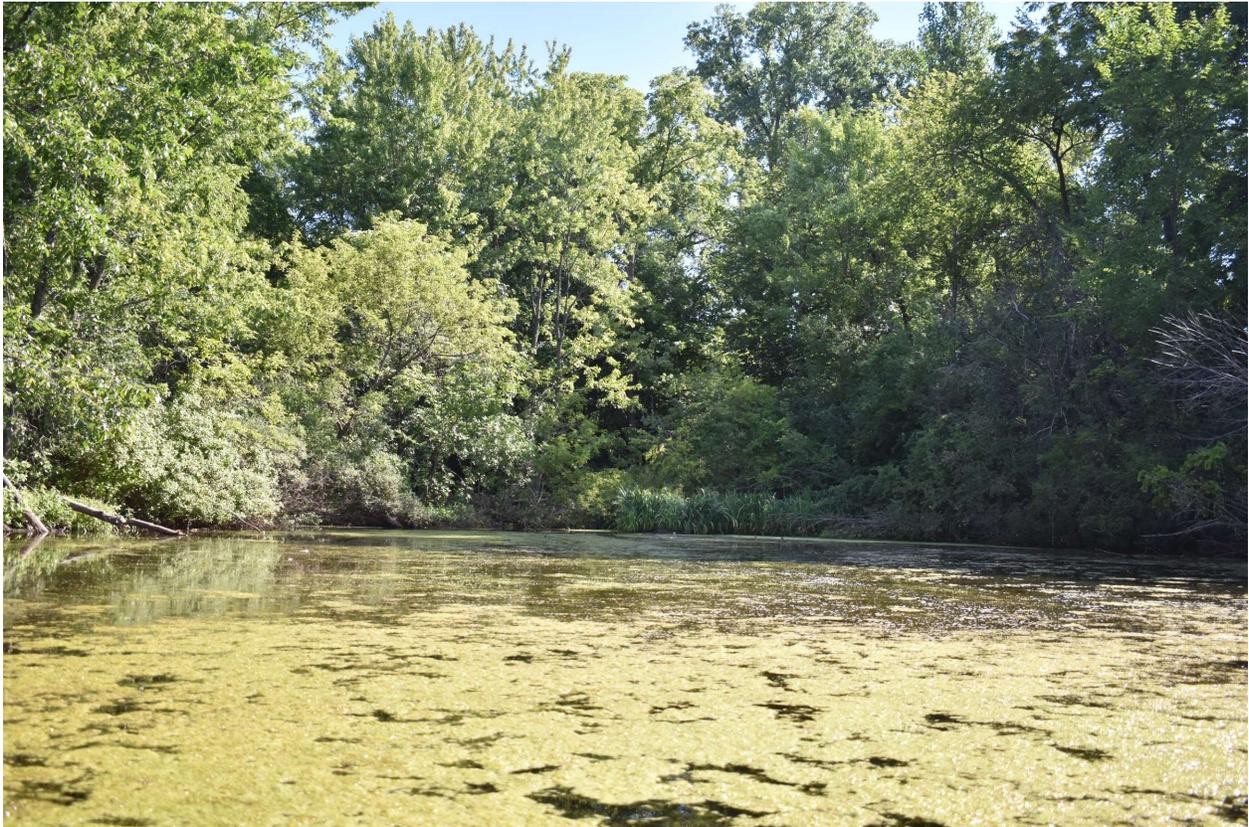
Emergent and floating aquatic plants were observed in five parcels and four parcels, respectively. The parcels in which aquatic plants were observed typically bordered Lake George or the slower, wider section of the river immediately upstream (north) from Lake George (Figure 10). It should be noted that submerged aquatic plants are not included in the SHA, with an explanation given as “Plants growing only underwater (submergent) are not included in the survey because they may be difficult to observe.” (WI DNR 2020). There is a high density of submerged aquatic plants in Lake George and also seasonally, green algae (Photograph 13). The results of a 2020 invasive aquatic plant species survey conducted by Inter-Fluve provide further information on the species composition and densities of aquatic plants in the impoundment (Inter-Fluve 2020).

Photograph 13. Green algae bloom on Lake George.

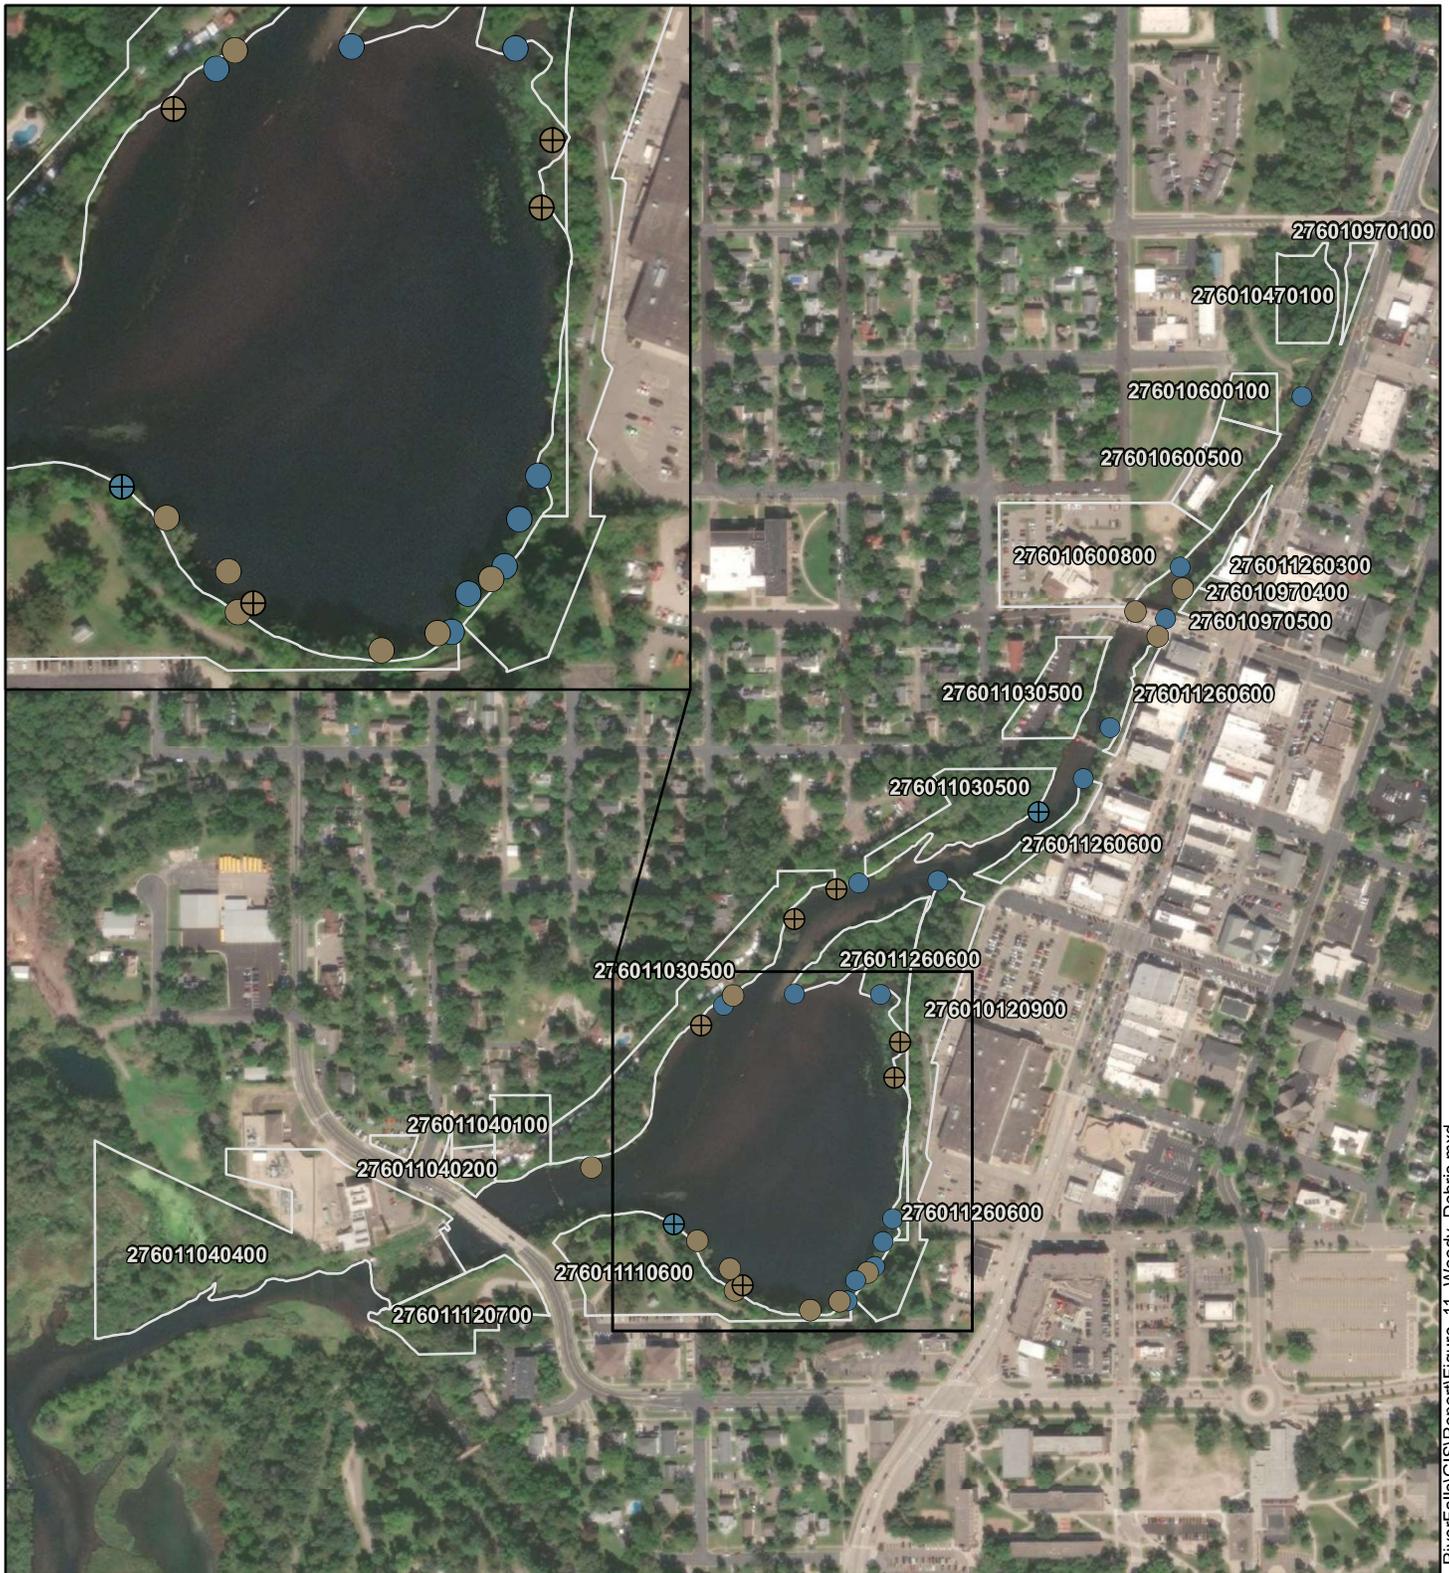
Figure 11. Large Woody Debris in Lake George

Photograph 14 shows the typical form of woody debris found on the edge of Lake George. The largest congregation of woody debris occurred along the southern to southeastern shoreline of Lake George, likely because of patterns of water flow and deposition.

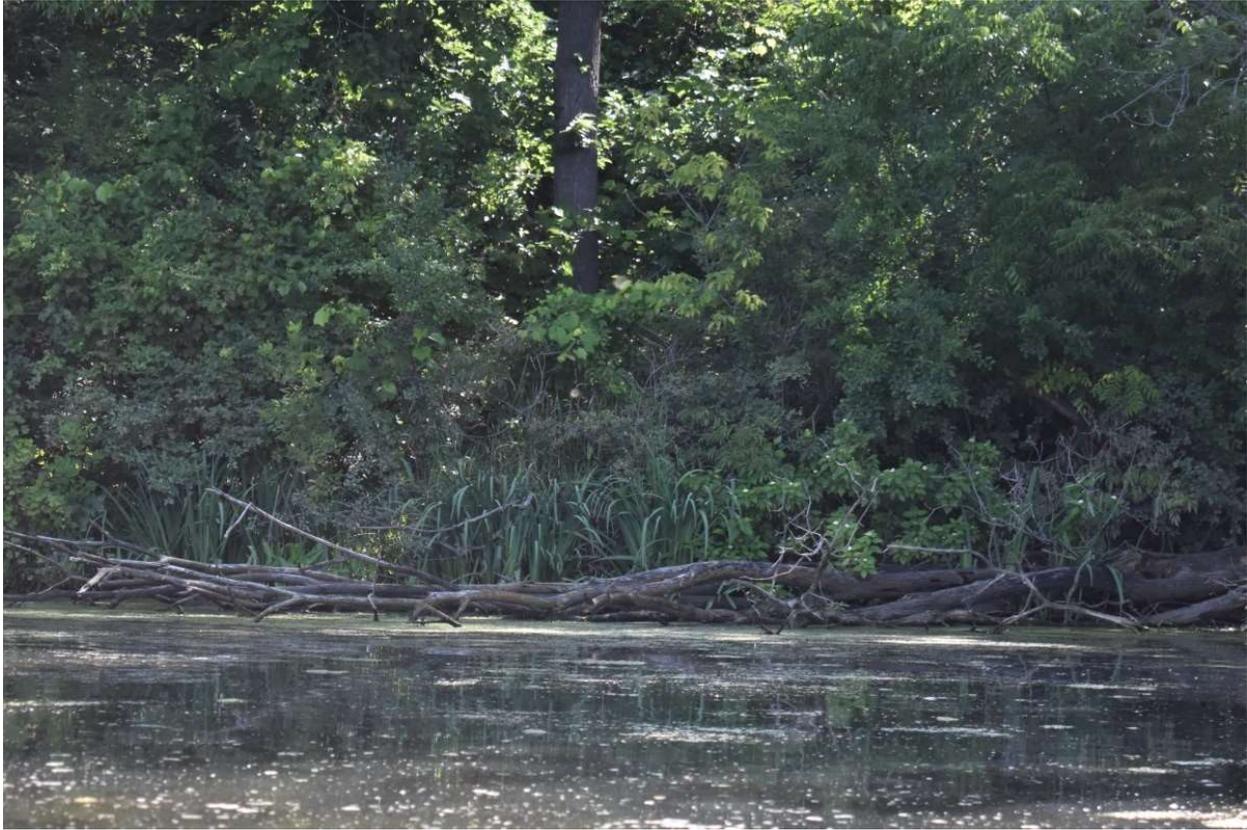
Photograph 14. Example of woody debris on the Lake George shoreline.

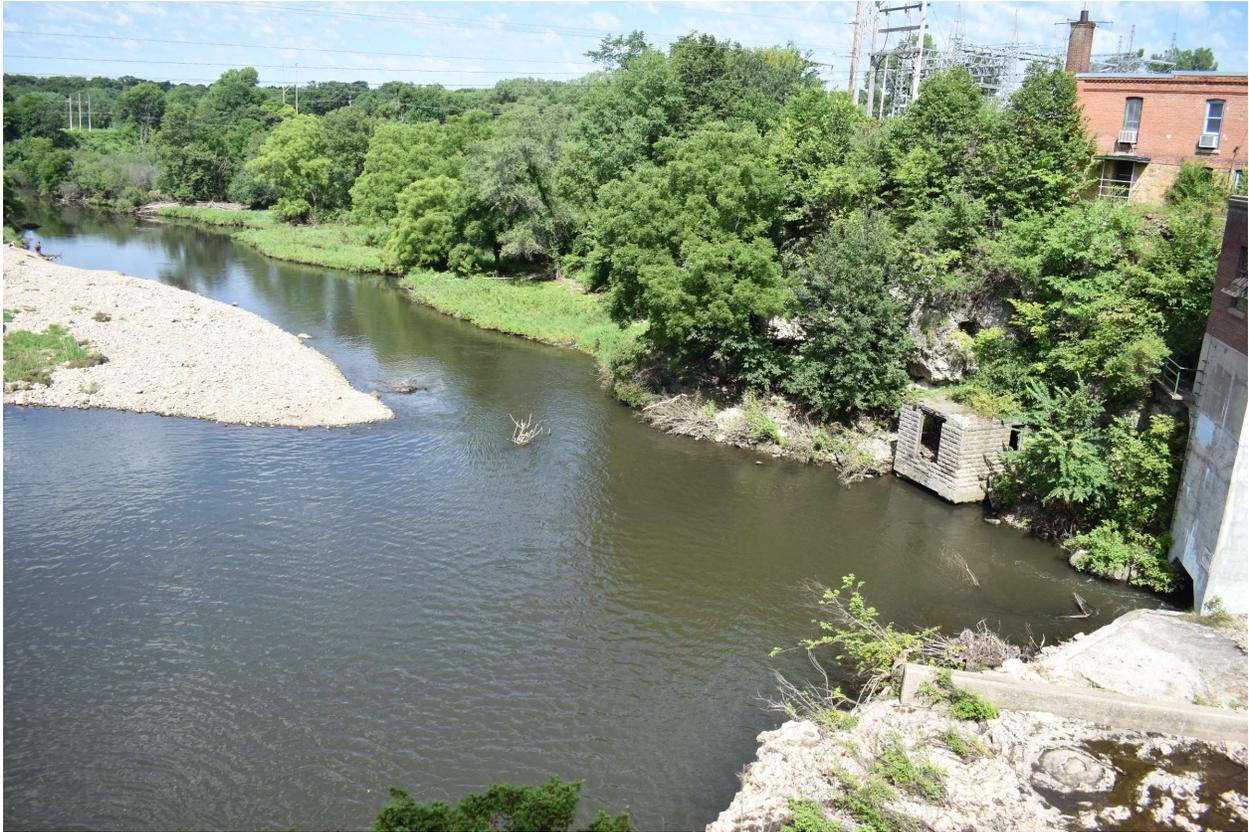
South of Junction Falls Dam, the shoreline changes rapidly from exposed bedrock waterfalls that have been modified by the installation of the dam, adjoining retaining wall, and powerhouse to a short “river reach” that leads to Lake Louise to the south. Lake Louise is the impoundment that has been created by installation of the Powell Falls Dam further south. This short stretch of channel between impoundments (Photograph 15) is likely to have become wider and shallower than pre-disturbance conditions, as is typical of river reaches where sediment transport has been impeded downstream and an impoundment has developed (Schmutz and Moog 2018). Swaths of reed canary grass (*Phalaris arundinacea*) dominate much of the northern shoreline of

this reach. Channelized water drainages have developed that connect the river to wetlands that have established immediately to the north. It is possible that these wetlands developed in response to installation of the two dams.

Photograph 15. Stretch of river south of Junction Falls Dam.

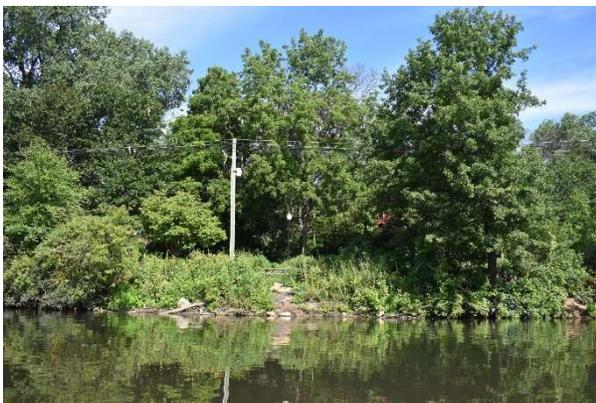
Photograph 16. View of southeast portion of Lake George shoreline.

Lake George is the second distinct portion of the Project Area and the focal point of this SHA study. The original river channel flowed near to the existing northwest shoreline (along Parcel No. 276011030500). When the dam was built, the impoundment was created to the south and east of the original channel in lower elevation floodplains or forests. Currently, the shoreline around the lake is mostly consistent in character (Photographs 16 and 17).

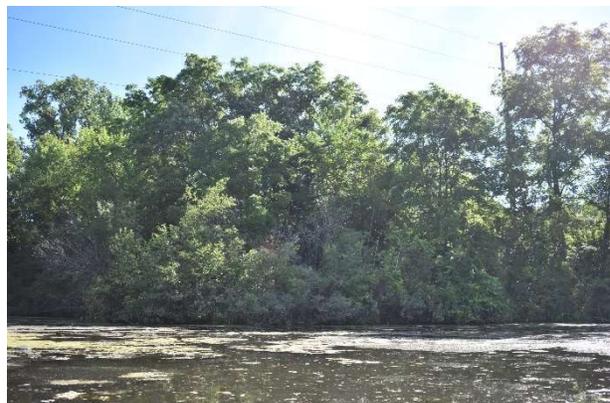
Photograph 17. View of northwest portion of Lake George shoreline.

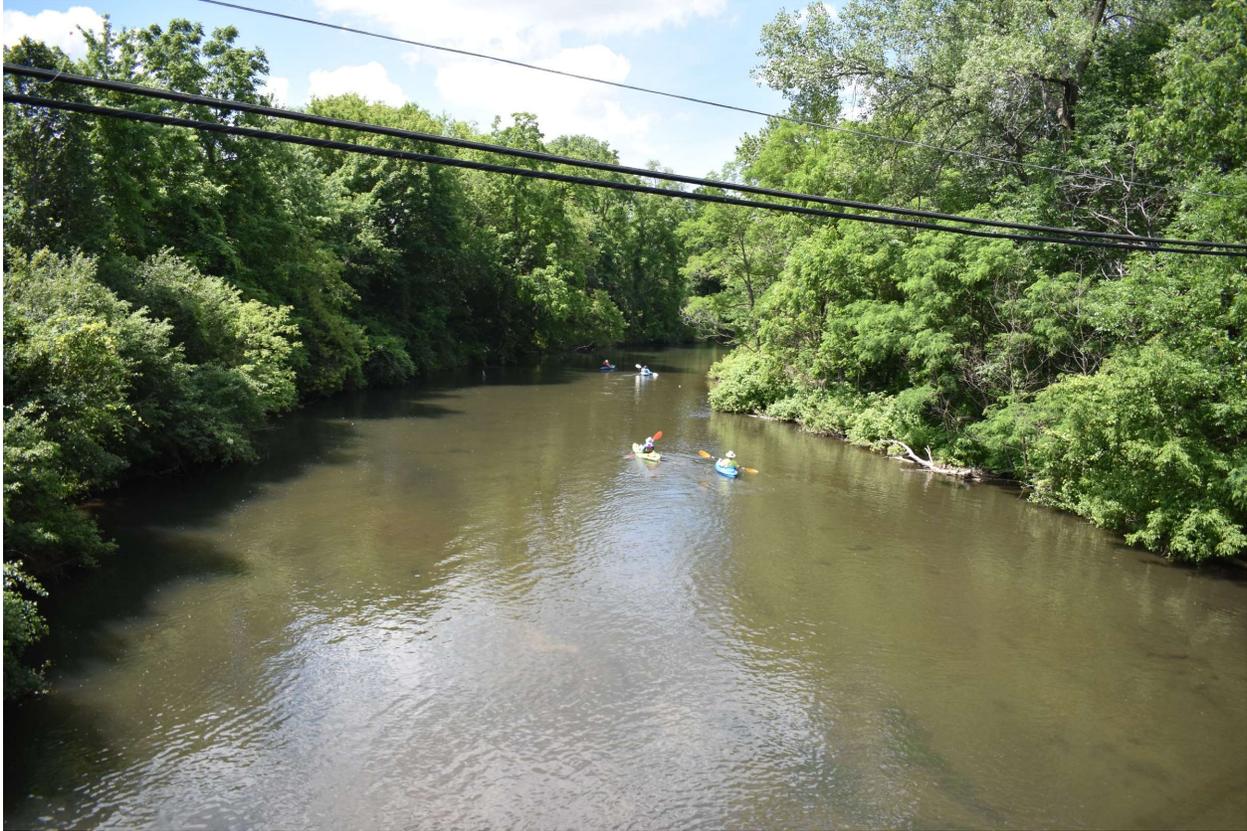
Photograph 18. Kayakers on the Kinnickinnic River north of Lake George.

The third relatively distinct portion of the Project Area is a short stretch of the upper Kinnickinnic River directly north of Lake George (Photograph 18). Closer to Lake George, this stretch appears to be wider, shallower, and slower moving than prior to establishment of the impoundment due to sediment deposition. Further upstream, the river is found in its natural form.
