River Falls Hydroelectric Project Riverine Habitat Evaluation below Powell Falls

January 2021

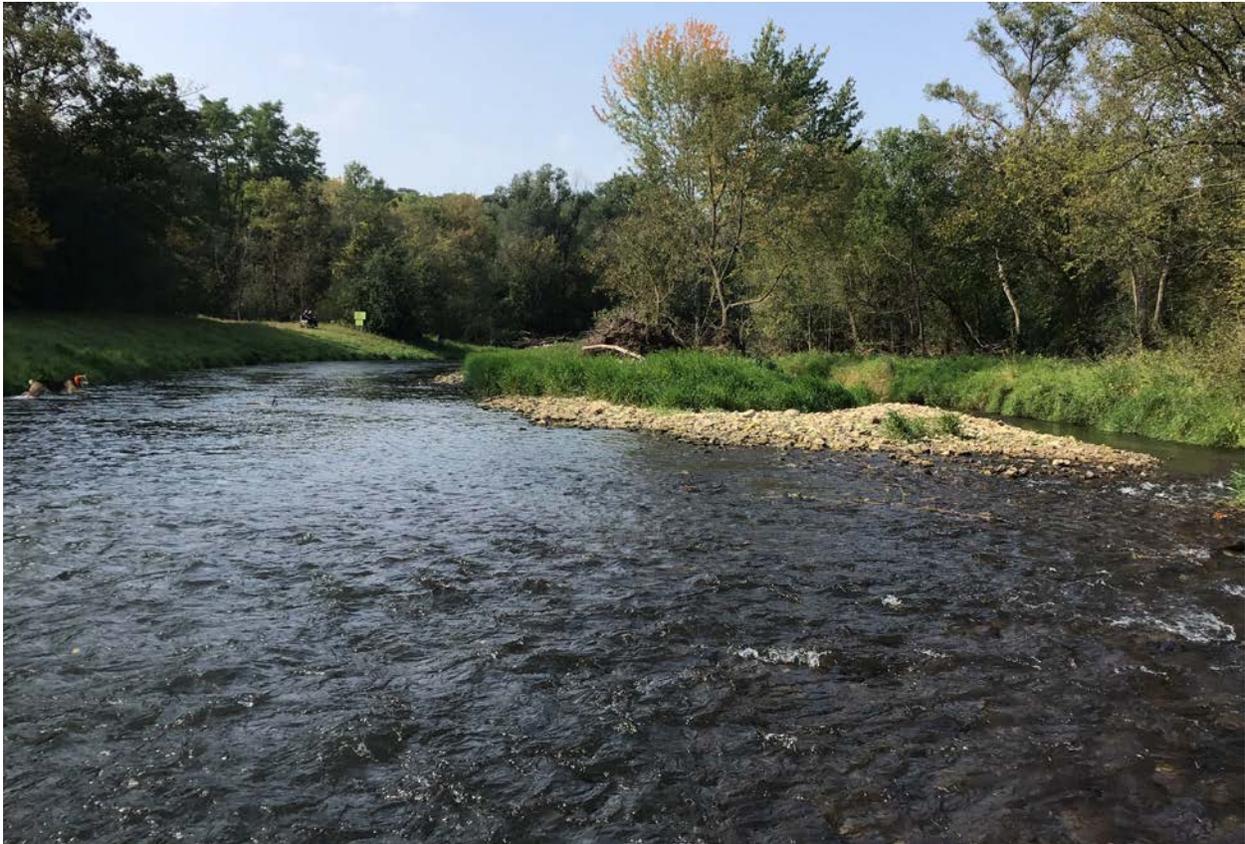
Figure 2: Typical photo collected at station 490+00 in representative subreach 1.

Representative subreach 1 was from station 484+00 to 500+00. Banks in representative reach 1 were typically vegetated. From Station 489+80 to Station 500+00 (approximately 120 feet), the left bank was bare and likely actively eroding. Exposed bank sediments were composed of sandy loam. Streambanks were generally stable and active erosion was interpreted as a result of the natural lateral migration of the river channel in response to flood events. For approximately 450 feet on river left, the river ran adjacent to a maintained trail and near a historic lime kiln. This portion of the bank was stabilized with riprap below the ordinary high water. A 300-foot long, 40-foot wide vegetated island was present within the reach. The island was vegetated with reed canary grass and a cluster of four 3-to-6-inch diameter deciduous trees. Bankfull widths averaged 66 feet (+/- 4.5 feet), wetted width averaged 59 feet (+/- 3.4 feet), and bankfull thalweg depth averaged 4 feet (+/- 0.5 feet). Riffles were typically composed of poorly sorted sand to cobble with cobbles typically embedded by smaller material and had bankfull depths which averaged 2 feet. Depth of refusal on riffles was generally between 2 and 3 feet. Pools were typically composed of well sorted sand or gravel with residual depths of 2 feet (+/- 0.5 feet). Valley width was estimated to be 400 feet. Overbank

sedimentation was common, with sediments composed of well sorted fine sand and typically deposited as sand sheets in low lying floodplain forest and were thickest in areas associated with the Rocky Branch. There was on average one large wood piece per 100 feet. This subreach contained a low density of habitat features with few large wood pieces and overhanging vegetation. Undercut banks were absent. Pools were typically shallow. The main habitat feature within this subreach was coarse riffle substrate and boulders associated with the riprap bank.

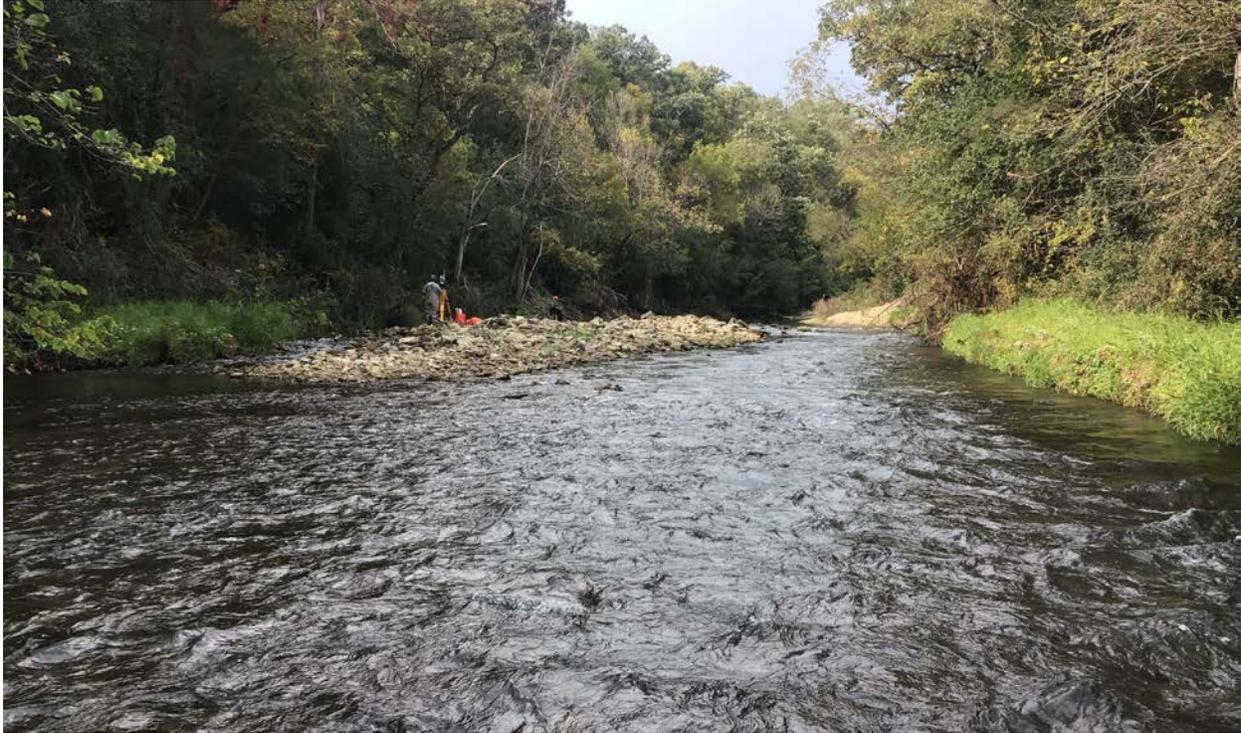
Figure 3: Typical photo collected at station 445+00 in representative subreach 2.

Representative subreach 2 was from station 434+00 to 444+00. Banks in representative subreach 2 were approximately 80% vegetated with alternating banks exposed. Where exposed, bank sediments consisted of poorly sorted sand and gravel. Streambanks were generally stable and active erosion was interpreted as a result of the natural lateral migration of the river channel in response to flood events. Bankfull widths averaged 67 feet (+/- 6.2 feet), wetted width averaged 63 feet (+/- 7.0 feet), and bankfull thalweg depth averaged 4 feet (+/- 1.3 feet). Riffles were typically composed of poorly sorted sand to cobble with cobbles typically embedded by smaller material and had bankfull depths which averaged 2.5 feet. Depth of refusal on riffles was generally between 1 and 2 feet. Pools were typically composed of well sorted sand or gravel with residual depths of 2 feet (+/- 1 foot). Valley width was estimated to be 450 feet. Overbank sedimentation was common with sediments composed of well sorted fine sand. A mid-channel bar was present near the upstream terminus of the reach and was composed of poorly sorted sand to boulders. There was on average 0.4 large wood pieces per 100 feet in this reach. This subreach contained a low density of habitat features with few large wood pieces, boulders, and overhanging vegetation. Undercut banks were absent. Pools were typically shallow. The main habitat feature within this subreach was coarse riffle substrate.

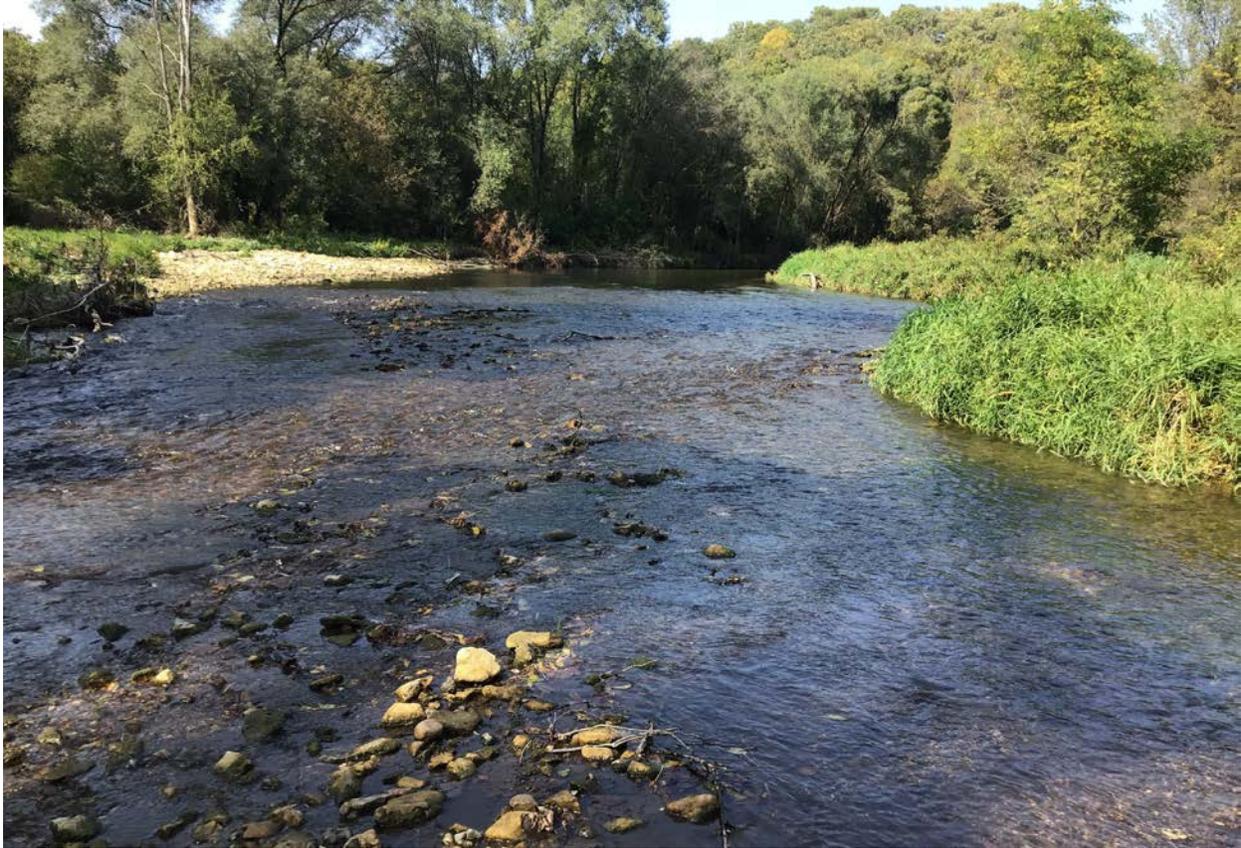
Figure 4: Typical photo collected at station 315+00 in representative subreach 3.

Representative subreach 3 was from station 305+00 to 316+00. Banks in representative reach 3 were approximately 60% vegetated with alternating banks exposed. Where exposed, bank sediments consisted of sandy loam overlaying poorly sorted sand and gravel or bedrock. Streambanks were generally stable and active erosion was interpreted as a result of the natural lateral migration of the river channel in response to flood events. Bankfull widths averaged 61 feet (+/- 10.1 feet), wetted width averaged 42 feet (+/- 16.7 feet), and bankfull thalweg depth averaged 4 feet (+/- 1.5 feet). Riffles were typically composed of poorly sorted sand to cobble with cobbles typically embedded by smaller material and had bankfull depths which averaged 2 feet. Depth of refusal on riffles were generally between 2 and 3 feet. Pools were typically composed of well sorted sand with residual depths of 2 feet (+/- 1 feet). Valley width was estimated to be 550 feet. Overbank sedimentation was common with sediments composed of well sorted fine sand and typically deposited as sand sheets on the inside of meander bends. Several mid-channel bars were presented and were composed of poorly sorted sand to cobbles with higher portions vegetated. There was on average 1.5 large wood pieces per 100 feet in this subreach. This subreach contained a low density of habitat features with few large wood pieces, boulders, and overhanging vegetation. Undercut banks were absent. Pools were typically shallow. The main habitat feature within this subreach was coarse riffle substrate.

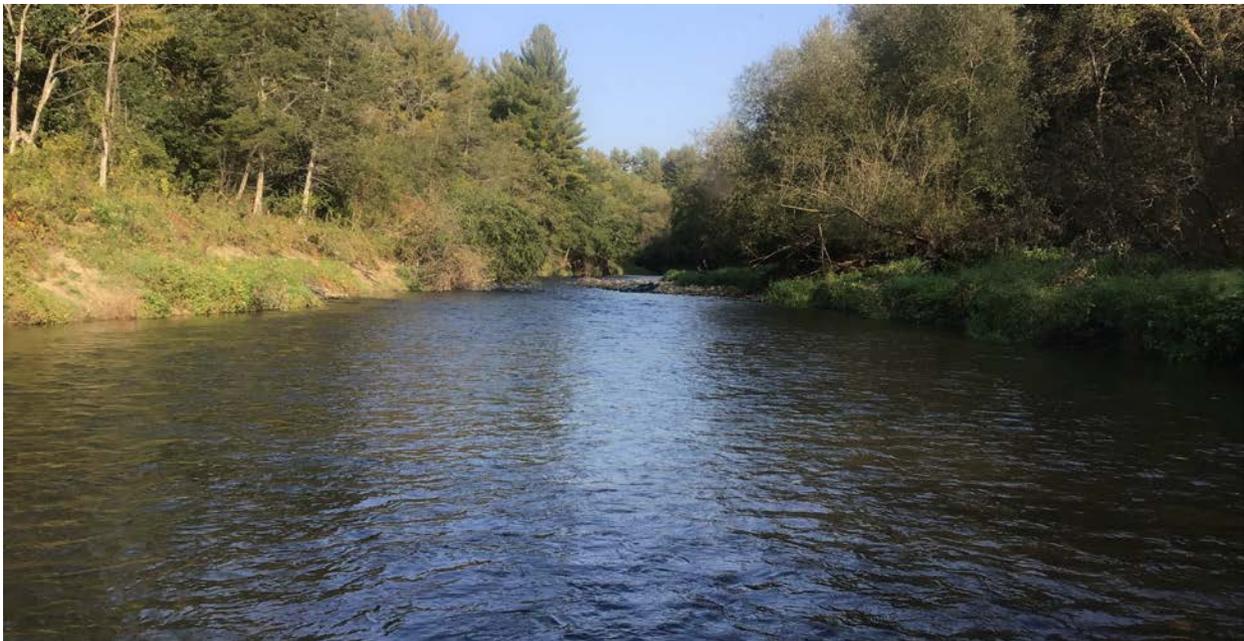
Figure 5: Typical photo collected at station 229+00 in representative subreach 4.

Representative subreach 4 was from station 220+00 to 233+00. Banks in representative subreach 4 were 85% vegetated. Where exposed, bank sediments consisted of sandy loam overlaying poorly sorted sand and gravel. Streambanks were generally stable and active erosion was interpreted as a result of the natural lateral migration of the river channel in response to flood events. Bankfull widths averaged 67 feet (+/- 5.4 feet), wetted width averaged 60 feet (+/- 4.6 feet), and bankfull thalweg depth averaged 4 feet (+/- 0.2 feet). Riffles were typically composed of poorly sorted sand to cobble with cobbles typically embedded by smaller material and had bankfull depths which averaged 2.5 feet. Depth of refusal on riffles was generally between 3 and 4 feet. Pools were typically composed of well sorted sand with residual depths of 1 foot (+/- 0.5 feet). Bars were transitional between alternate and points bars and were composed of poorly sorted sand to cobbles with higher portions vegetated. Valley width was estimated to be 250 feet. There were on average 0.3 large wood pieces per 100 feet in this subreach. This subreach contained a low density of habitat features with few large wood pieces, boulders, and overhanging vegetation. Undercut banks were absent. Pools were typically shallow. The main habitat feature within this subreach was coarse riffle substrate.

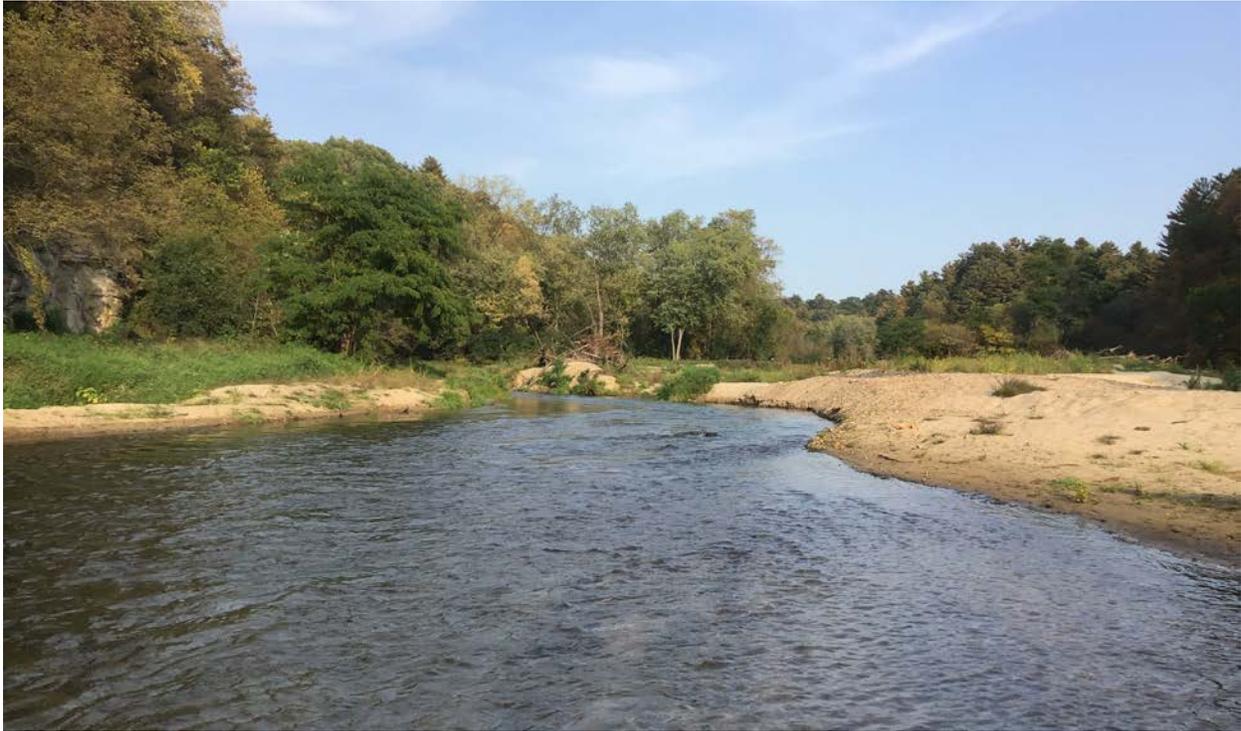
Figure 6: Typical photo collected at station 106+00 in representative subreach 5.

Representative subreach 5 was from station 100+00 to 108+00. Banks in representative subreach 5 were 60% vegetated. Where exposed, bank sediments consisted of sandy loam. Streambanks were generally stable and active erosion was interpreted as a result of the natural lateral migration of the river channel in response to flood events. Bankfull widths averaged 100 feet (+/- 58.3 feet), wetted width averaged 71 feet (+/- 28.2 feet), and bankfull thalweg depth averaged 5 feet (+/- 0.8 feet). Riffles were typically composed of poorly sorted sand to cobble with cobbles typically embedded by smaller material and had bankfull depths which averaged 2.5 feet. Depth of refusal on riffles was generally greater than 5 feet. Pools were typically composed of well sorted sand with residual depths of 2 feet (+/- 1 feet). Point bars were composed of poorly sorted sand to gravels with higher

portions vegetated. Valley width was estimated to be 300 feet. There were on average 1.8 large wood piece per 100 feet in this subreach. This subreach contained a low density of habitat features with few large wood pieces, boulders, and overhanging vegetation. Undercut banks were absent. Pools were typically shallow. The main habitat feature within this subreach was coarse riffle substrate.

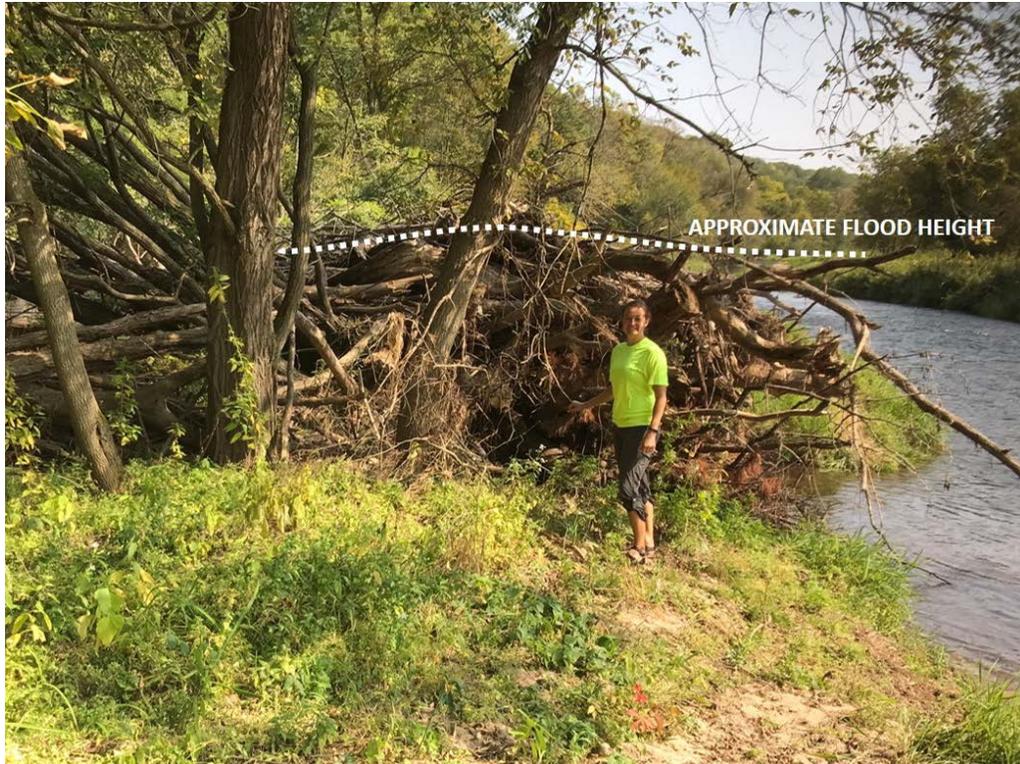
A large flood occurred on the Kinnickinnic on June 29, 2020, which caused discharge to rise to a maximum of 6,220 cfs at the USGS gage on County Road F. Coarse and large wood racked against existing trees, and overbank deposits consisting of fine sand were noted throughout all reaches and were interpreted to be a result of the recent flood. Racked flood debris was up to 8 feet above the existing bankfull elevation, suggesting the maximum elevation of recent flooding (Figure 7). The

Figure 7: Flood debris wracked behind several trees. Photo collected at station 334+00.

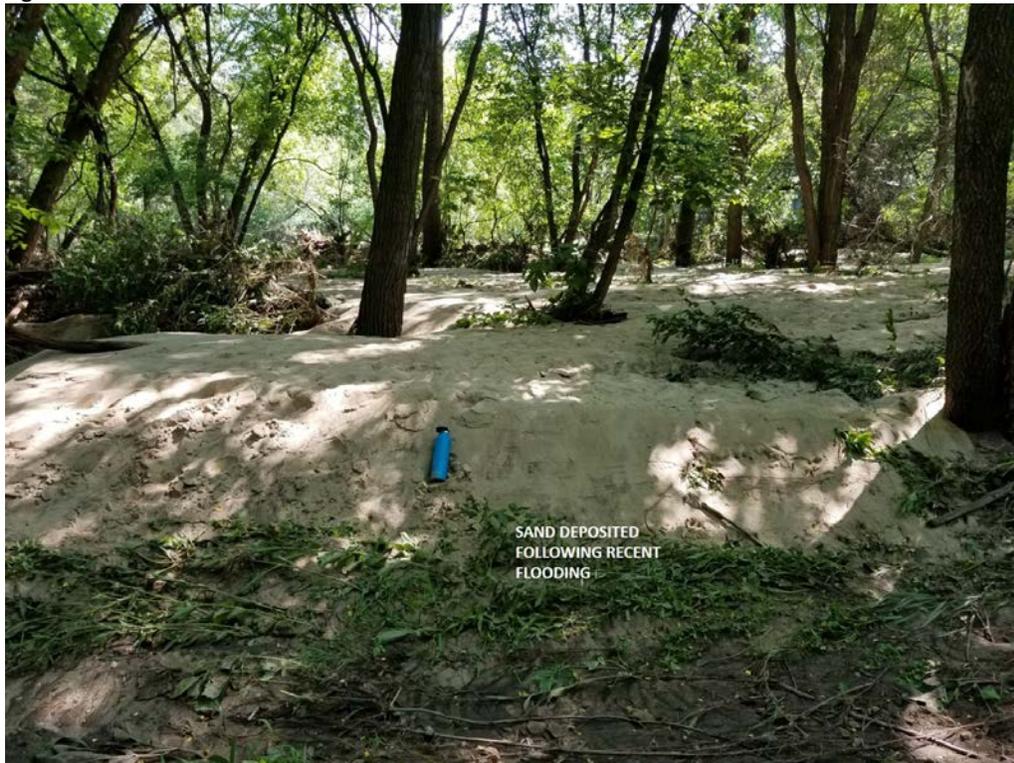
USGS gage at County Road F indicates that the gage height was over 10 feet higher than the normal gage height. Overbank sedimentation of fine sand was noted in all reaches and varied in thickness from less than 1 inch to 4 feet (Figure 8). The thickest deposits were typically associated with tributary confluences, particularly the Rocky Branch, or associated with gullies. These deposits were typically 1-2 feet thick but were up to 4 feet thick at the leading edge of sand sheets. Thinner deposits (typically less than 6 inches thick) were observed throughout the remainder of the floodplain.

Figure 8: Sand deposited near the Rocky Branch confluence following recent floods. Photo collected at station 483+00.

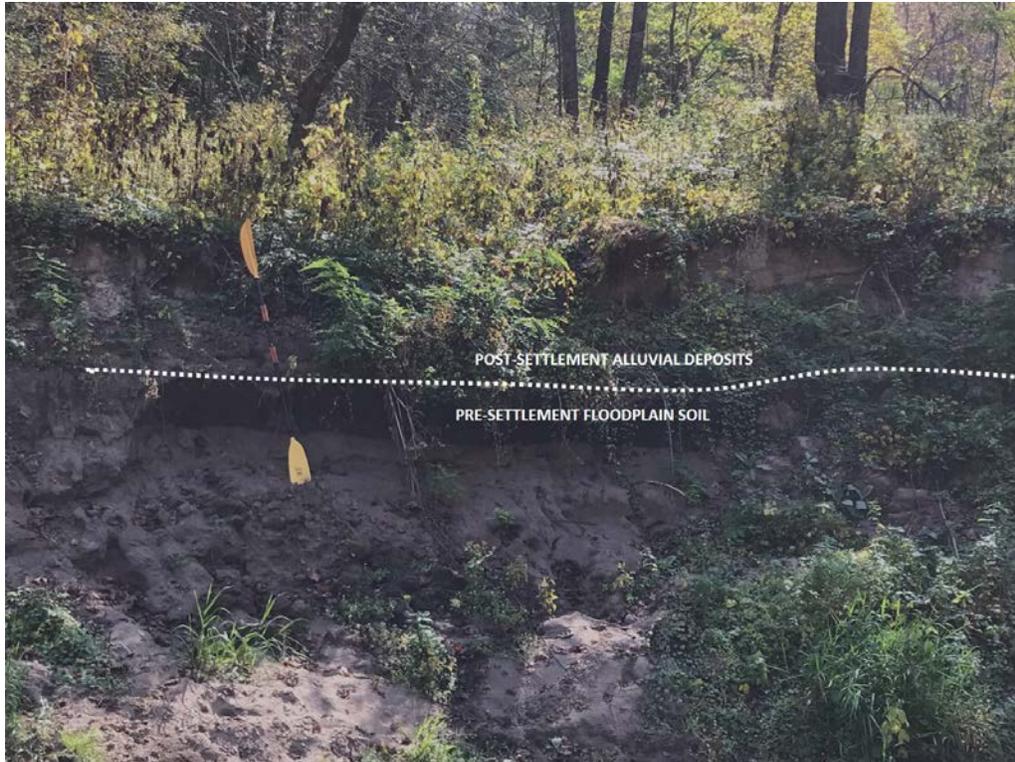
Legacy sand deposits overlaying soil horizons were also noted, and were commonly associated with tributary gullies in Reach 4 (Figure 9). The surface of these areas was forested, so the deposition of the sand must be older than the trees currently growing on the surface. It was interpreted that the deposition of the sand on top of the soil horizon is a result of land clearing by Euro-American settlers which destabilized upland surfaces and caused sediment to wash into the Kinnickinnic Gorge where it was deposited on the floodplain. This is similar to observations in other Driftless Area streams (Dauwalter et al. 2019). The result of this historic deposition is a floodplain that has aggraded in areas and is now elevated above the natural floodplain. The river is still actively moving these legacy sediments downstream in addition to contemporary sediment inputs, and overtime will construct a new, lower floodplain.

Figure 9: Photo of cutbank showing pre-settlement soil horizon and post-settlement alluvial deposits. Photo collected at station 168+00.

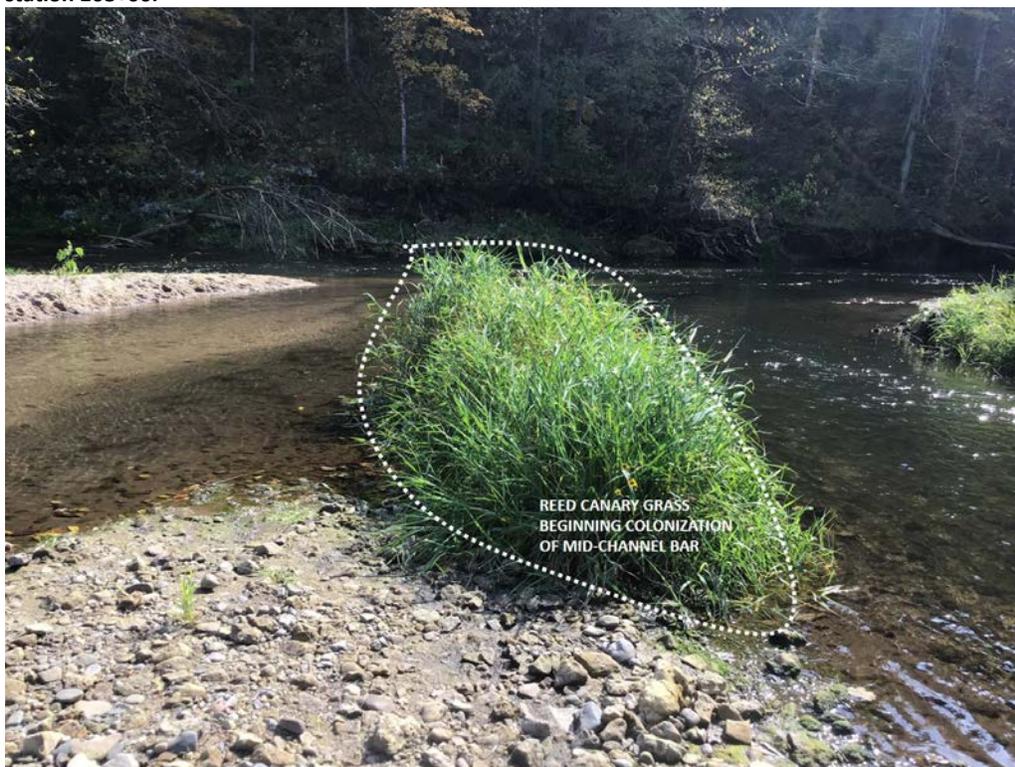
Reed canary grass, an invasive species common in wetland areas throughout the country and in the upstream watershed, was present through all reaches of the Kinnickinnic survey and was typically present on point and mid-channel bars (Figure 10). Reed canary grass forms a monoculture stand in open floodplain and channel areas, shading out competing plants and limiting diversity and habitat for a variety of fauna. In addition, reed canary grass can stabilize what would normally be mobile sand and gravel bars, which results in increased roughness, decreased cross-sectional area and can increase bank erosion by forcing the channel away from the stabilized mid-channel bar.

Figure 10: Mid-channel bar showing colonization of reed canary grass and the stabilization of the bar. Photo collected at station 313+00.

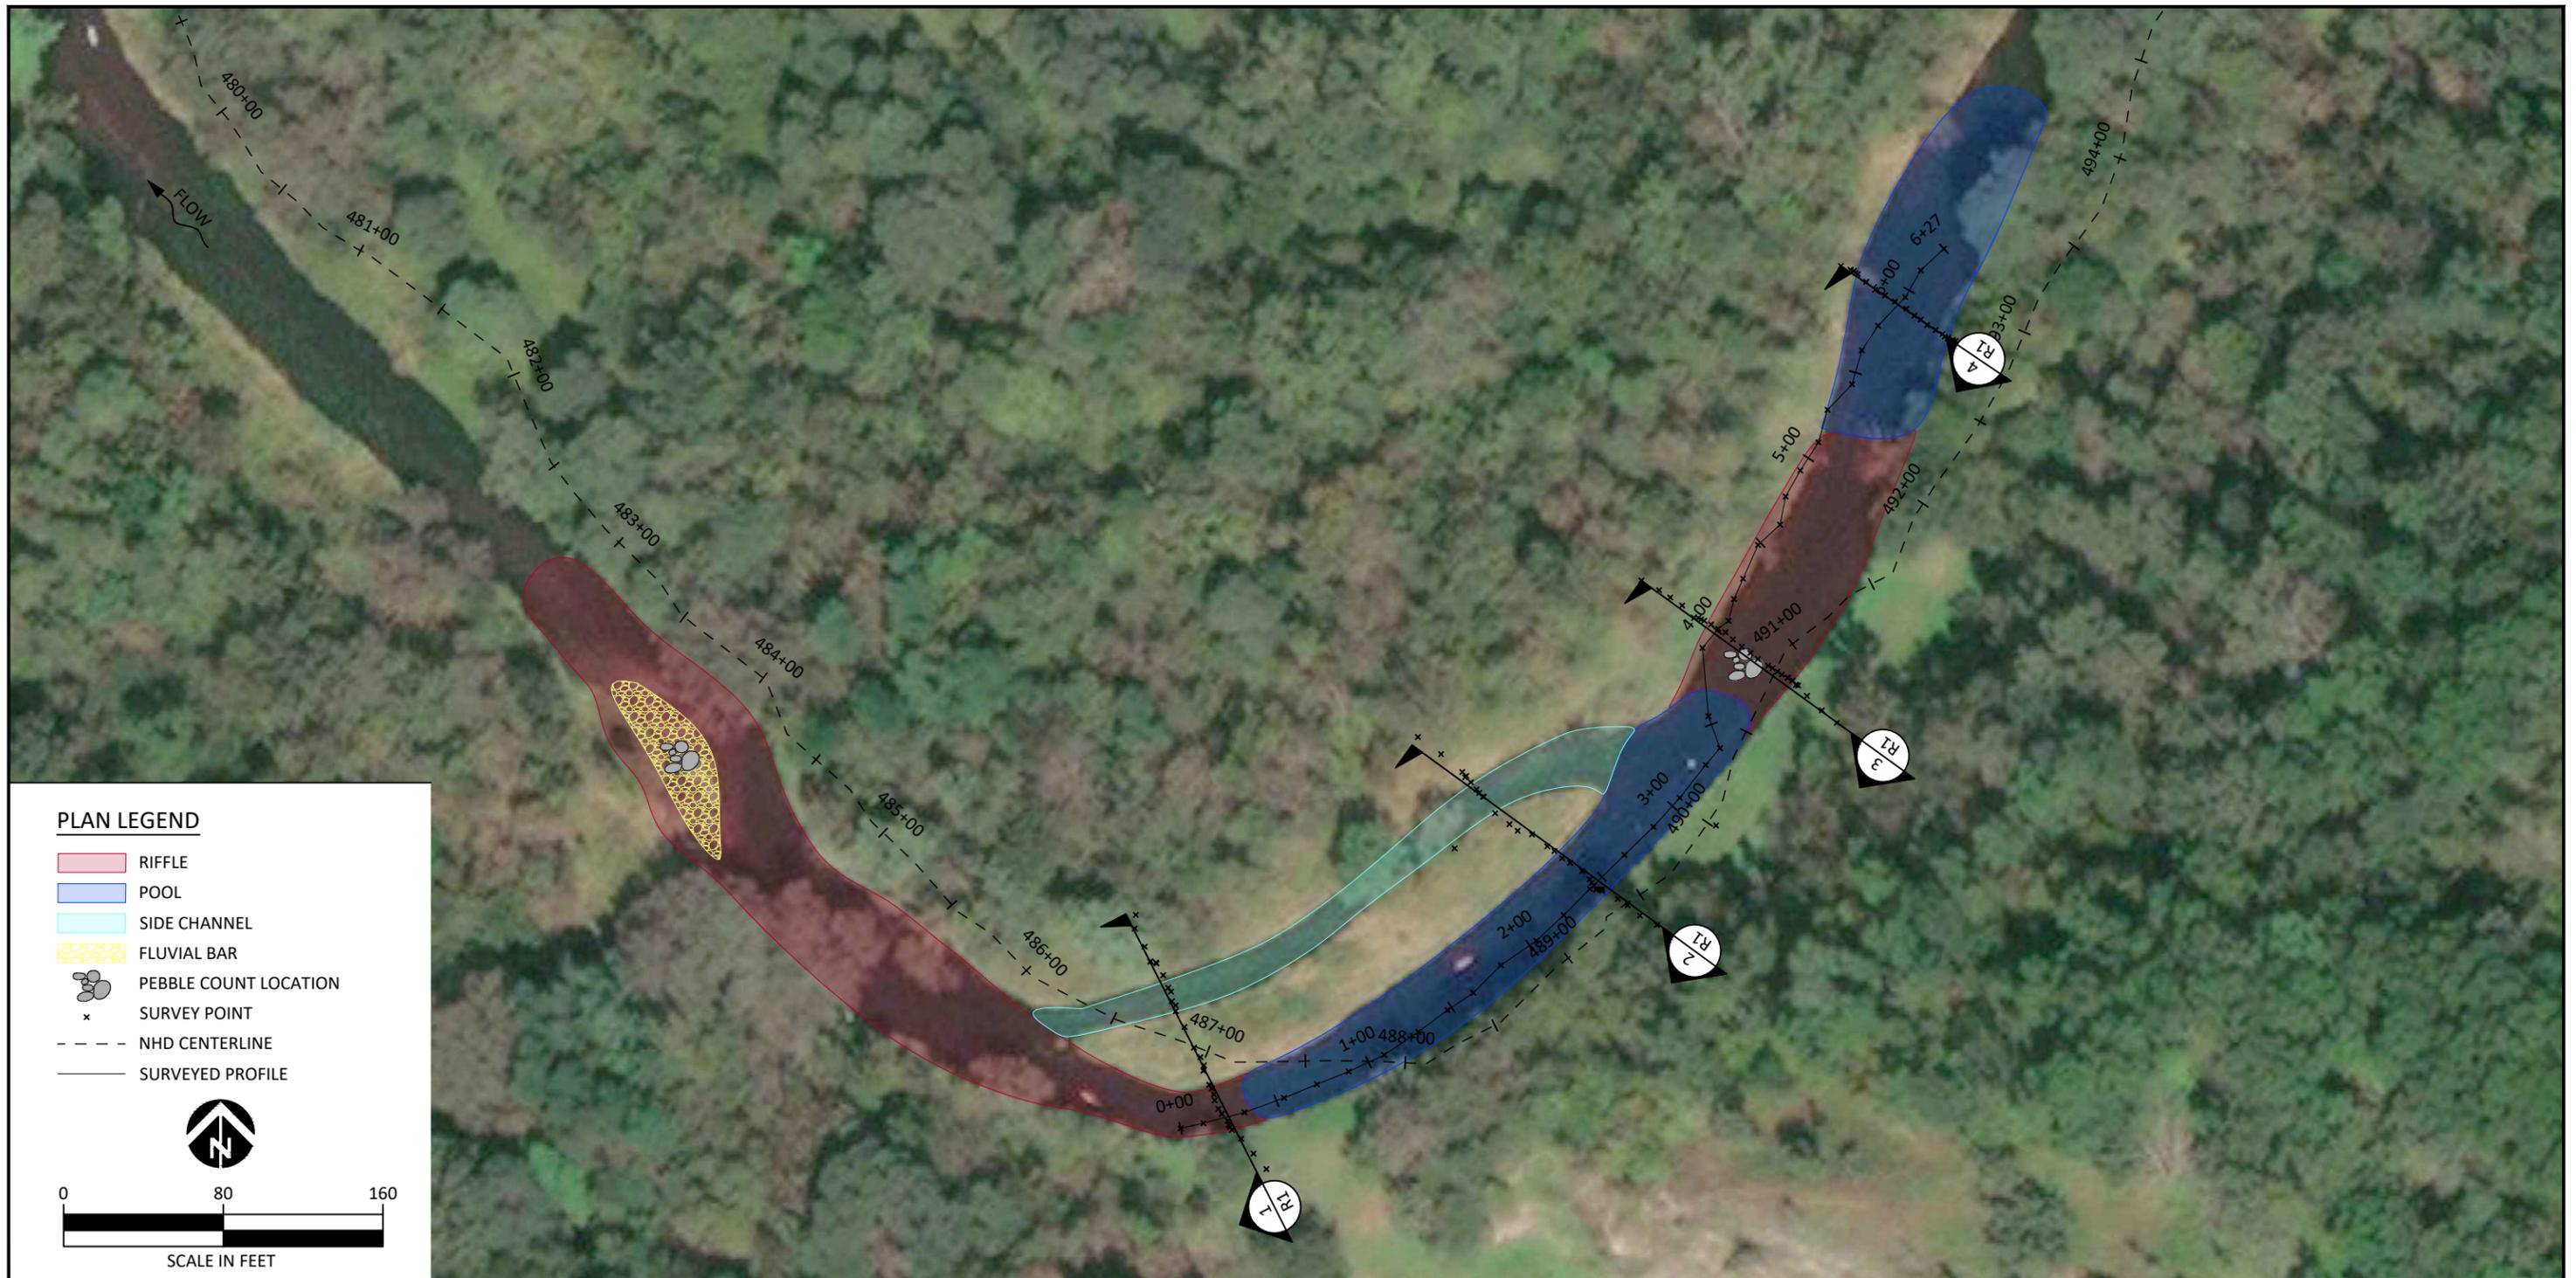
REPRESENTATIVE REACH 1

LONGITUDINAL PROFILE
UNREFERENCED VERTICAL SCALE

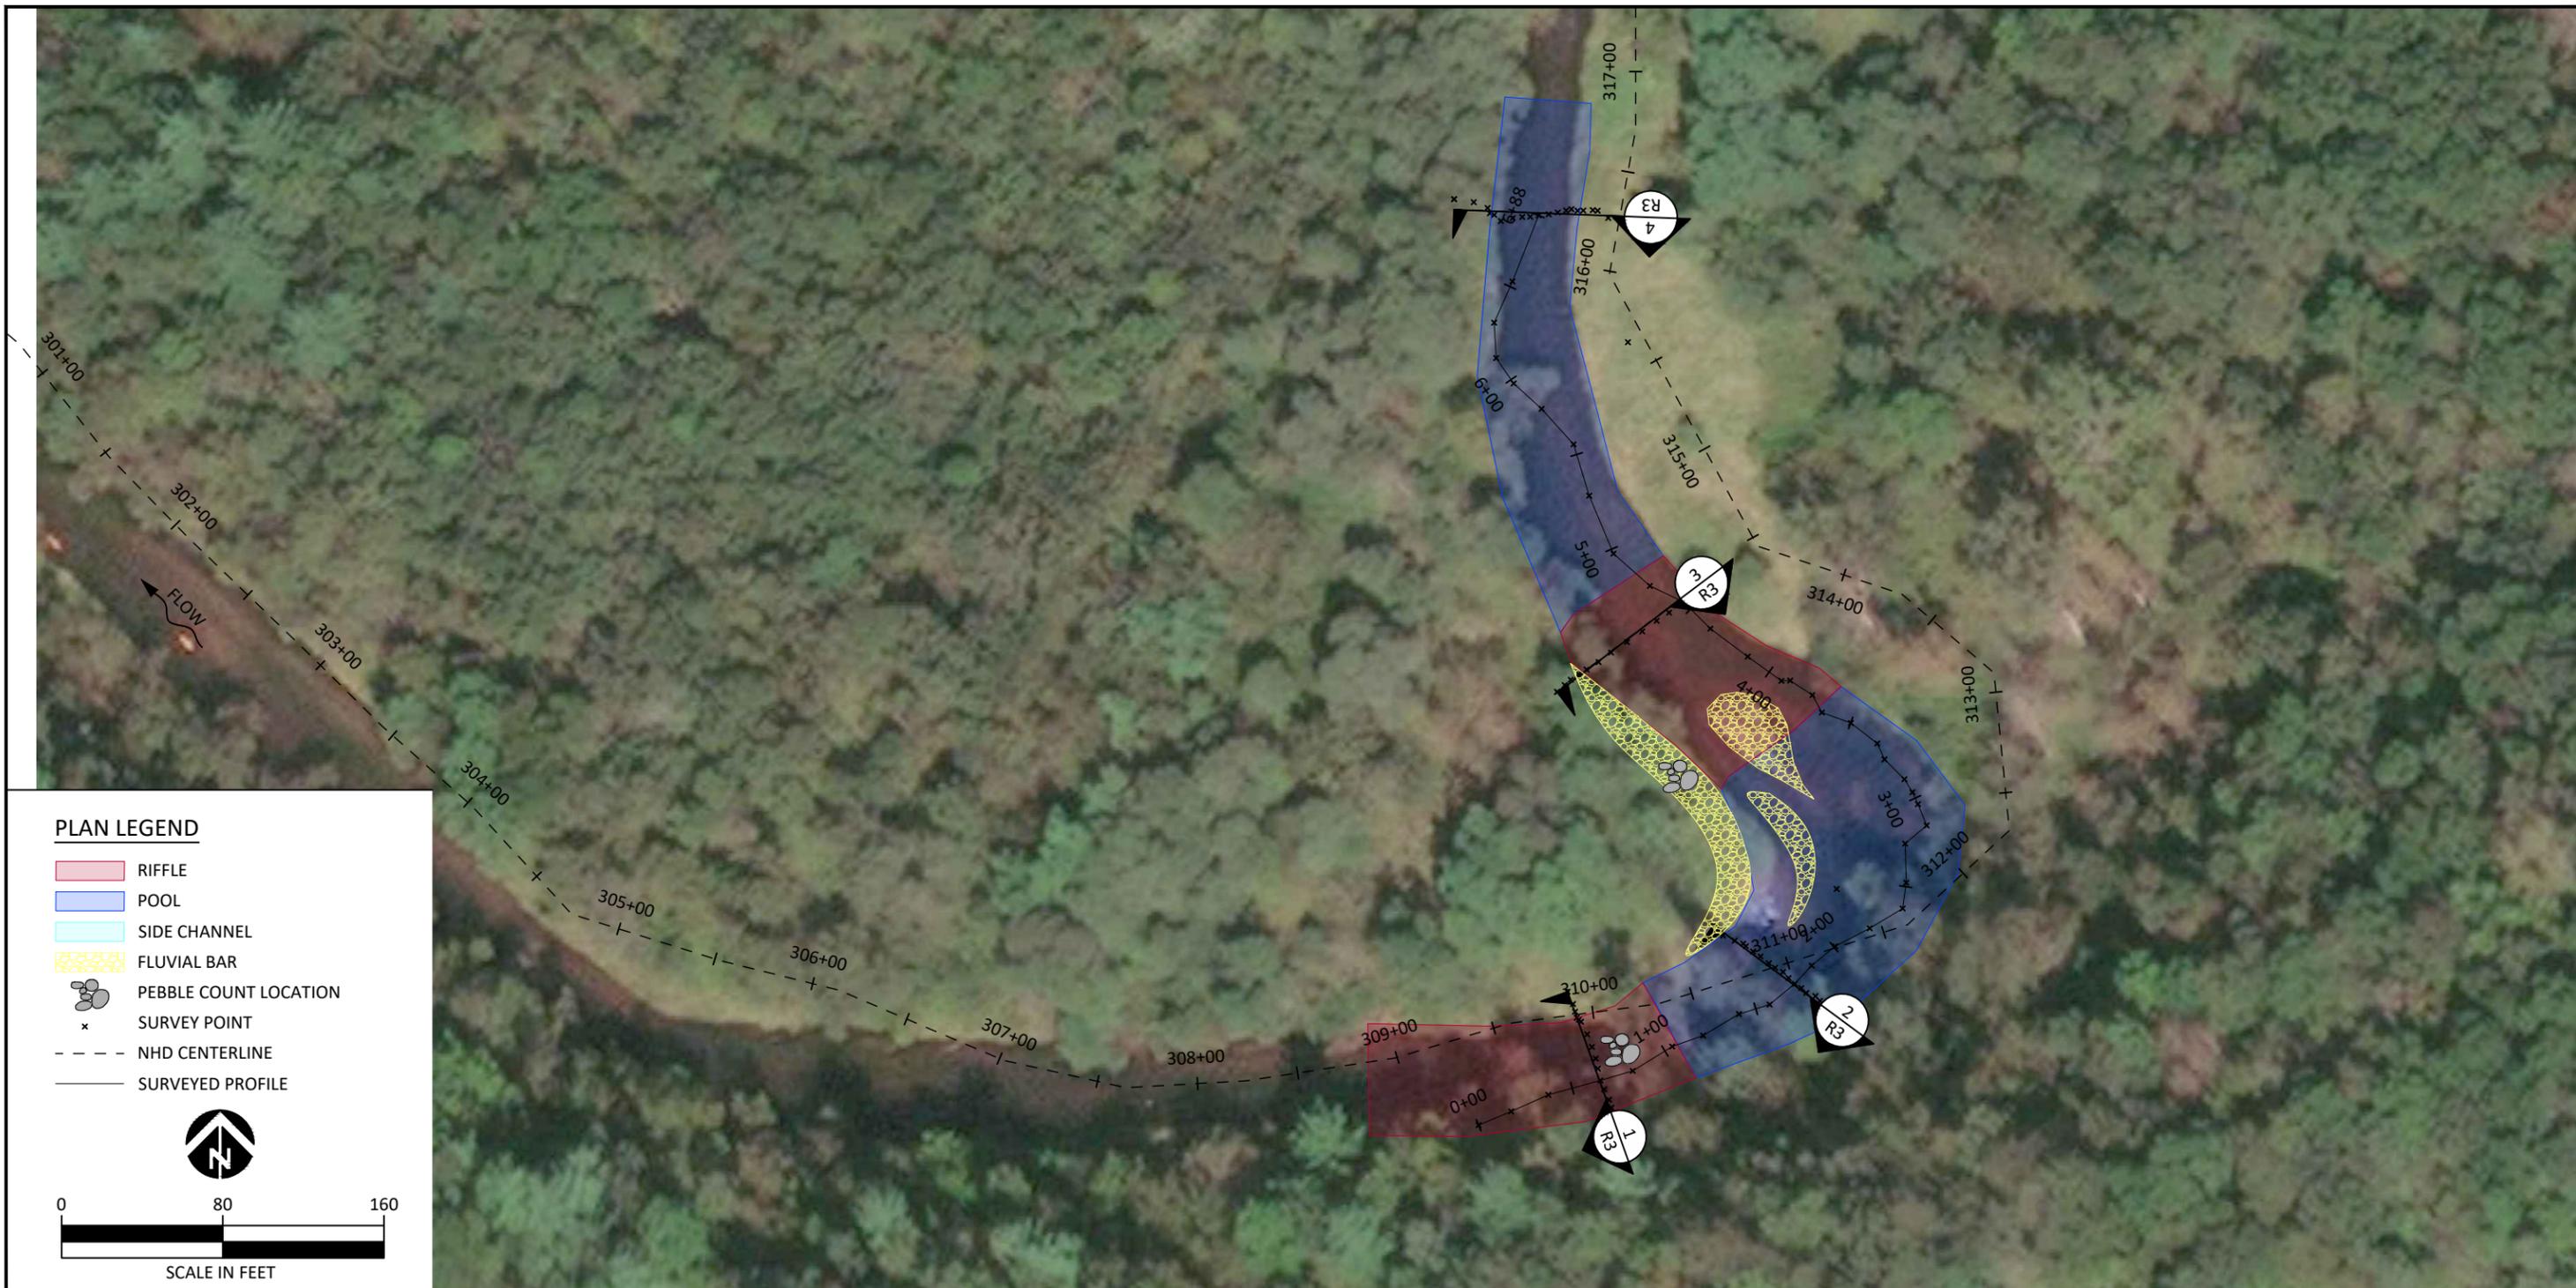
REPRESENTATIVE REACH 3

LONGITUDINAL PROFILE
UNREFERENCED VERTICAL SCALE

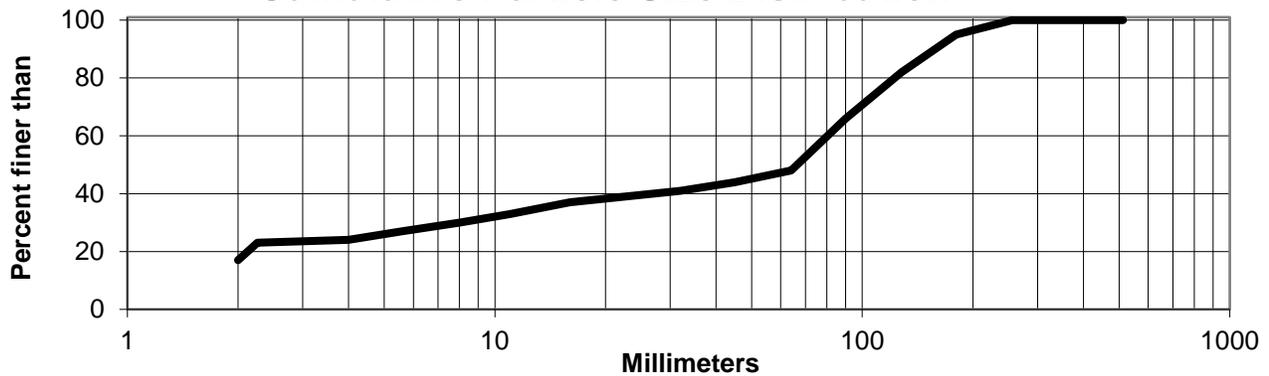
Cumulative Particle Size Distribution

Pebble Count Name: Reach 3 Bar
 Sampling Method: Random Walk
 Geomorphic Position: Riffle
 Stratigraphic Position: Surface

Sediment size (mm)	Particle Count	Total Percent	Cumulative Percent
2	0	0.00	0.00
2.26	12	12.00	12.00
4	3	3.00	15.00
5.6	3	3.00	18.00
8	2	2.00	20.00
11	5	5.00	25.00
16	6	6.00	31.00
32	10	10.00	41.00
45	16	16.00	57.00
64	19	19.00	76.00
90	9	9.00	85.00
128	10	10.00	95.00
180	1	1.00	96.00
256	4	4.00	100.00
512	0	0.00	100.00
Total:	100	100
