**RE: River Falls Hydroelectric Project, FERC Project No. 10489
Updated Study Report Meeting Summary**

**RIVER FALLS HYDROELECTRIC PROJECT, FERC No. 10489
INTERESTED PARTIES MAILING LIST**

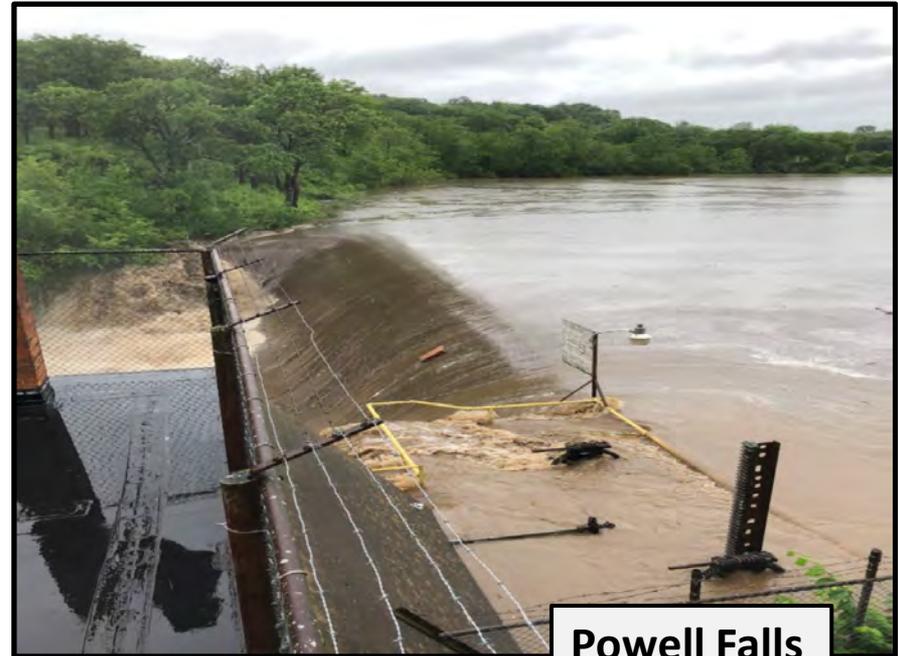
- Headworks at Powell Falls were underwater on June 29, 2020
- At the height of the flood, water was 7 feet above the crest of the dam

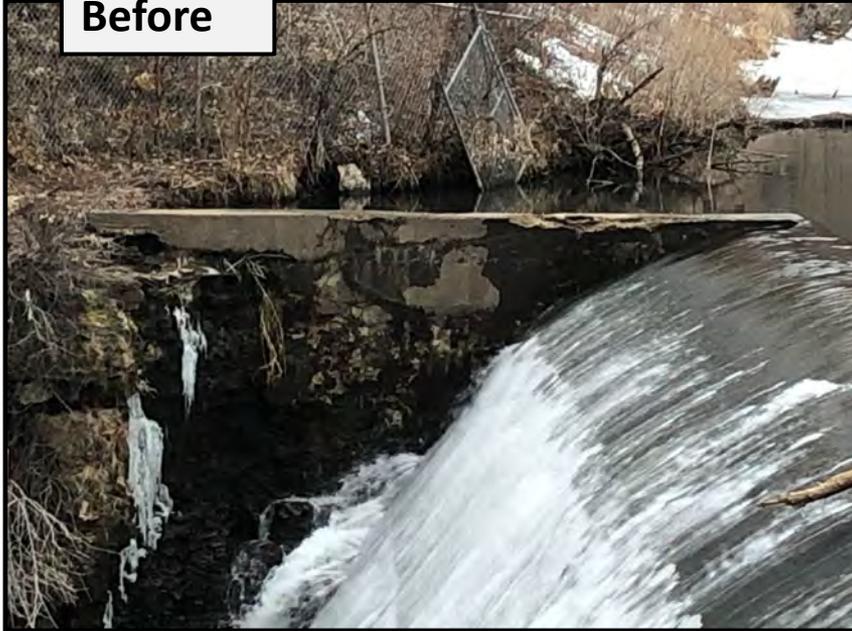
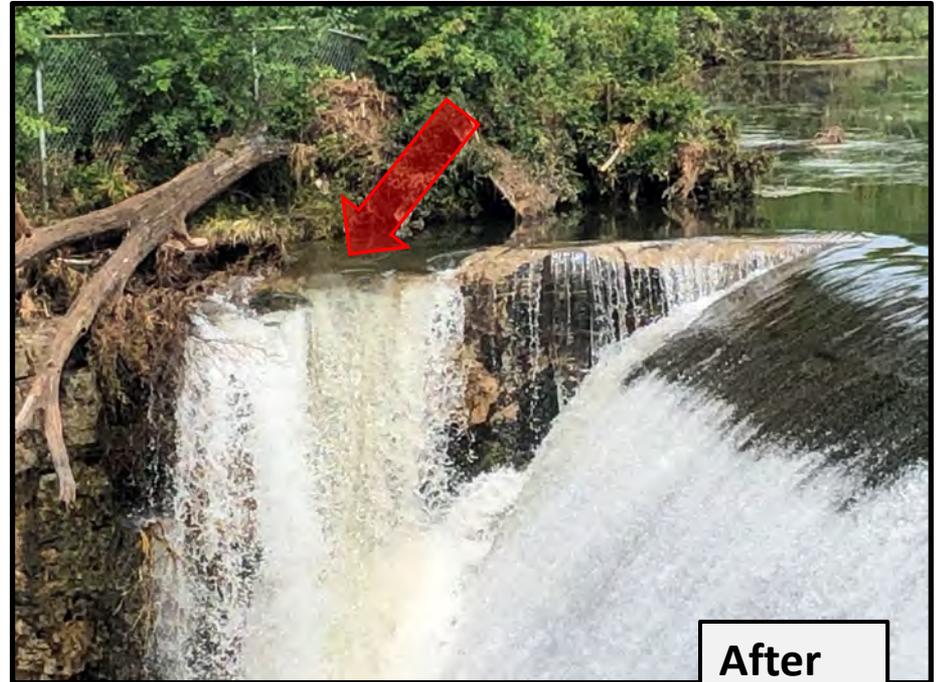
Before

- Damage to right wing wall

After

- iii. 2020 Flood
 - 1. Ms. Brotkowski reviewed the June 28-29, 2020 flood and described damage to the Powell Falls Dam.
 - 2. On July 16, 2020 RFMU filed a flood damage report with FERC Division of Dam Safety and Inspection.

- June 28-29, 2020: 7-8” of rainfall in parts of the Kinnickinnic Watershed
- Damage to the Powell Falls dam
- July 16, 2020: RFMU filed a flood damage report with FERC Division of Dam Safety and Inspection (D2SI)
- September 10, 2020: FERC D2SI requested a plan and schedule to address dam safety inspection and replacement of gages

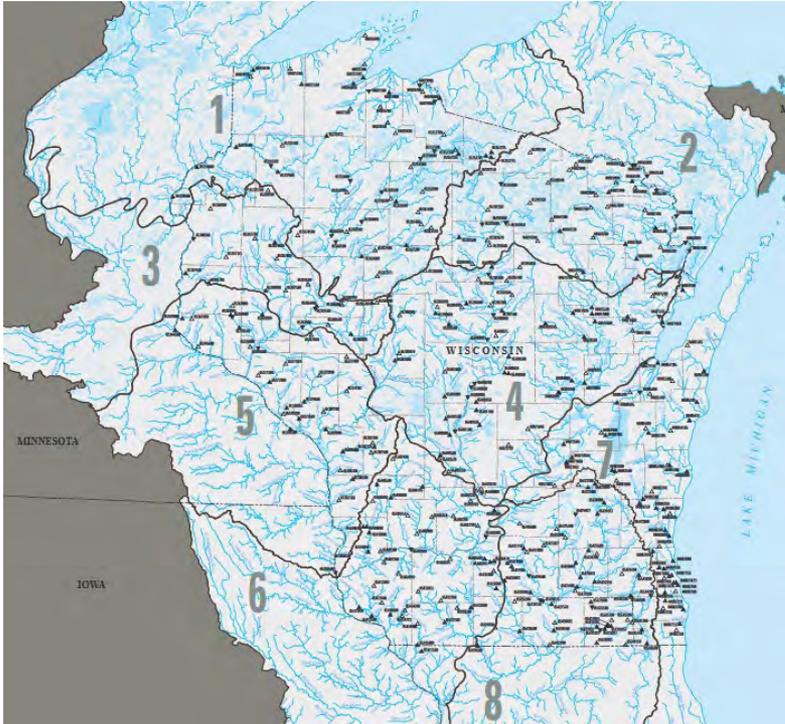
USGS REGRESSION EQUATIONS

- Watershed Area
- Soil Infiltration Rate
- Percent Forest Cover

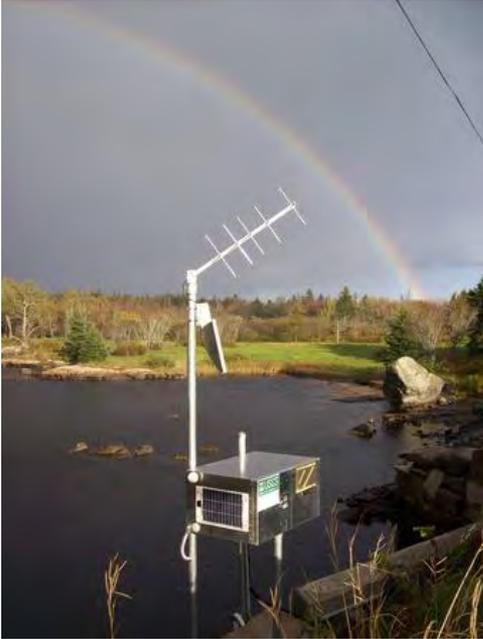
USGS GAGE DATA

1917-1921 and
2002 - Present

USGS 05342000 KINNICKINNIC RIVER NEAR RIVER FALLS, WI

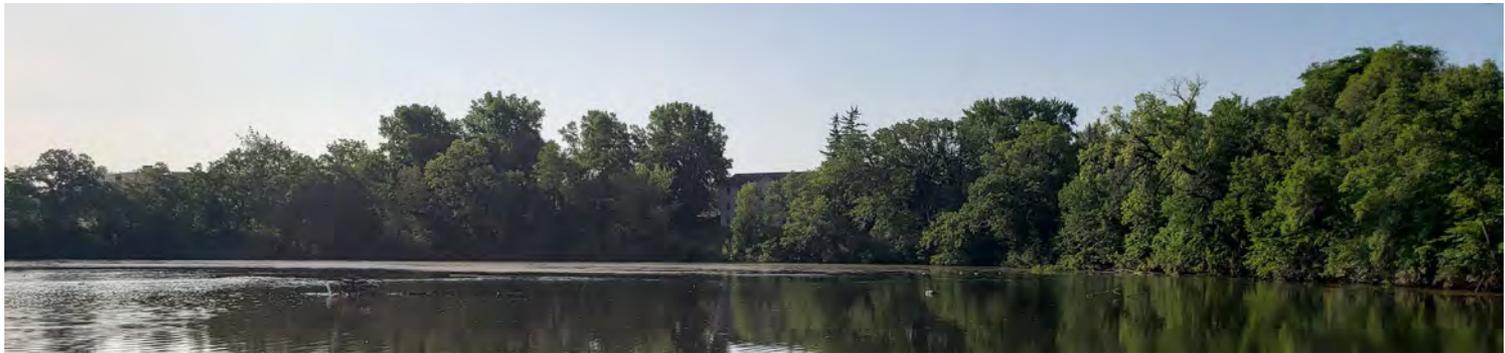
Ellen Faulkner, Ayres

- Dissolved oxygen and water temperature in the project area recorded at 15-minute intervals, summer 2019 and 2020
- Supporting observations including independent DO meter “grab samples,” air temperature, algae cover, streamflow

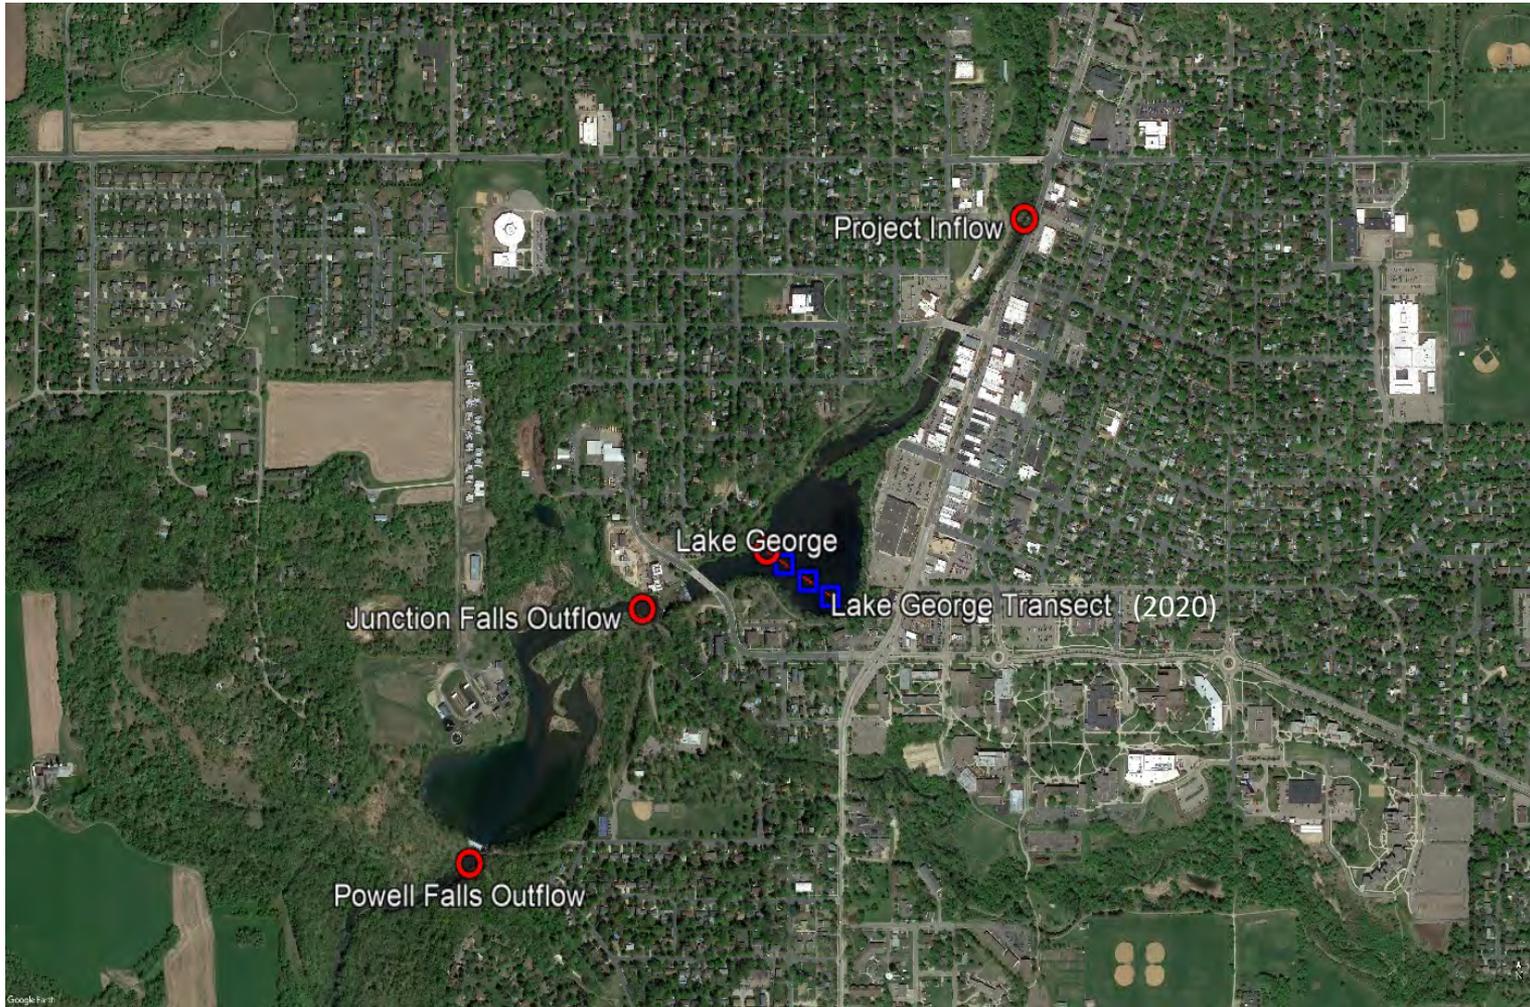
DO Meter Locations

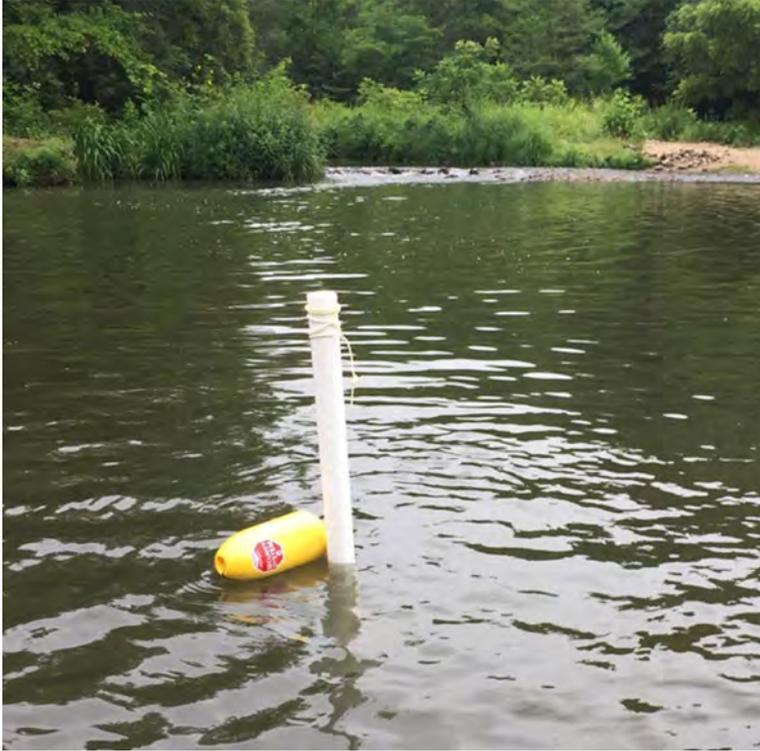
Continuous Instrumentation

Junction Falls outflow site, 2019

- 4 HOBO U26-001 DO and temperature data loggers
- Sensors positioned mid-water column
- Meter check, sensor cleaning, data download at 1-2 week intervals
- Public interference issues early in 2019 season, throughout 2020

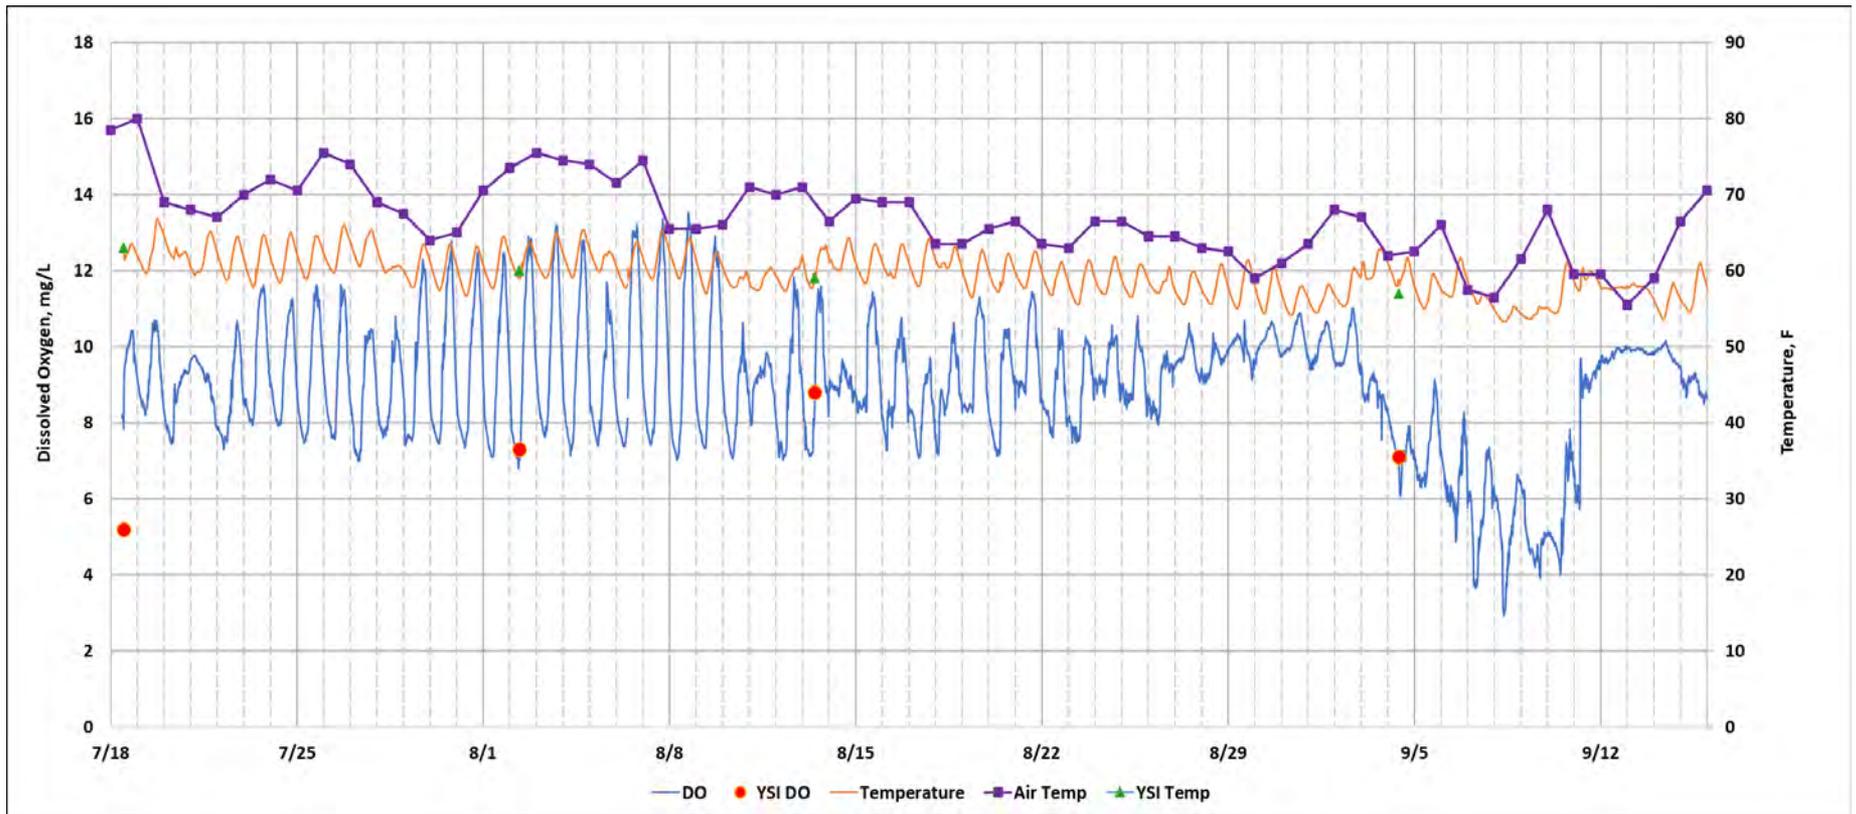
Water Quality Time Series – Junction Falls Outflow, 2019

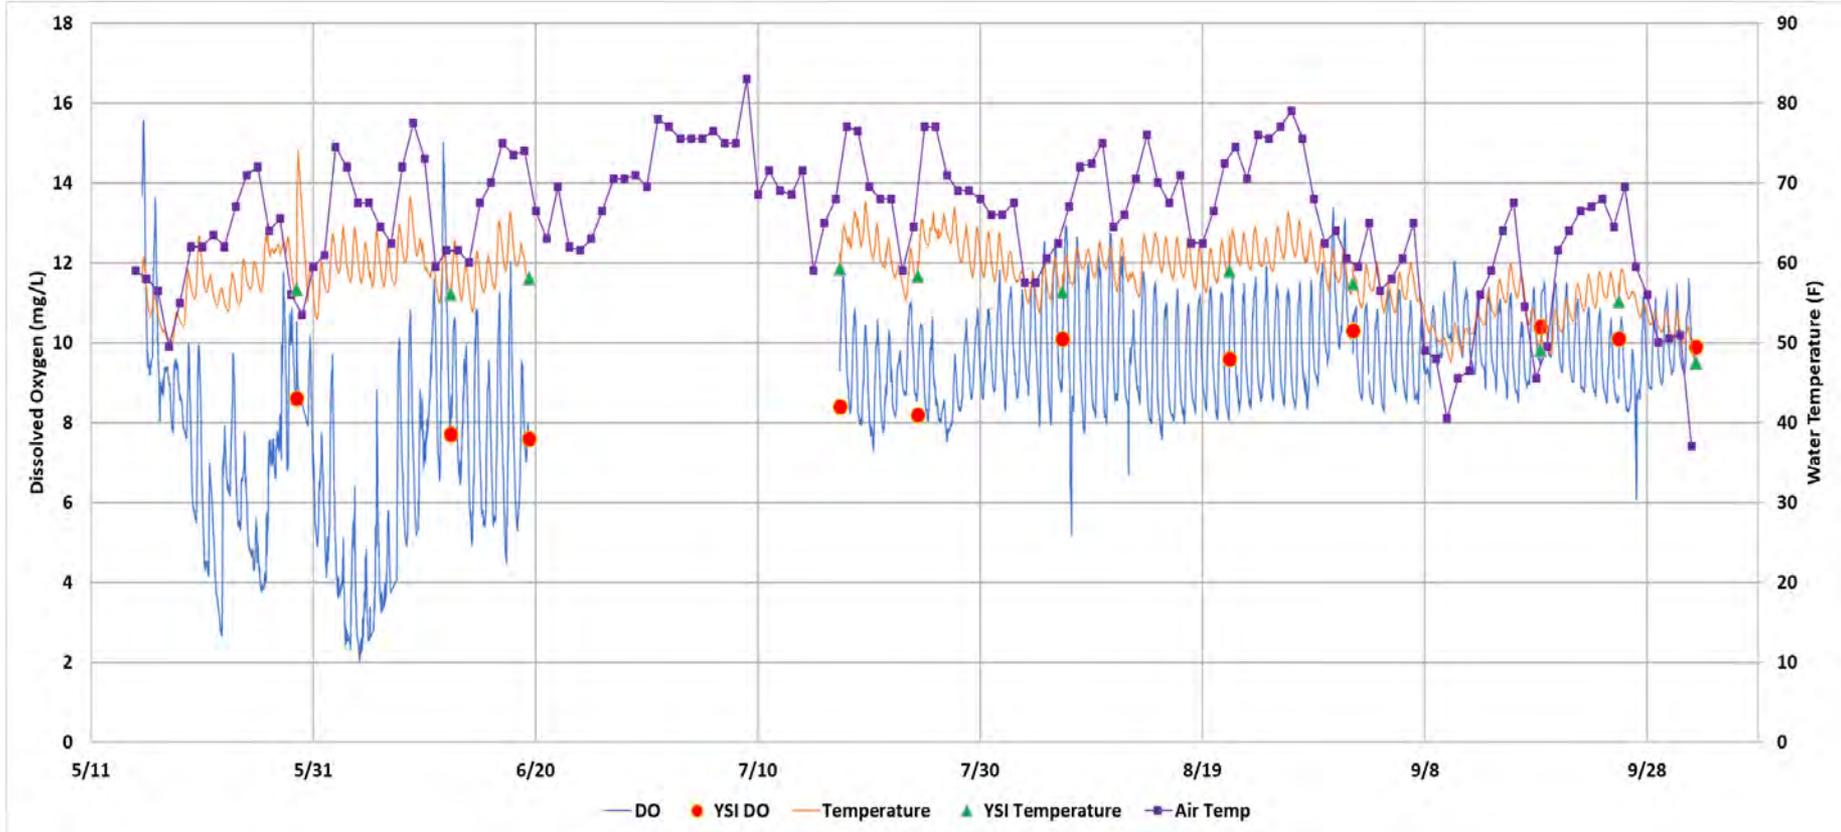
Water Quality Time Series – Lake George, 2020

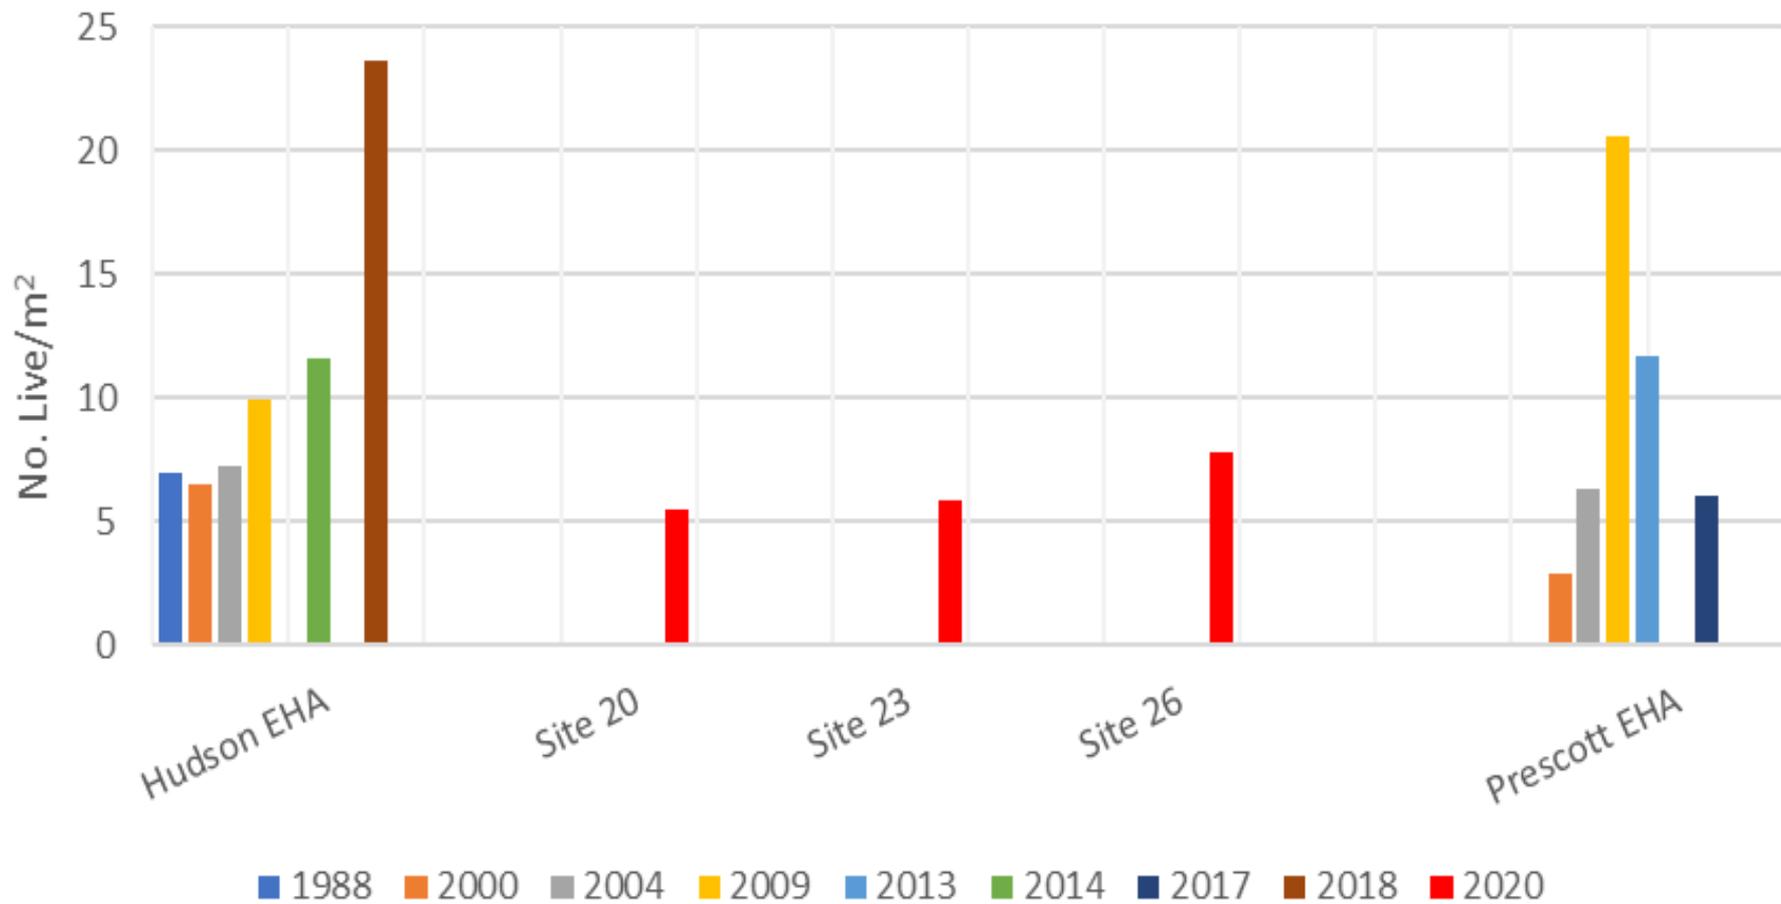
Native Mussel Density - St. Croix EHAs and This Study

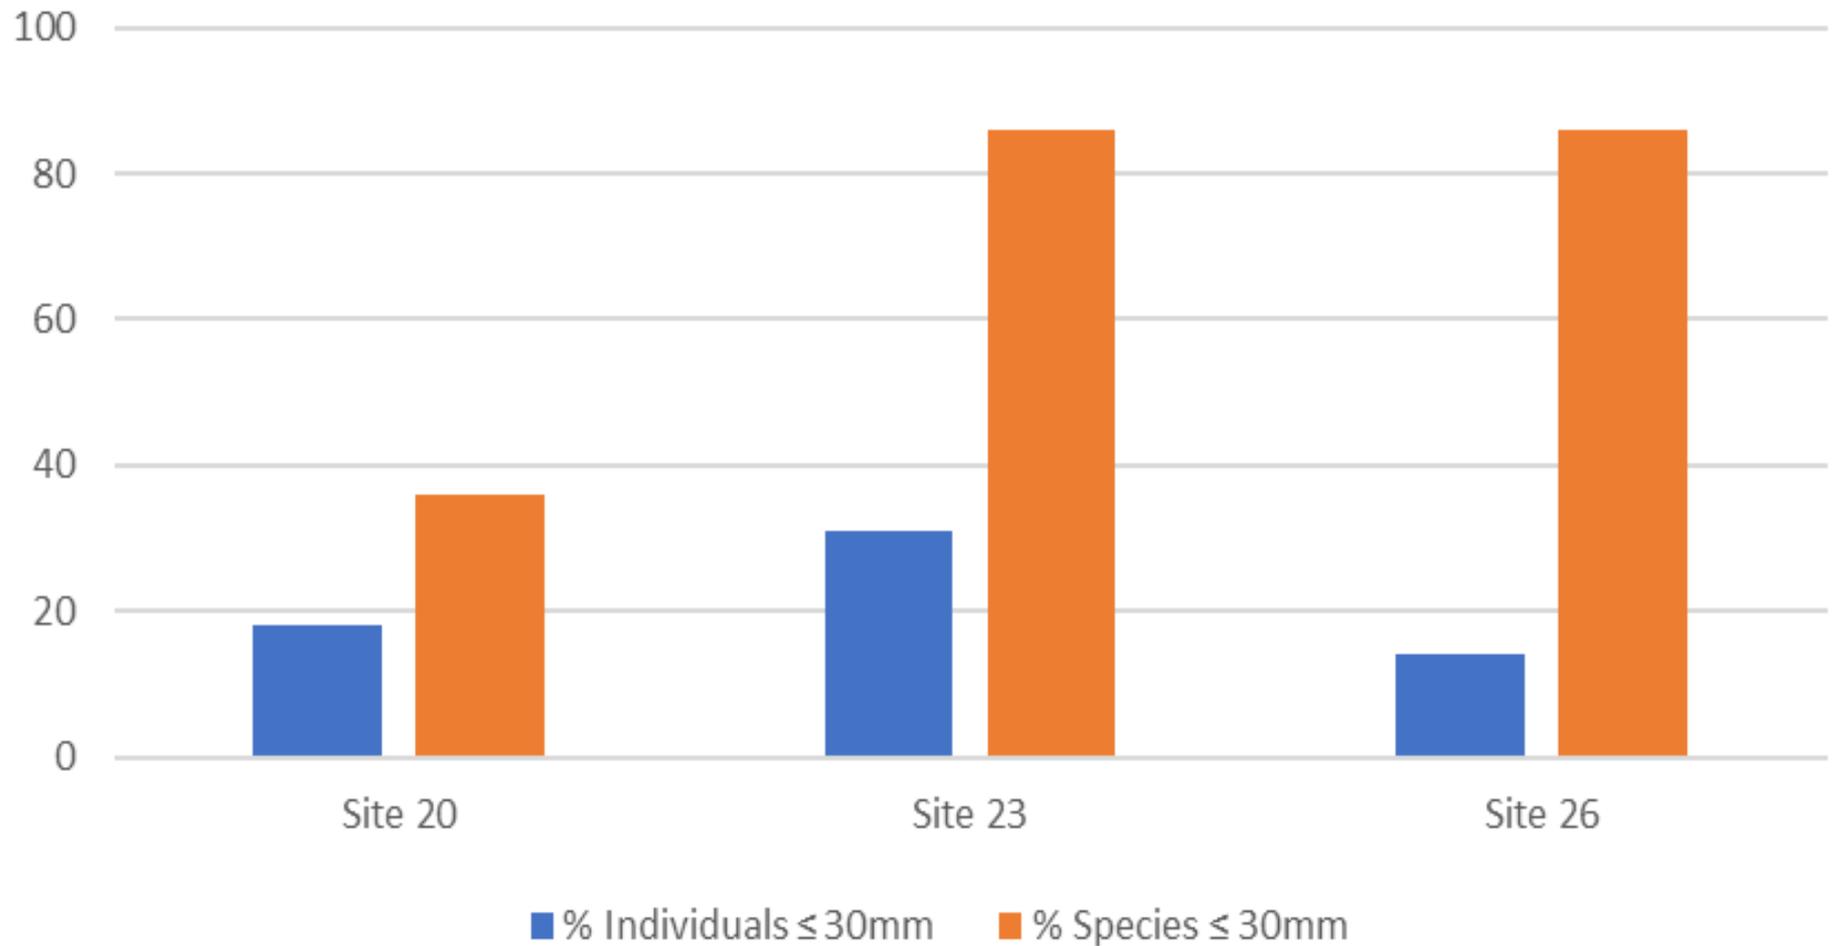
Site 20, 23, 26 - Percent Individuals and Species \leq 30mm

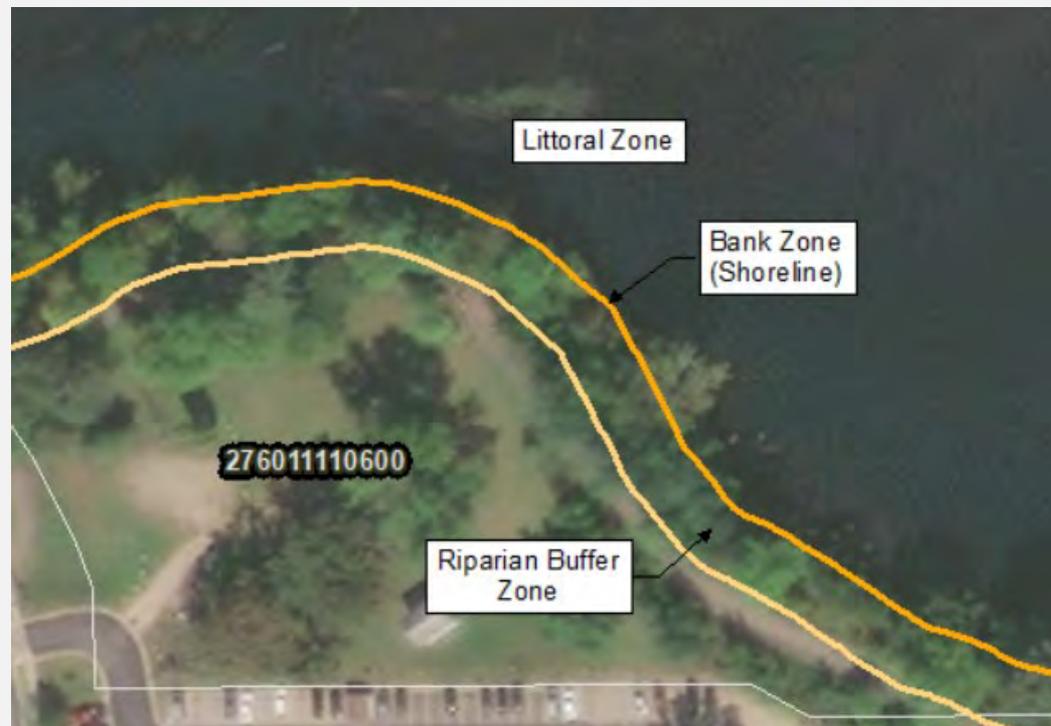
Assessment Zones for Lake George SHA

- Littoral Zone: defined as the in-water area of the lake starting at the present water line and extending approximately 50 feet into the lake
- Bank Zone: the area between the top of the bank lip and the bank toe, which includes the ordinary high-water mark (OHWM)
- Riparian Buffer Zone: begins at the top edge of the bank zone and extends inland 35 feet.

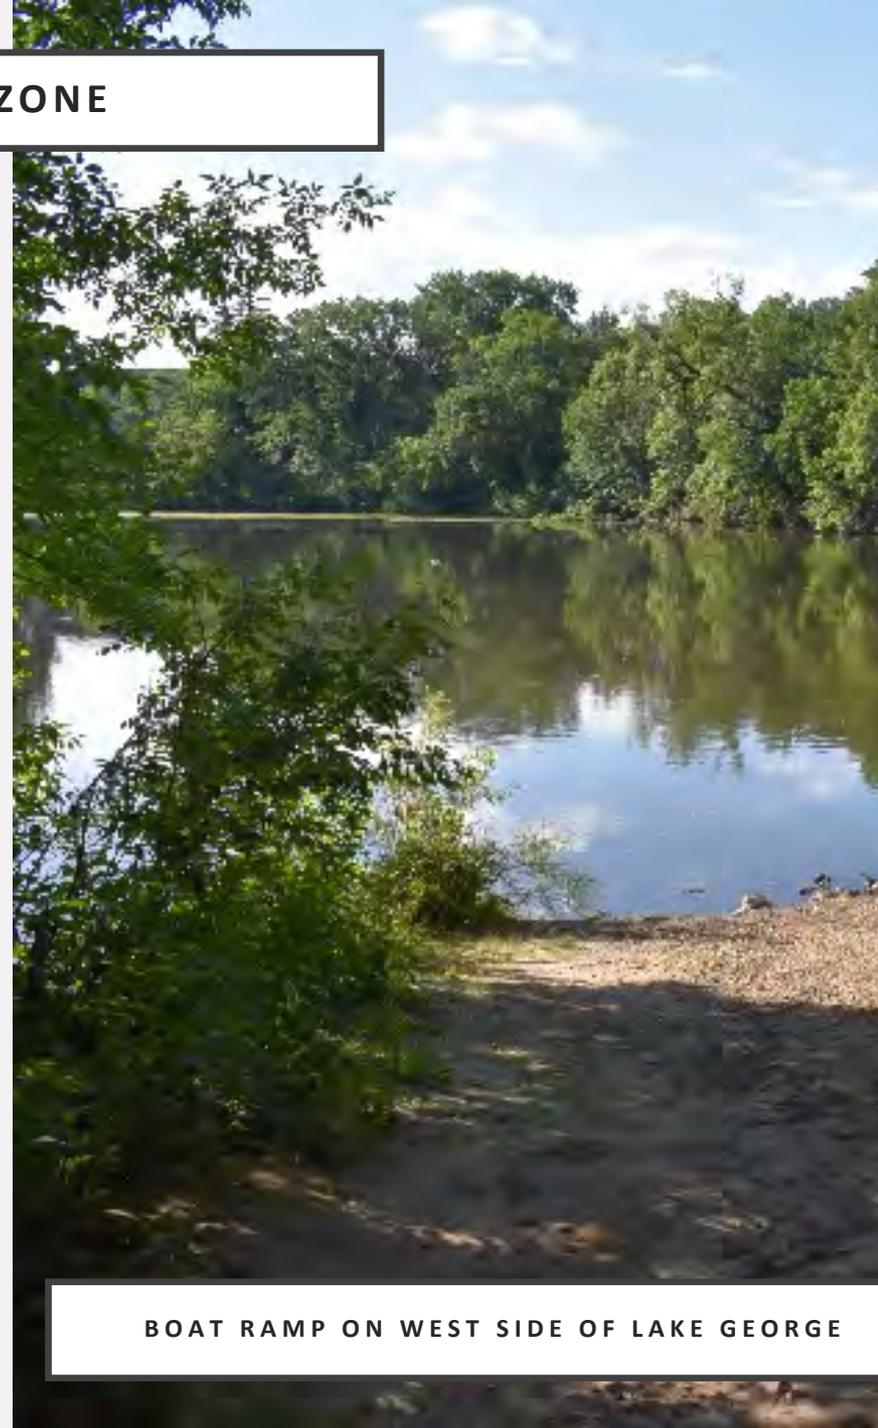
BOAT RAMP ON WEST SIDE OF LAKE GEORGE

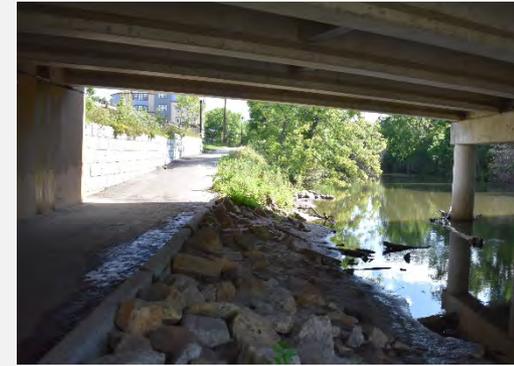
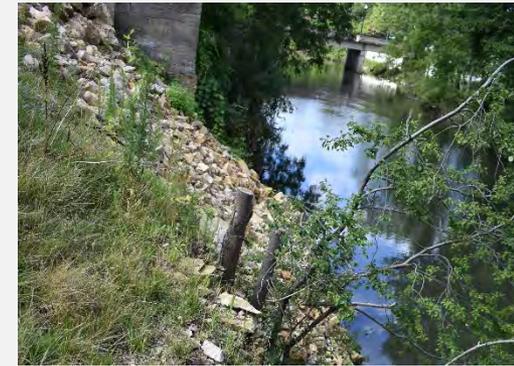
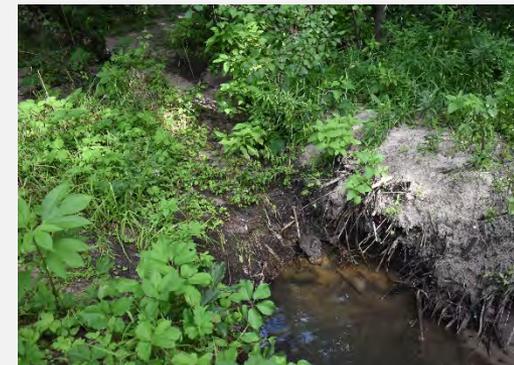
TYPICAL POINT SOURCE

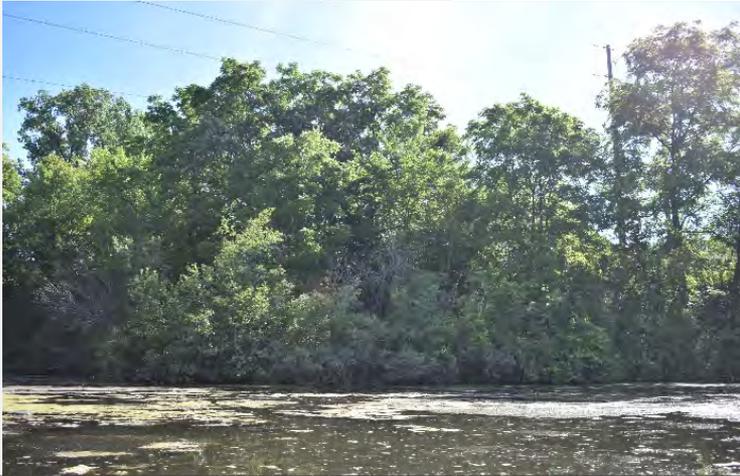
**VIEW OF NORTHWEST PORTION OF
LAKE GEORGE SHORELINE**

Modifications within the current bank zone of Lake George are minimal. Rip rap has been placed as stabilization in some areas. Due to the shallow nature of most areas of Lake George, the littoral zone (i.e., nearshore zone) is similar in character to much of the open water zone. Floating and/or emergent vegetation are found in small stretches around the shoreline.

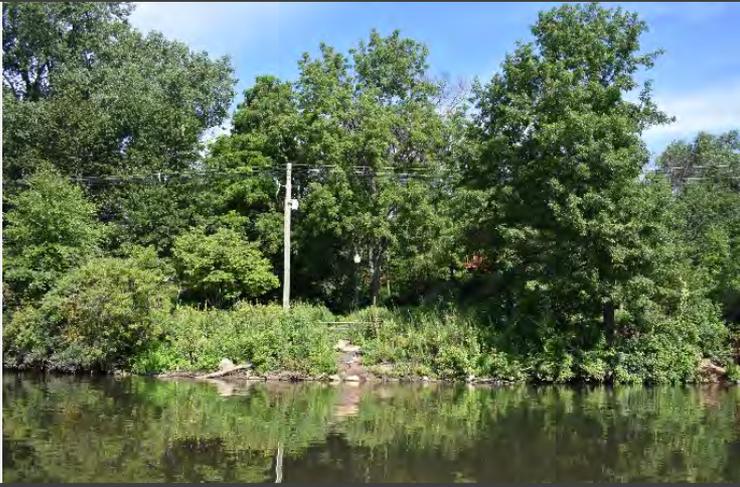
**VIEW OF SOUTHEAST PORTION OF
LAKE GEORGE SHORELINE**

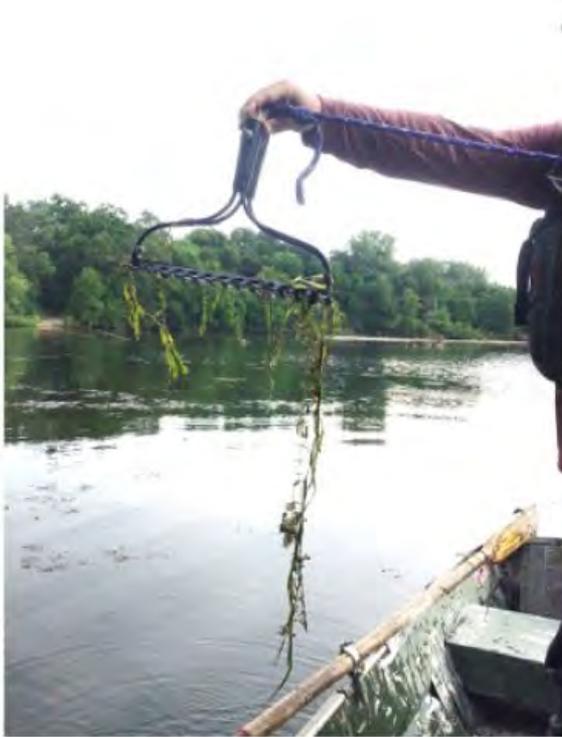
Rake Fullness 1, typically

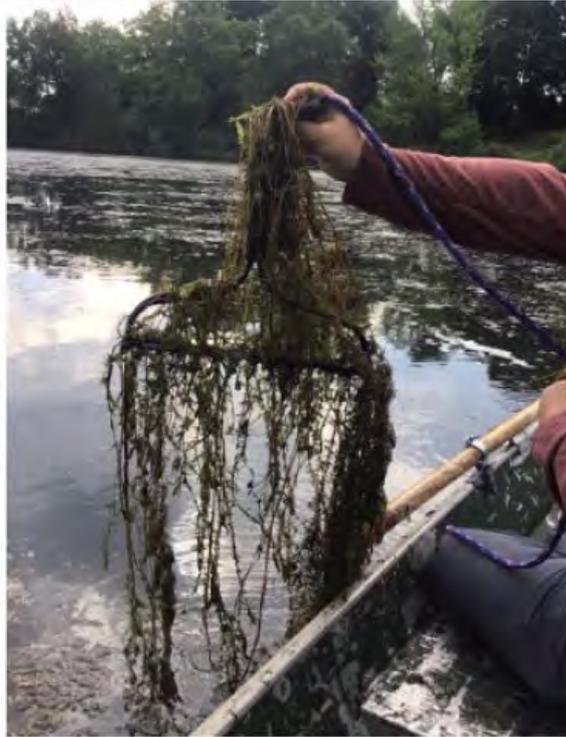
Rake Fullness 2, typically

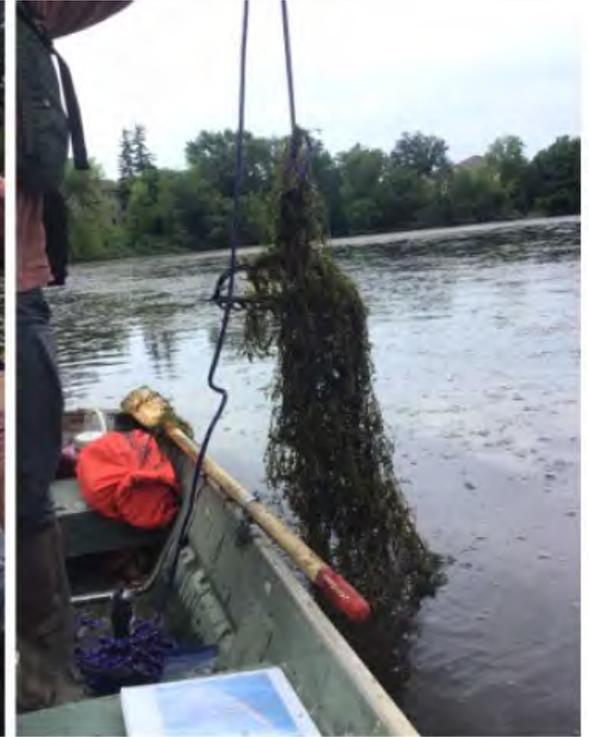
Rake Fullness 3, typically

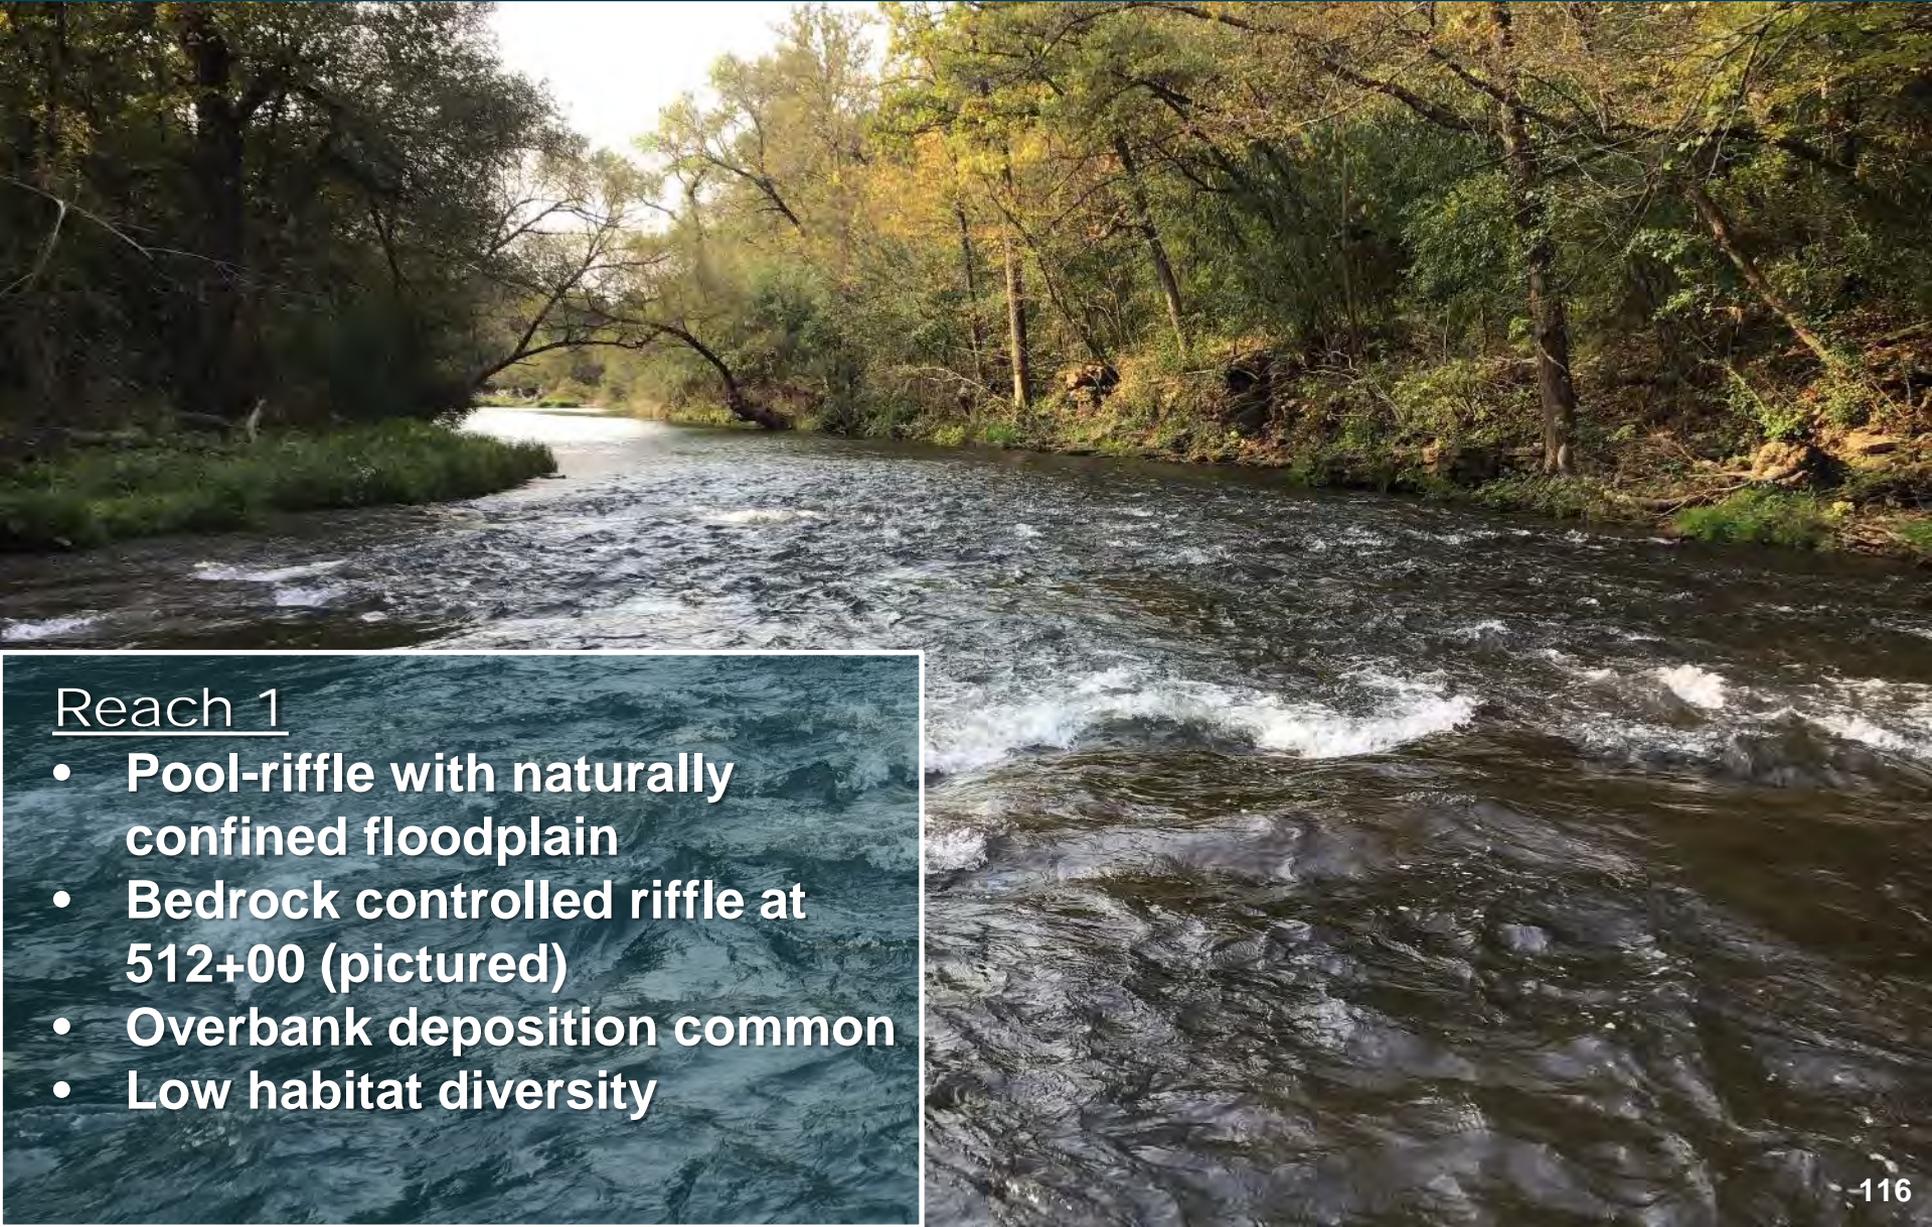
Reach 1

- Pool-riffle with naturally confined floodplain
- Bedrock controlled riffle at 512+00 (pictured)
- Overbank deposition common
- Low habitat diversity

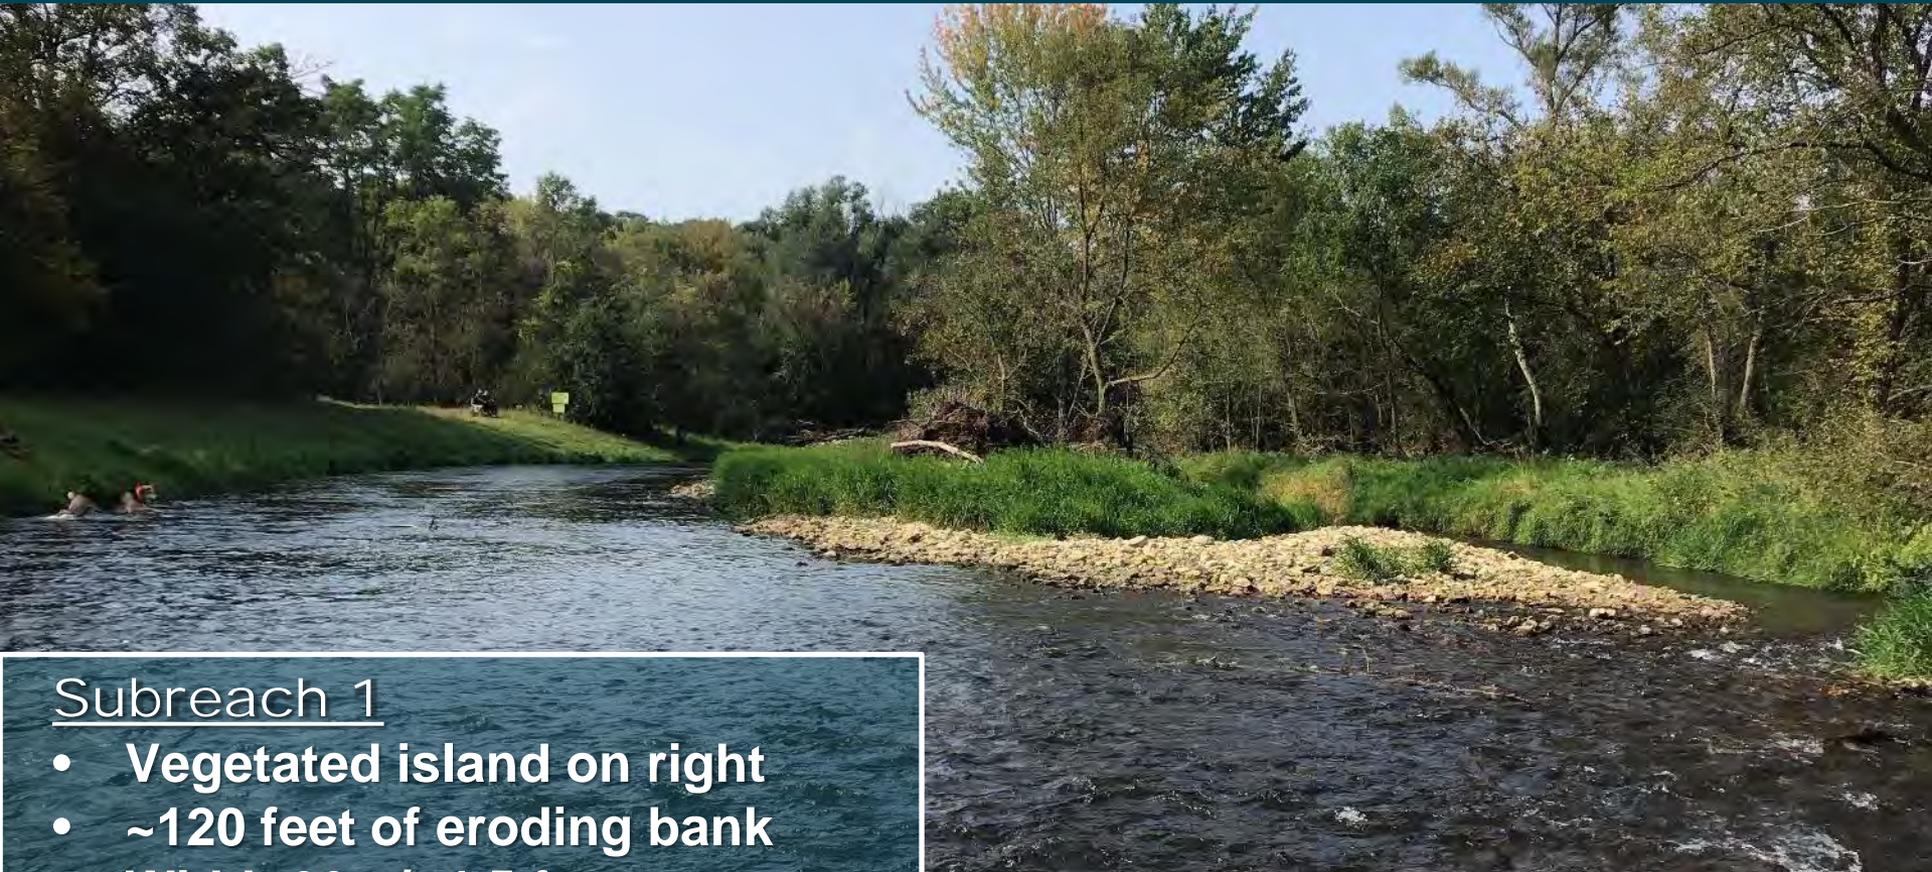
Subreach 1

- **Vegetated island on right**
- **~120 feet of eroding bank**
- **Width 66 +/- 4.5 feet**
- **Depth 4 +/- 0.5 feet**
- **Poorly sorted sand and gravel riffles**

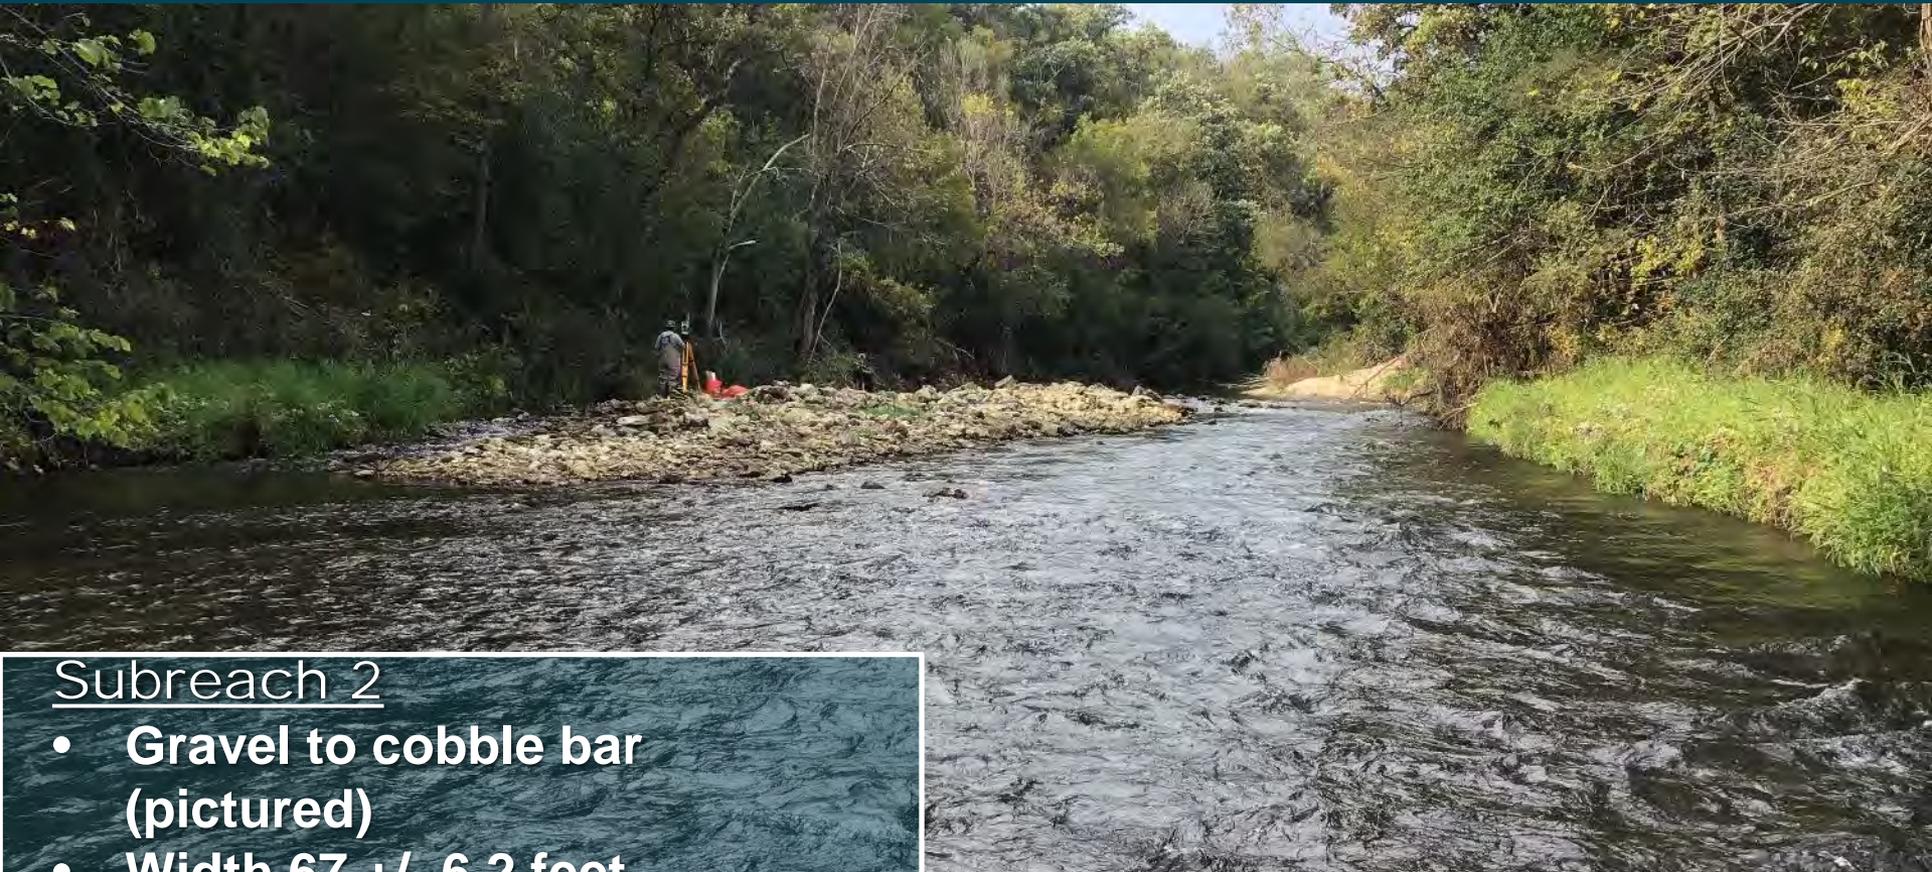
Subreach 2

- Gravel to cobble bar (pictured)
- Width 67 +/- 6.2 feet
- Depth 4 +/- 1.3 feet
- Poorly sorted sand and gravel riffles
- Main habitat coarse riffle substrate
