**RE: River Falls Hydroelectric Project, FERC Project No. 10489
Updated Study Report Meeting Summary**

**RIVER FALLS HYDROELECTRIC PROJECT, FERC No. 10489
INTERESTED PARTIES MAILING LIST**

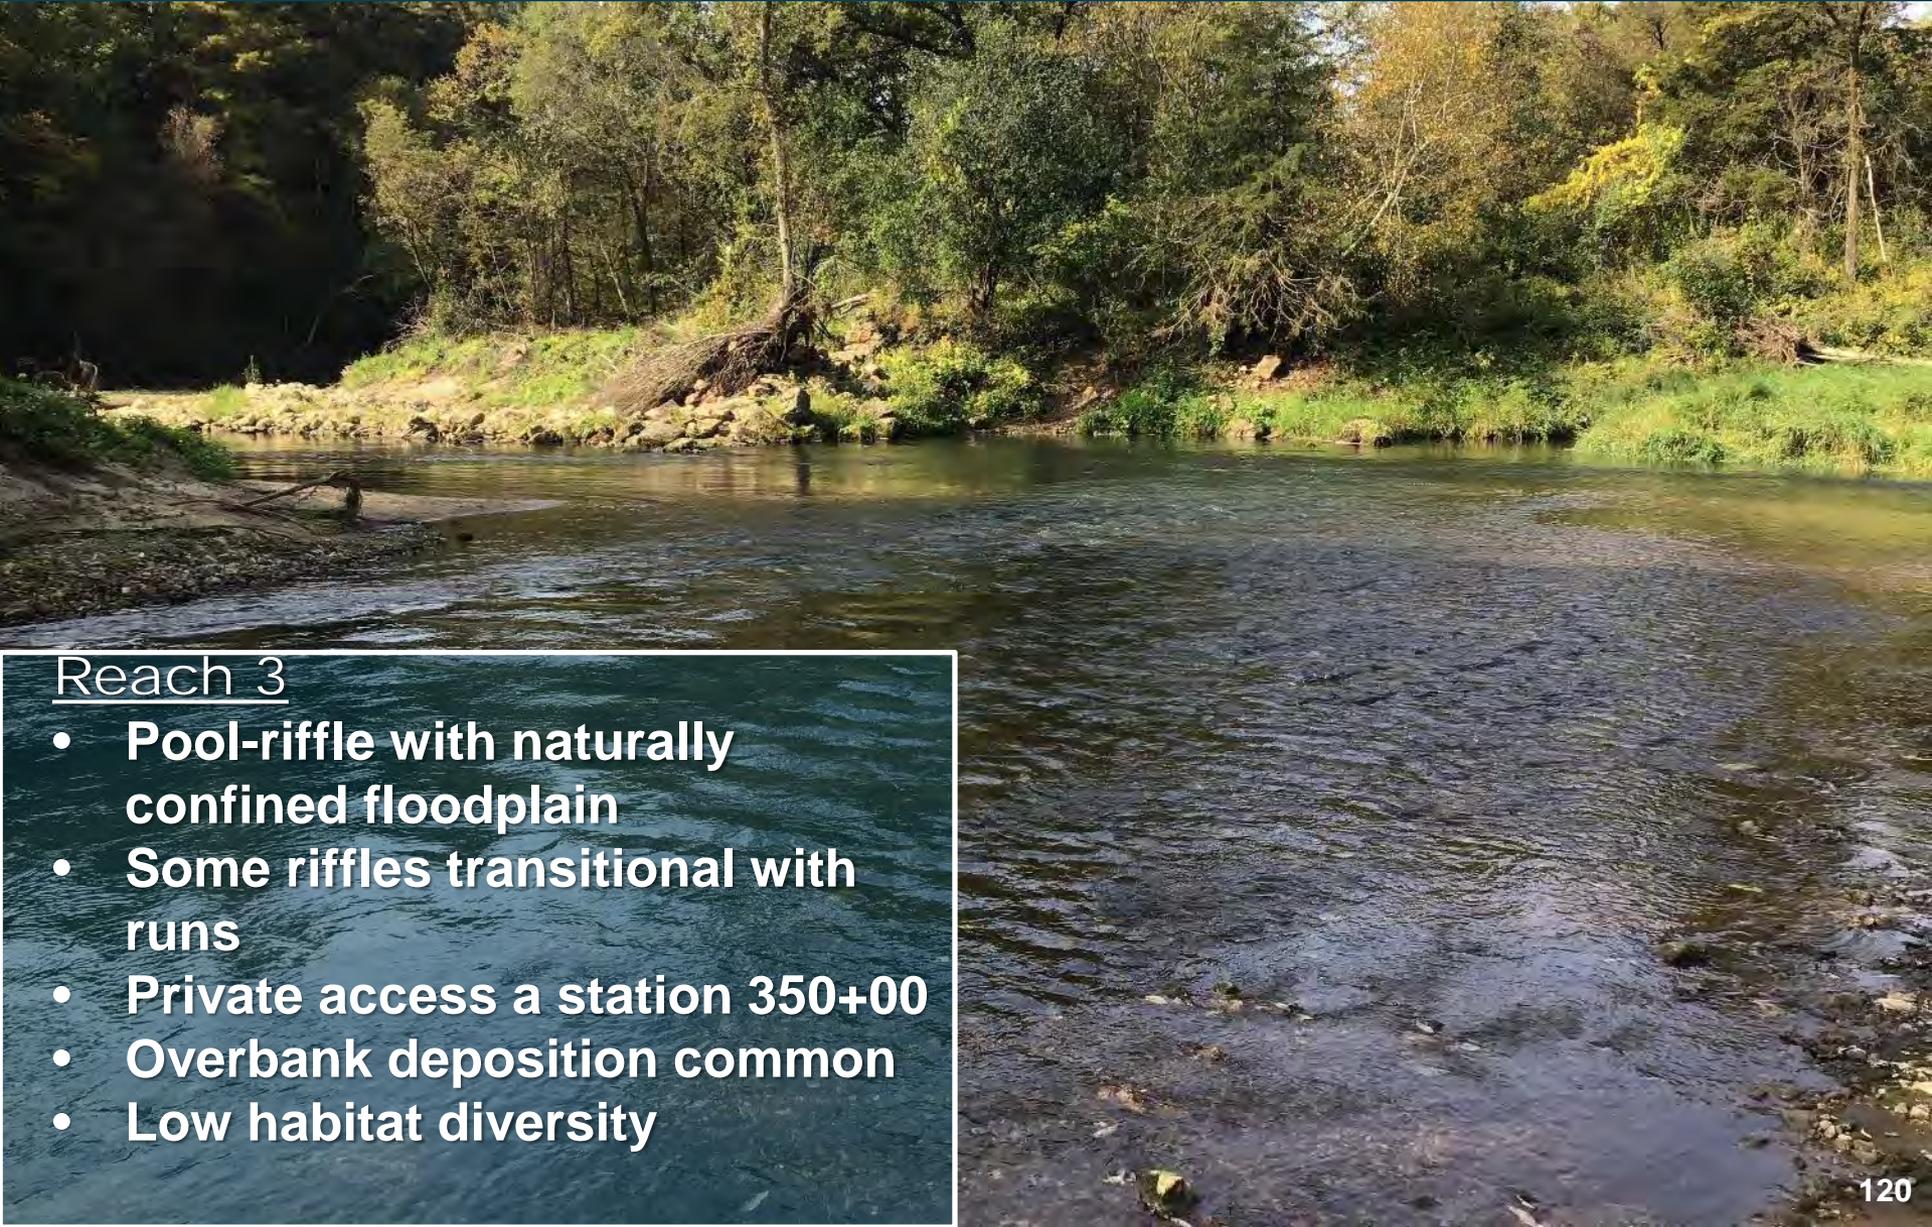
Reach 3

- **Pool-riffle with naturally confined floodplain**
- **Some riffles transitional with runs**
- **Private access a station 350+00**
- **Overbank deposition common**
- **Low habitat diversity**

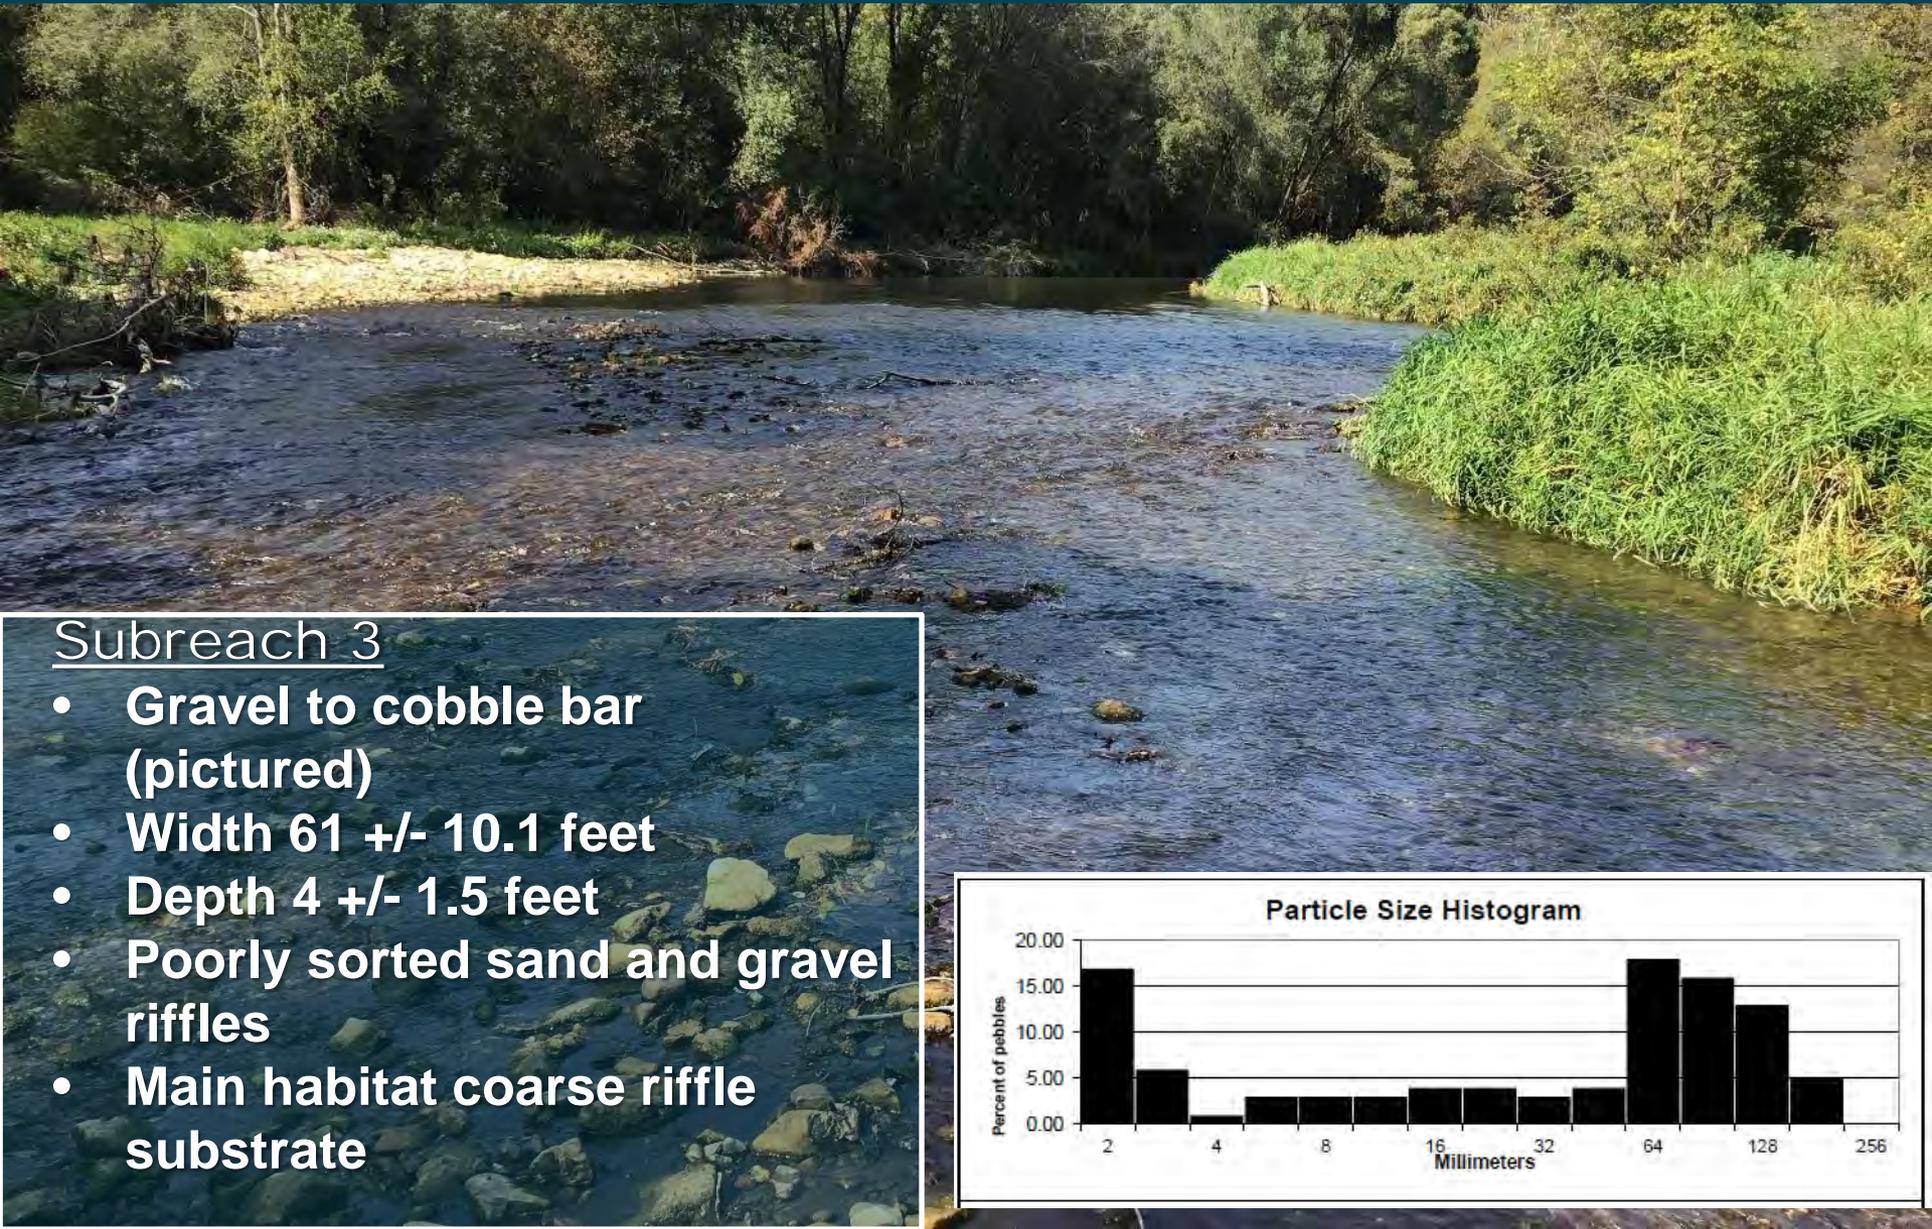
Subreach 3

- Gravel to cobble bar (pictured)
- Width 61 +/- 10.1 feet
- Depth 4 +/- 1.5 feet
- Poorly sorted sand and gravel riffles
- Main habitat coarse riffle substrate

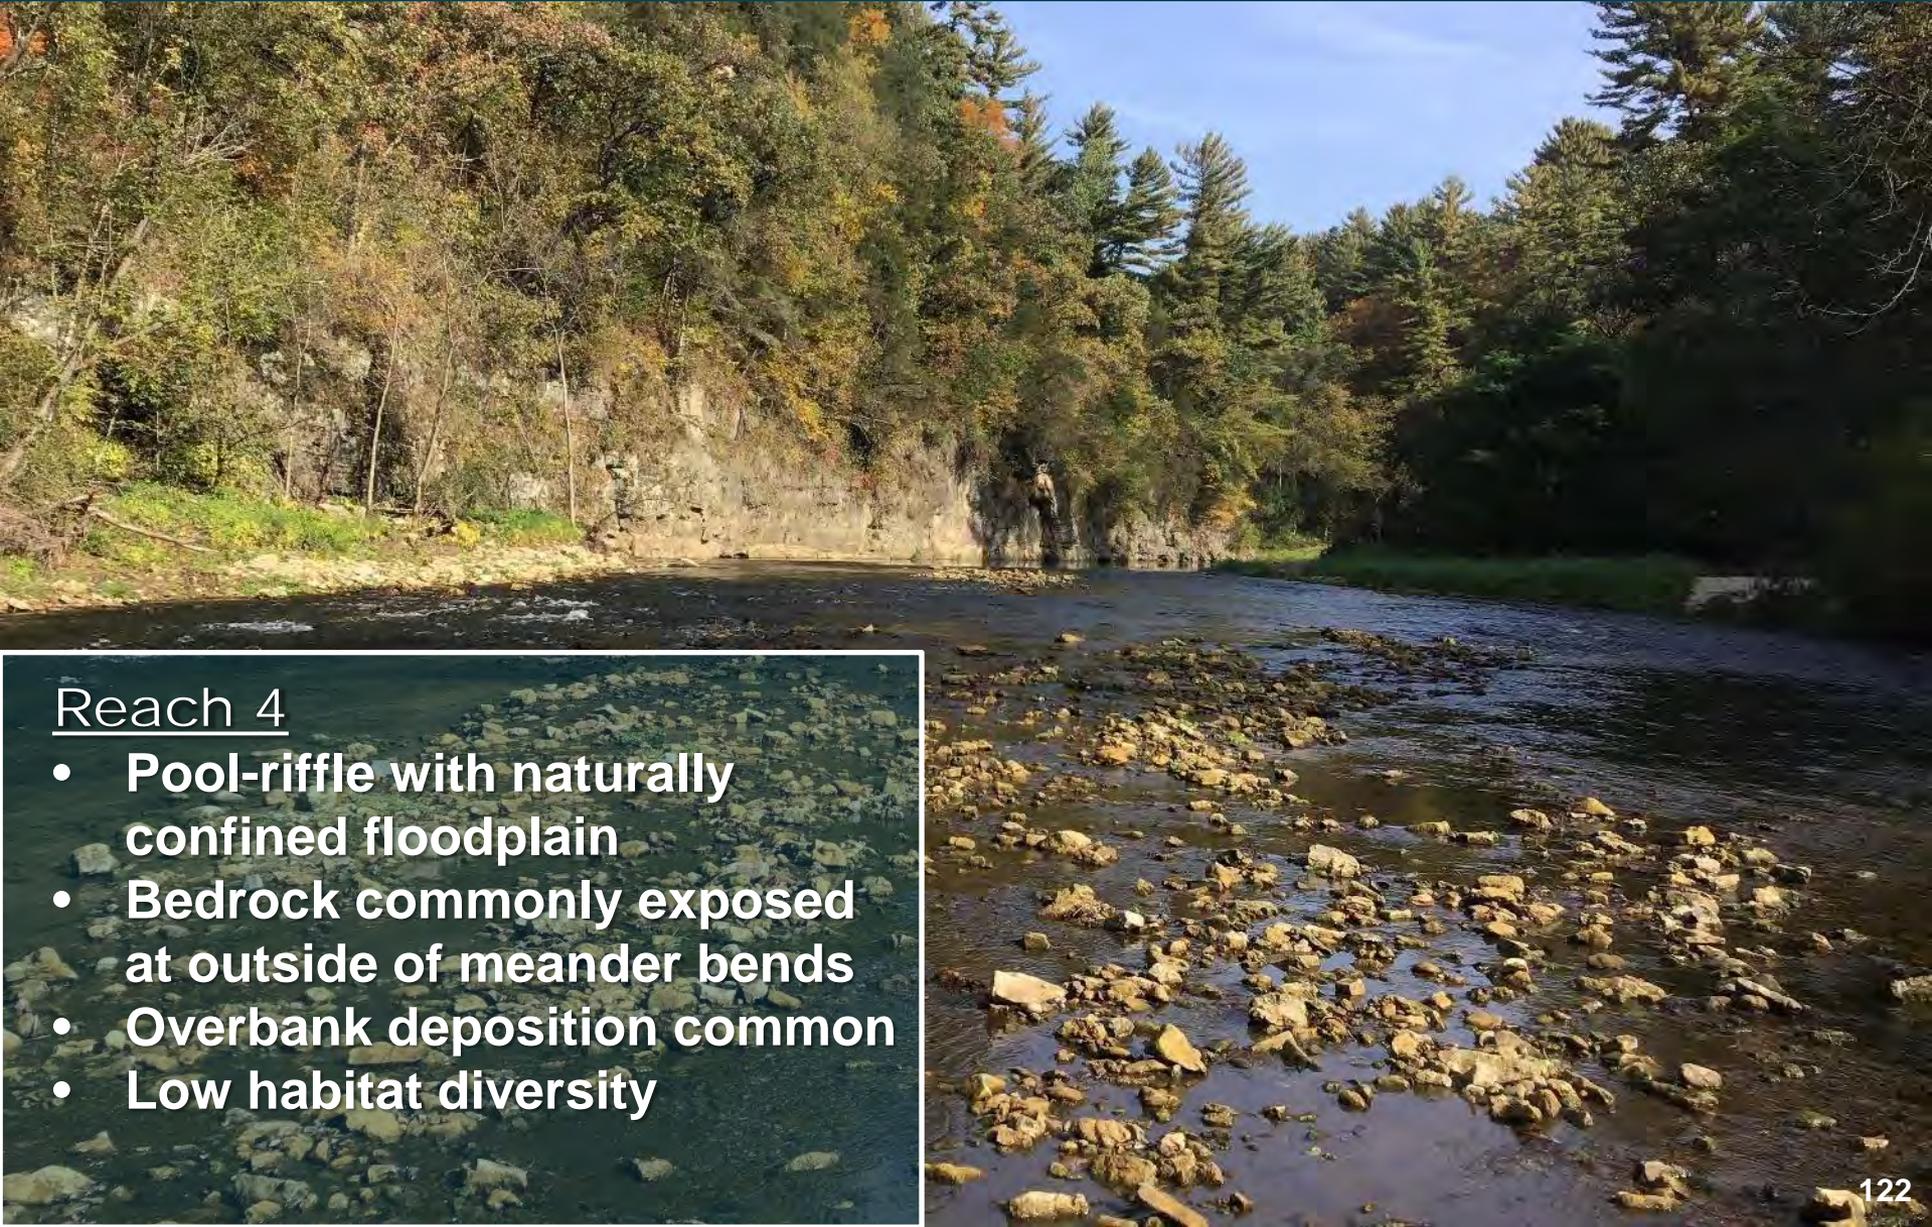
Reach 4

- **Pool-riffle with naturally confined floodplain**
- **Bedrock commonly exposed at outside of meander bends**
- **Overbank deposition common**
- **Low habitat diversity**

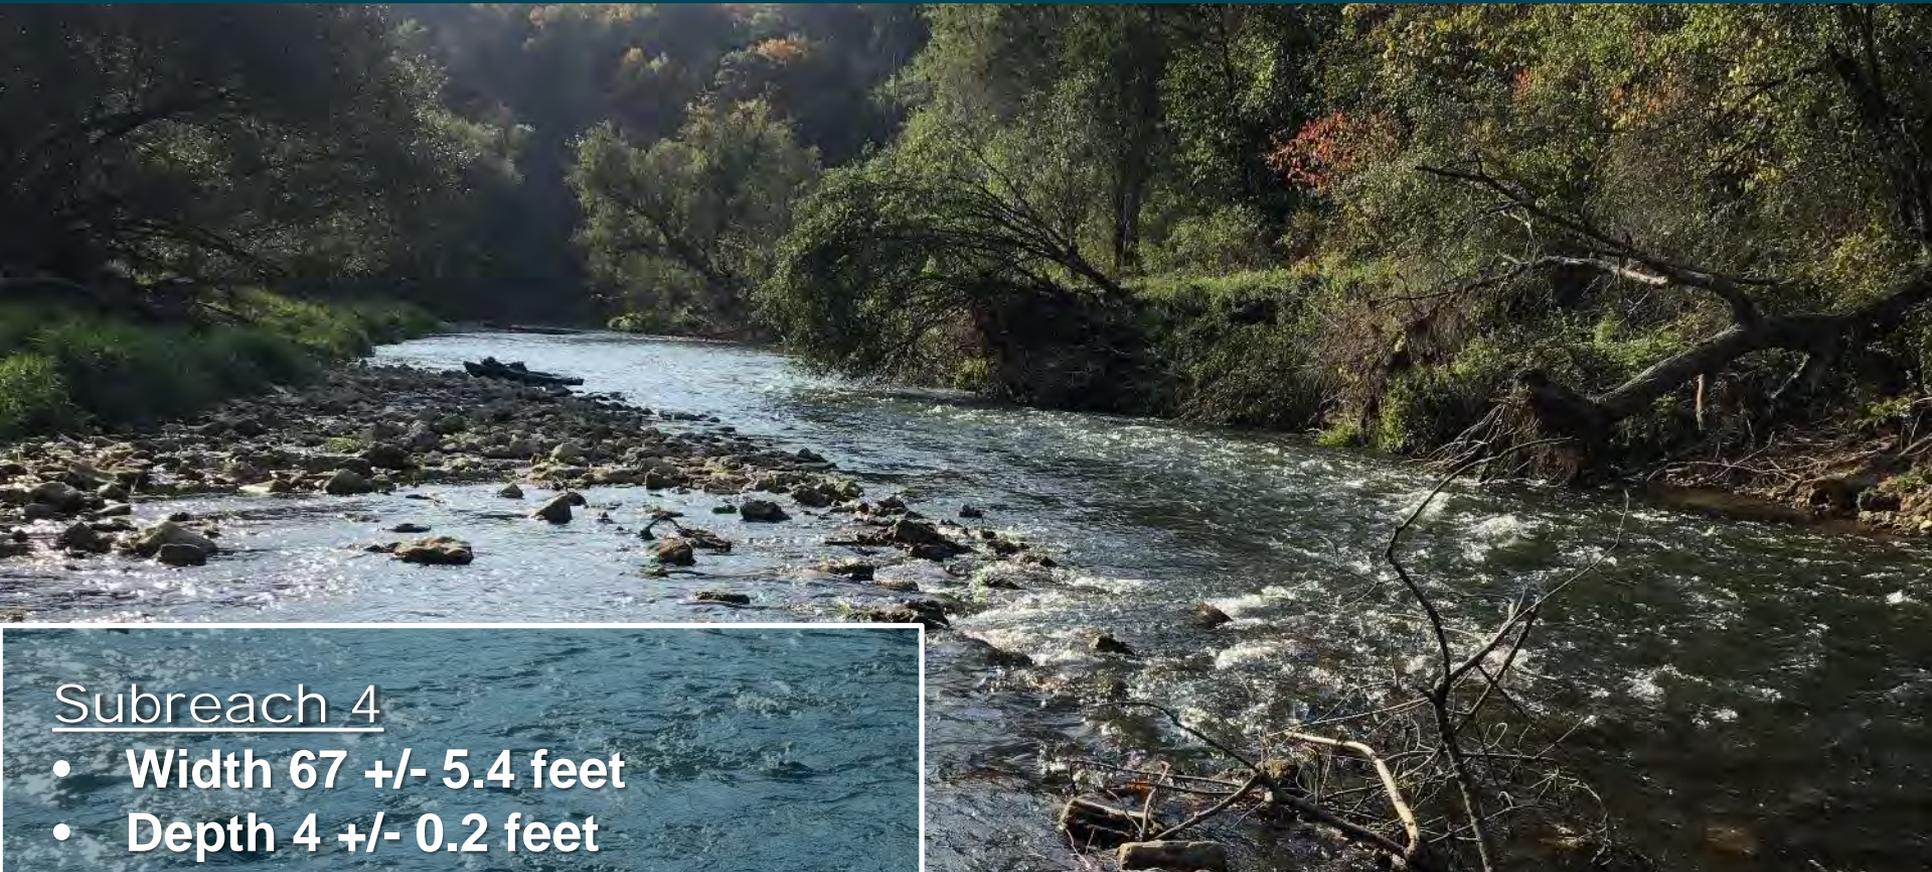
Subreach 4

- Width 67 +/- 5.4 feet
- Depth 4 +/- 0.2 feet
- Poorly sorted sand to cobble riffles
- Main habitat coarse riffle substrate

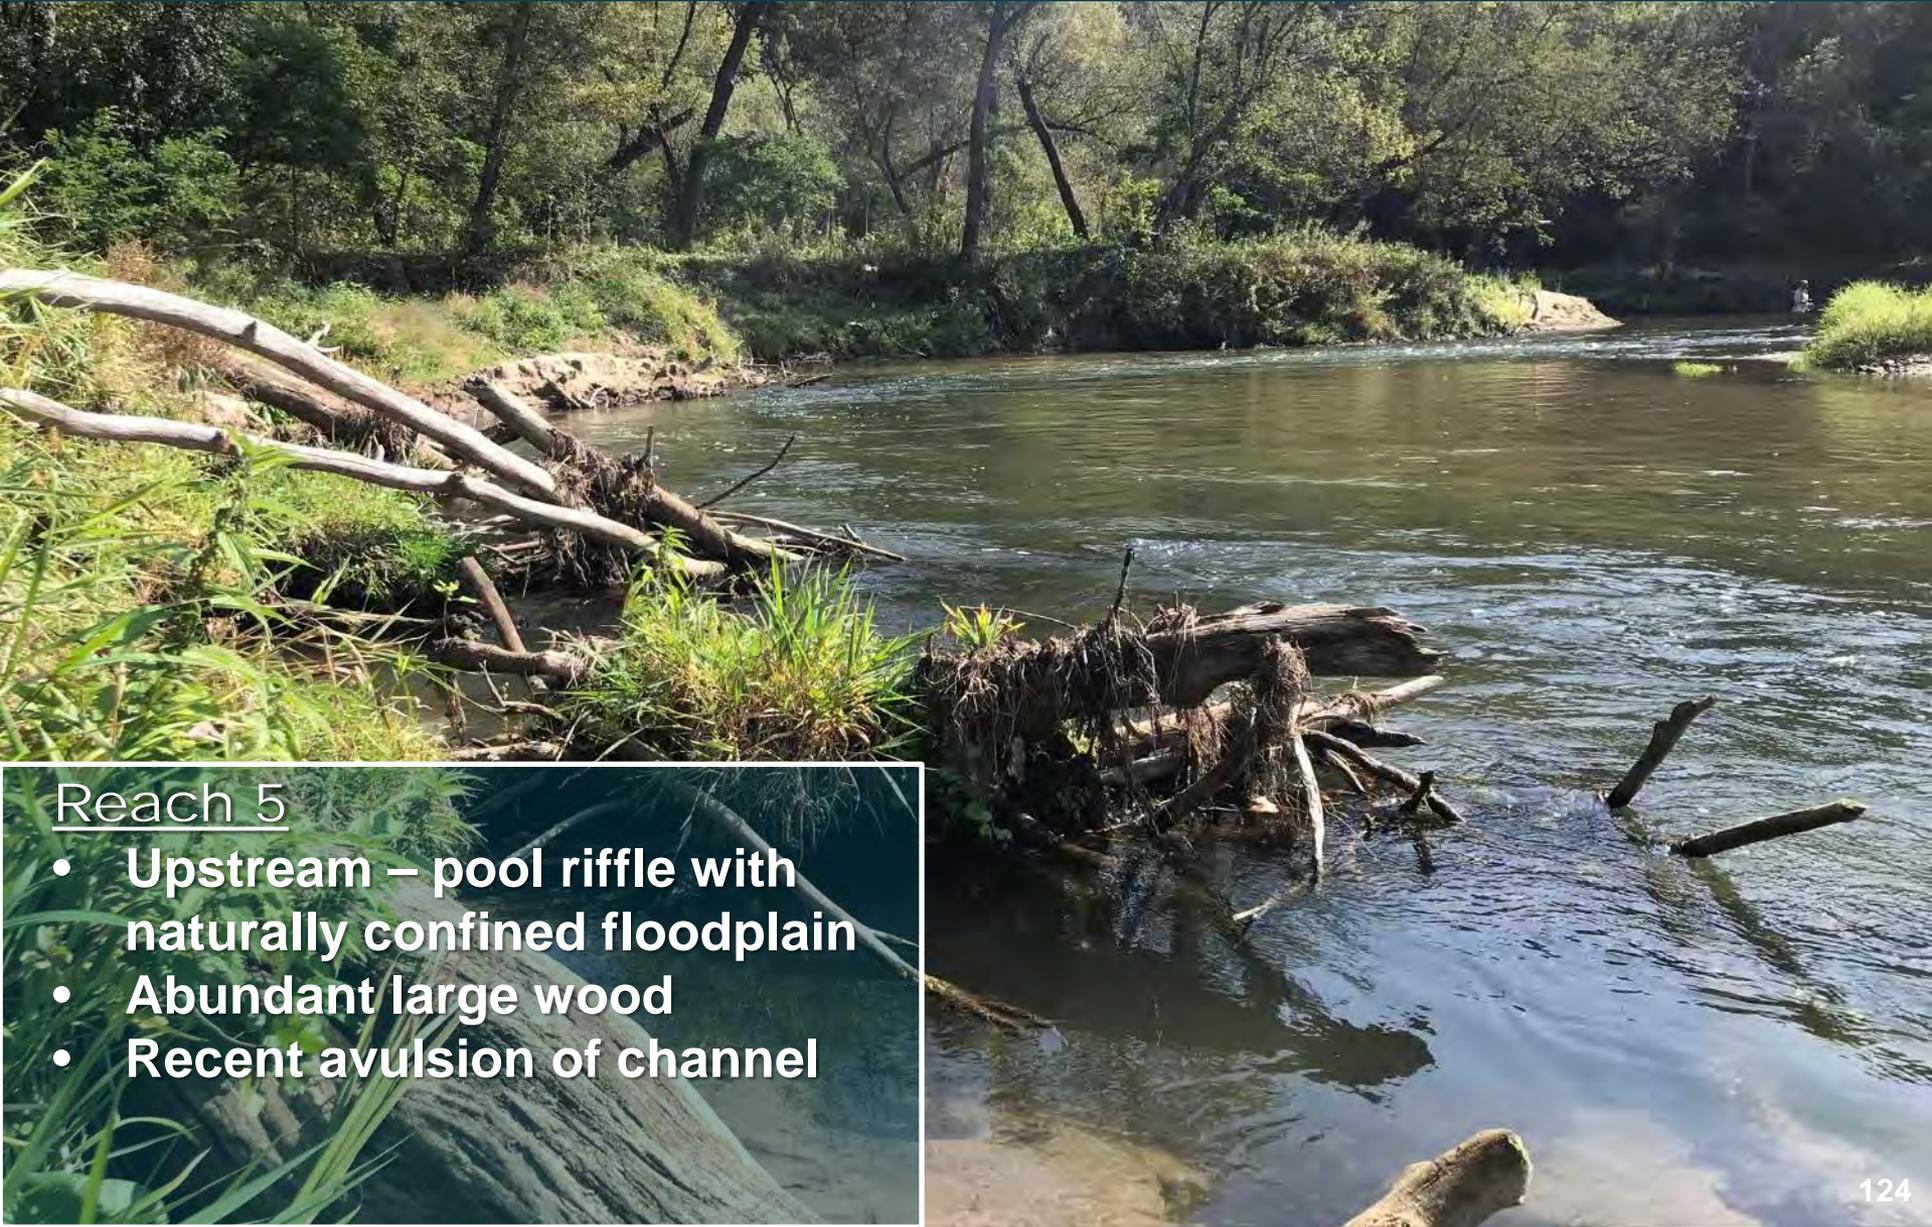
Reach 5

- **Upstream – pool riffle with naturally confined floodplain**
- **Abundant large wood**
- **Recent avulsion of channel**

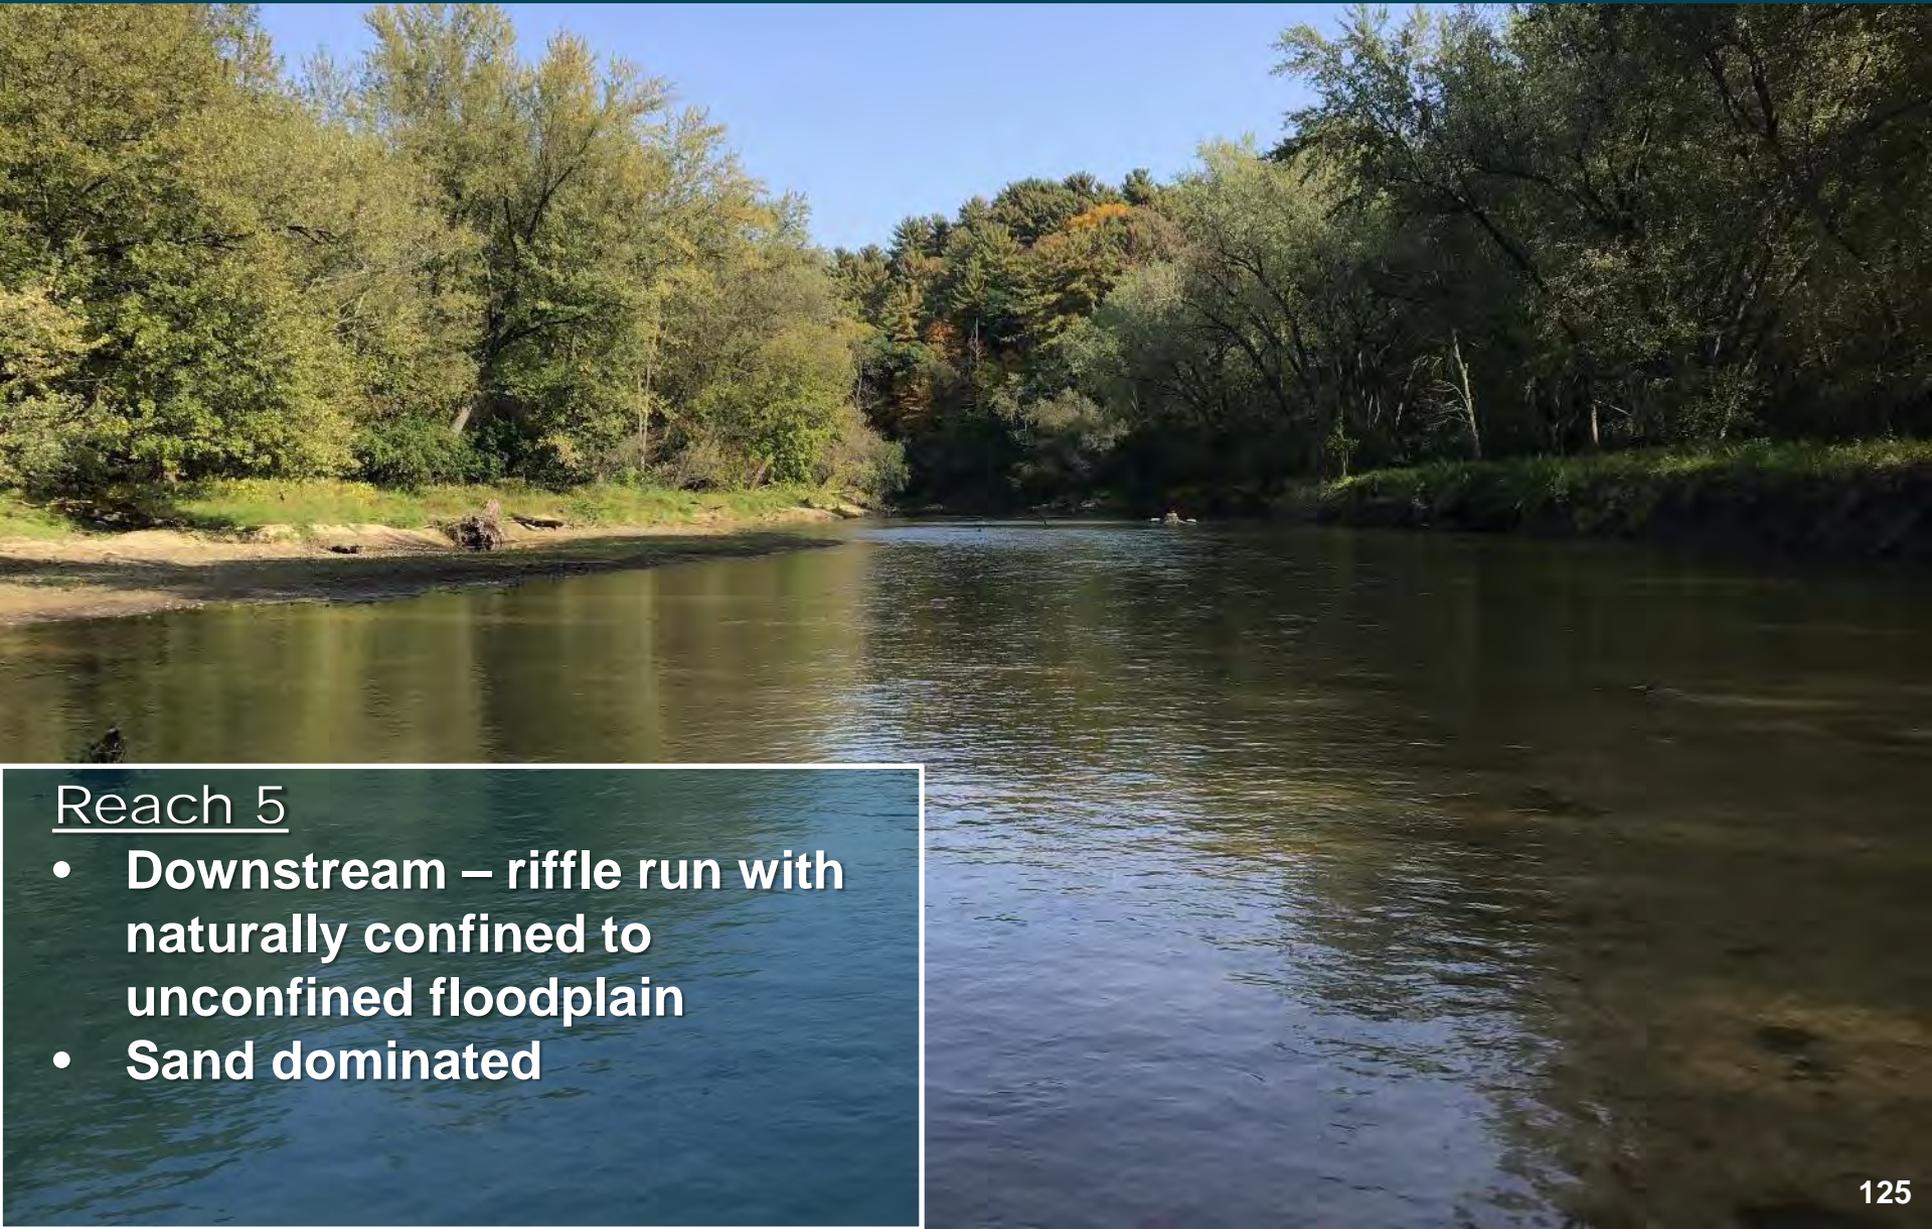
Reach 5

- **Downstream – riffle run with naturally confined to unconfined floodplain**
- **Sand dominated**

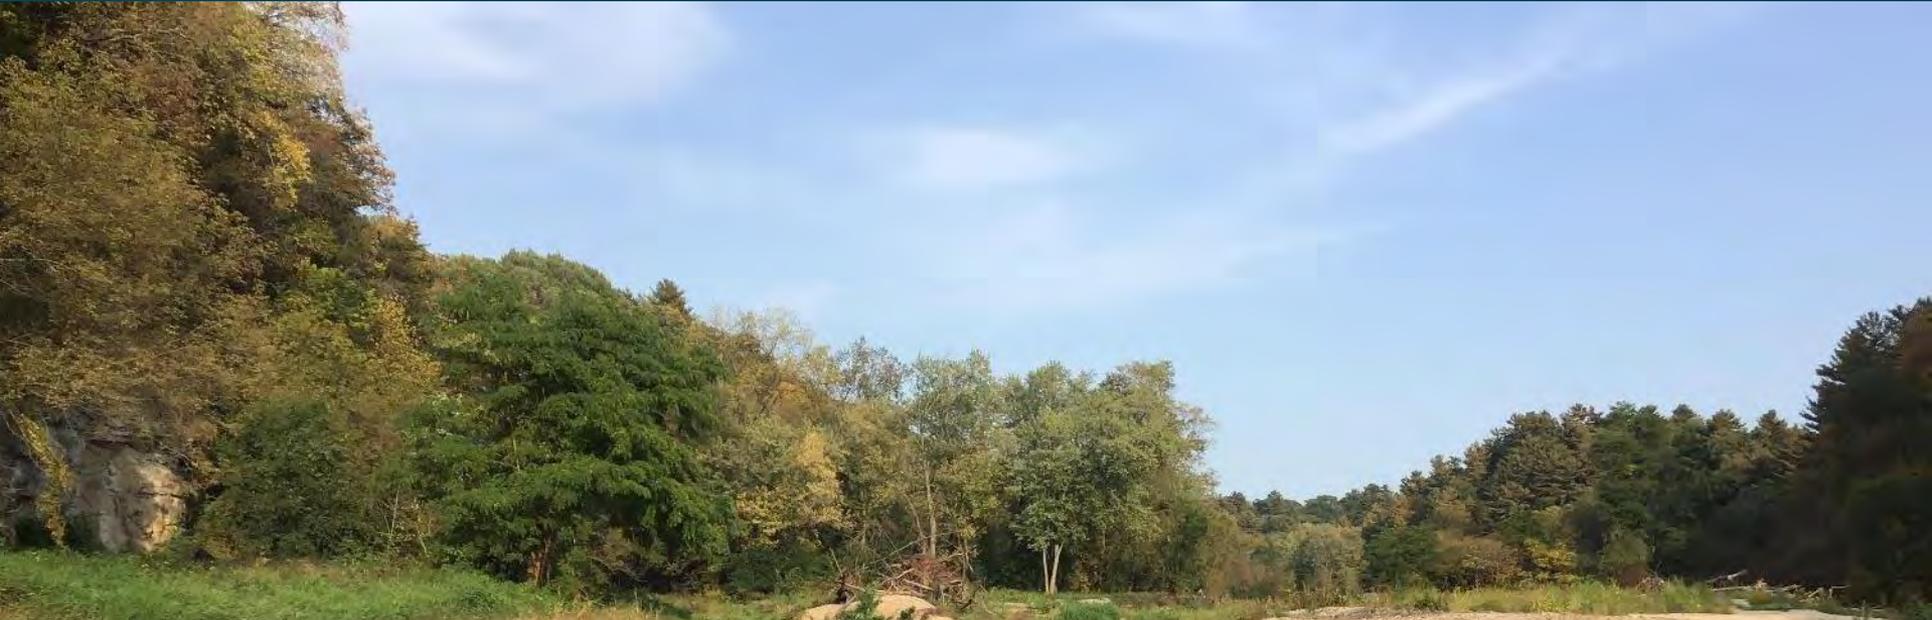
Subreach 5

- **Width 100 +/- 58.3 feet**
- **Depth 5 +/- 0.8 feet**
- **Poorly sorted sand to gravel riffles**
- **Main habitat coarse riffle substrate**

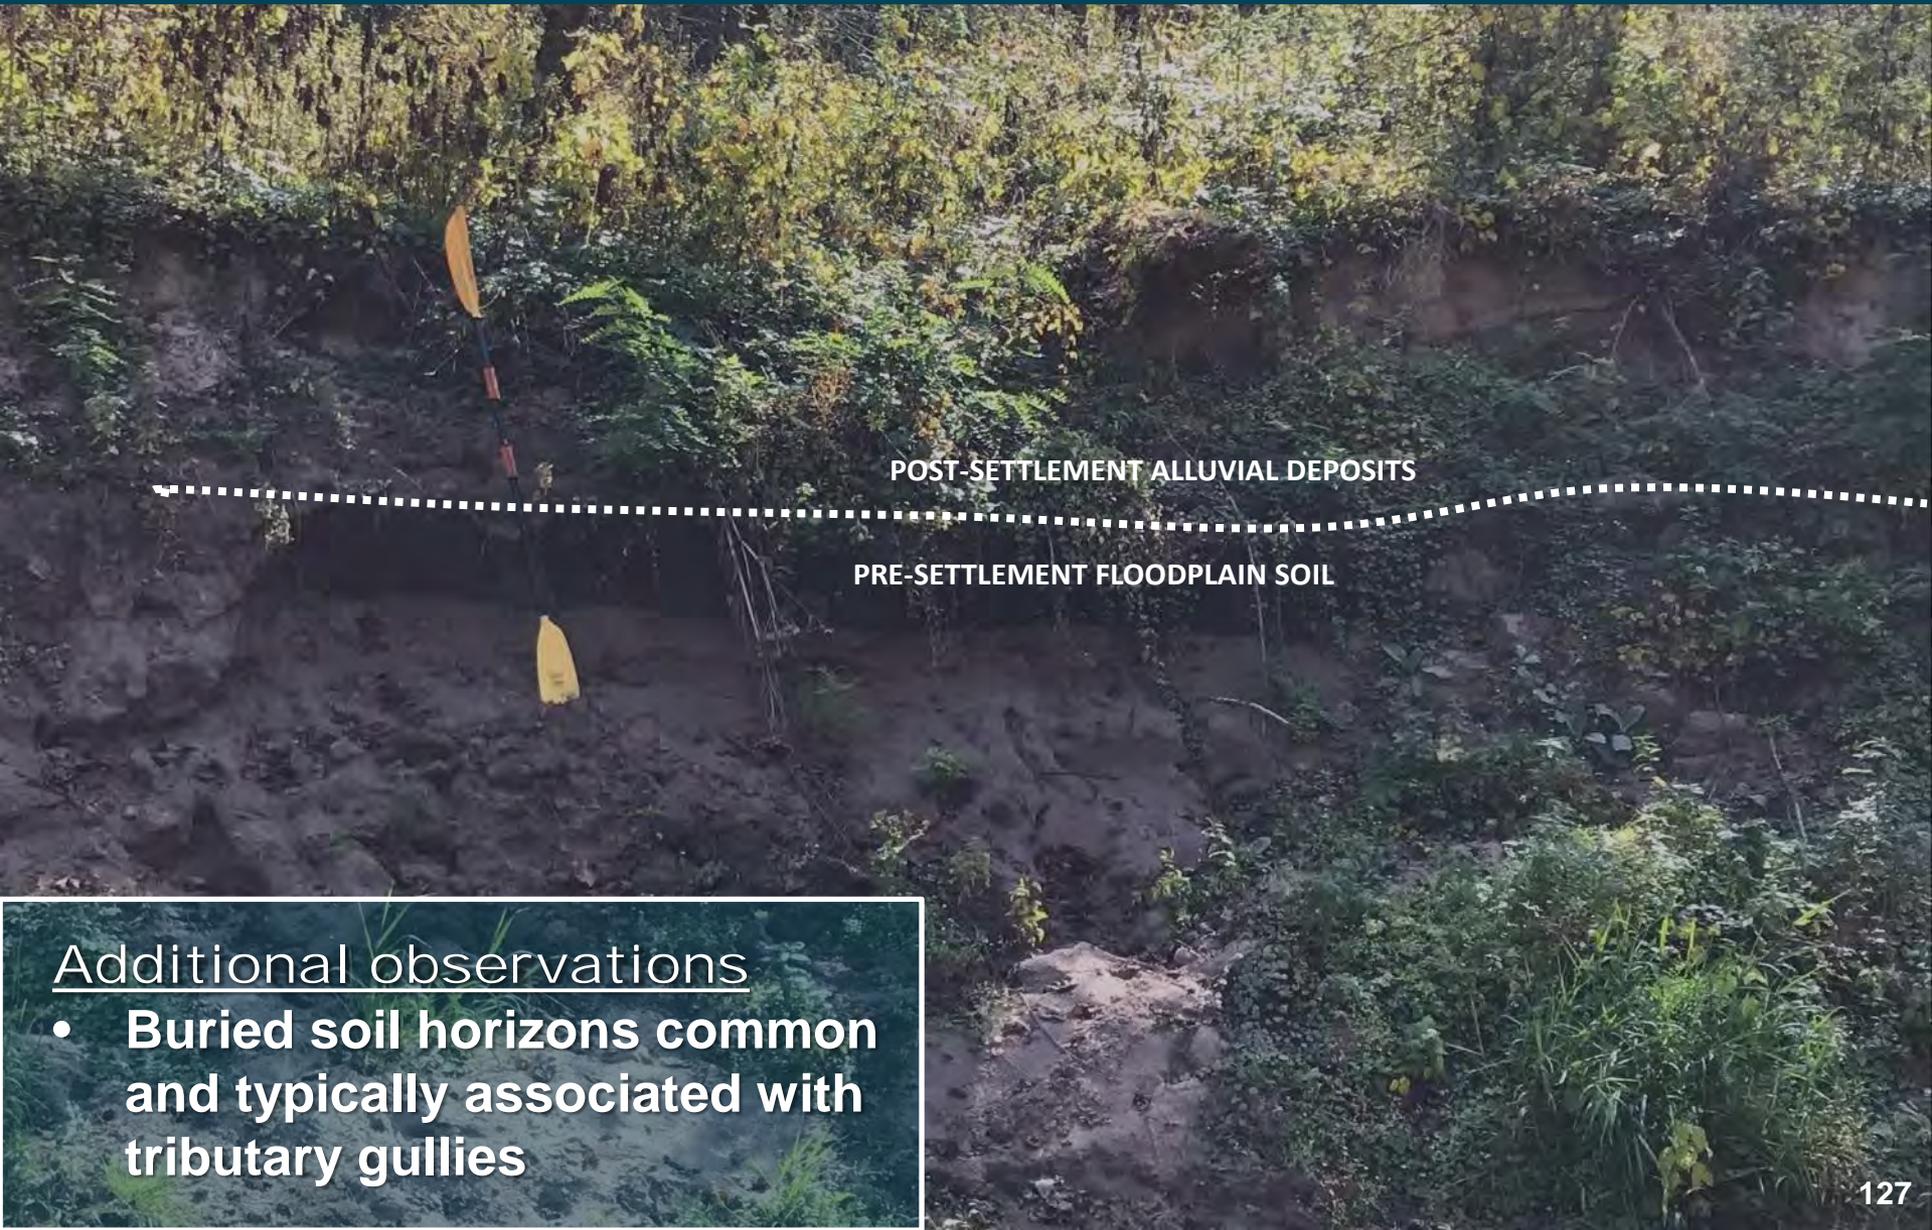
POST-SETTLEMENT ALLUVIAL DEPOSITS

PRE-SETTLEMENT FLOODPLAIN SOIL

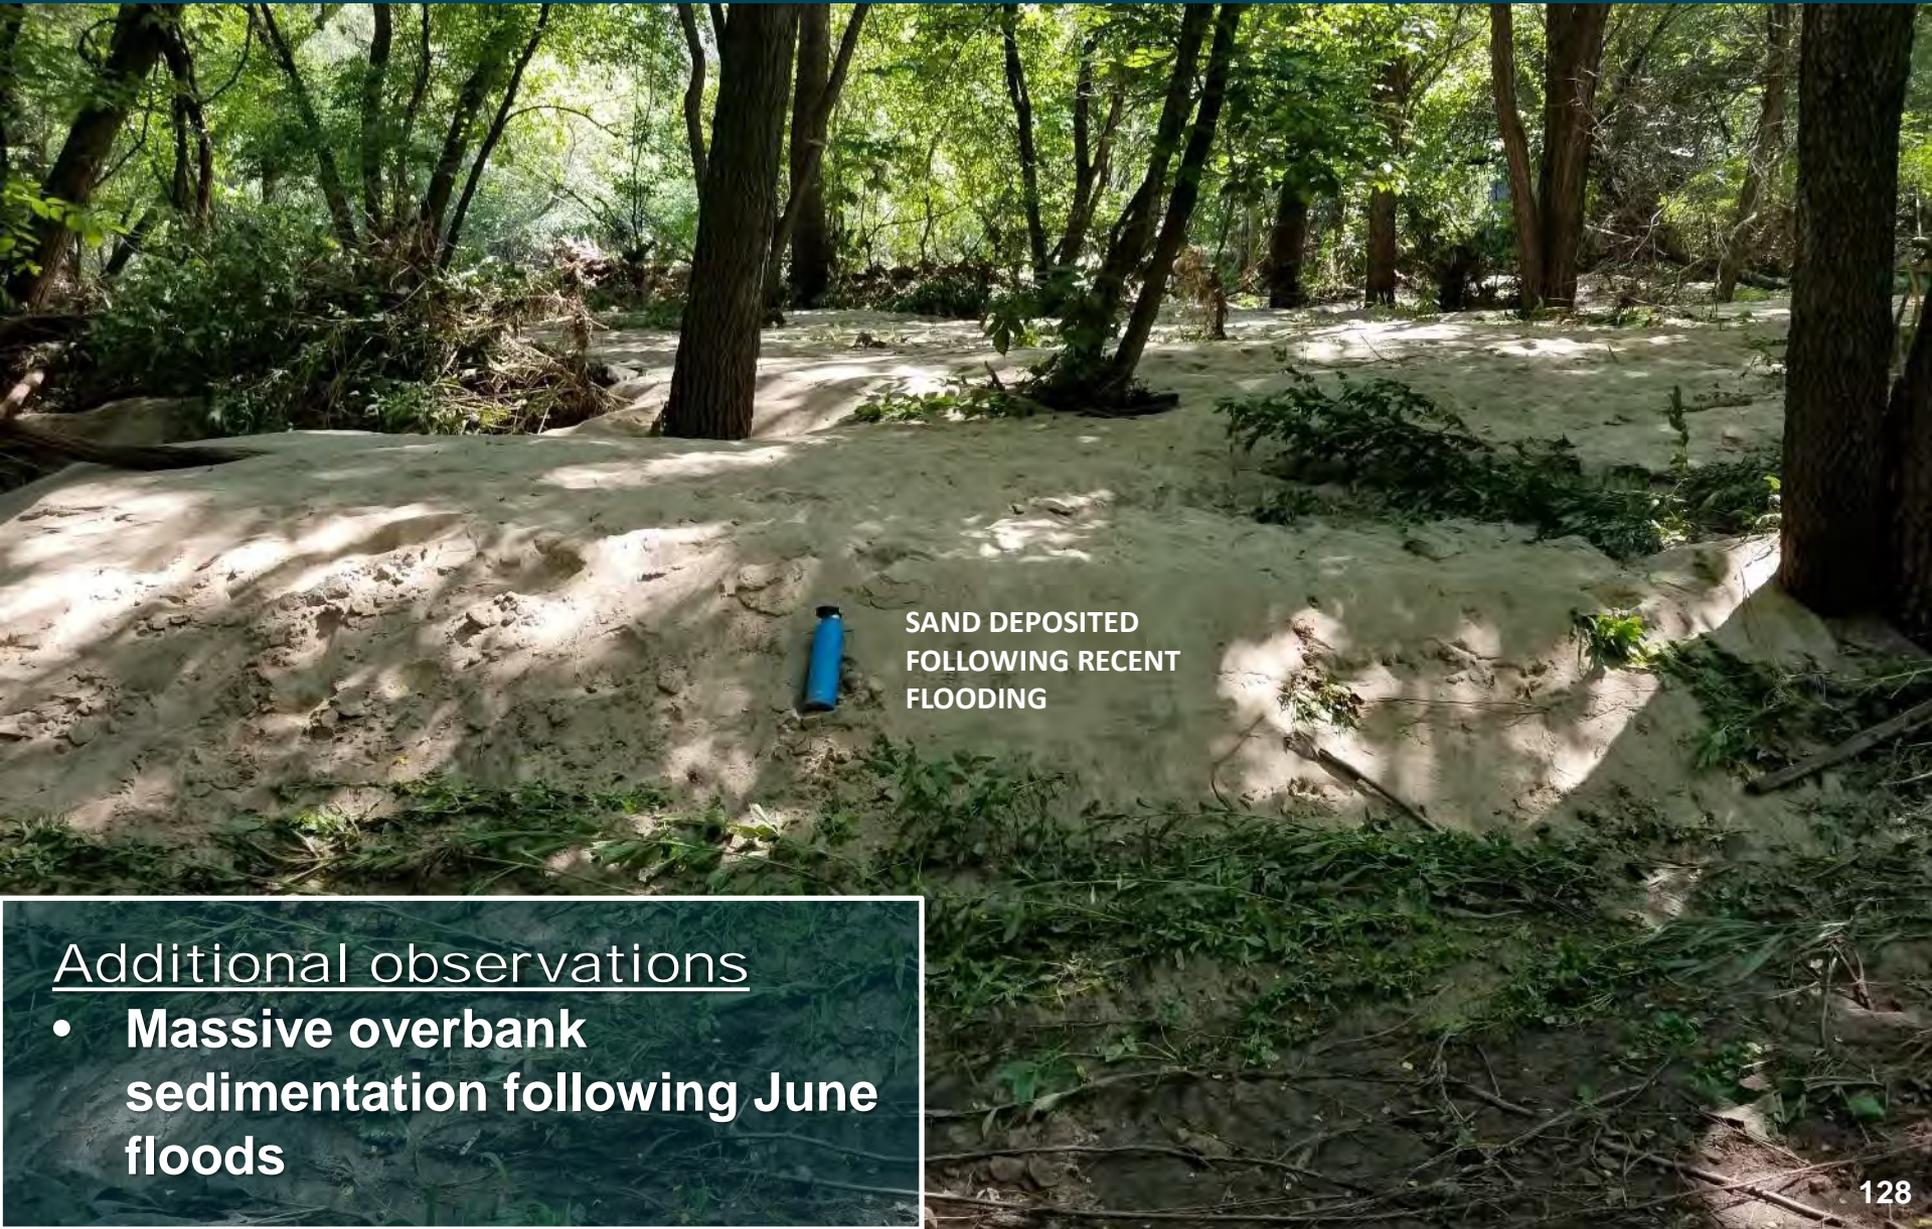
SAND DEPOSITED
FOLLOWING RECENT
FLOODING

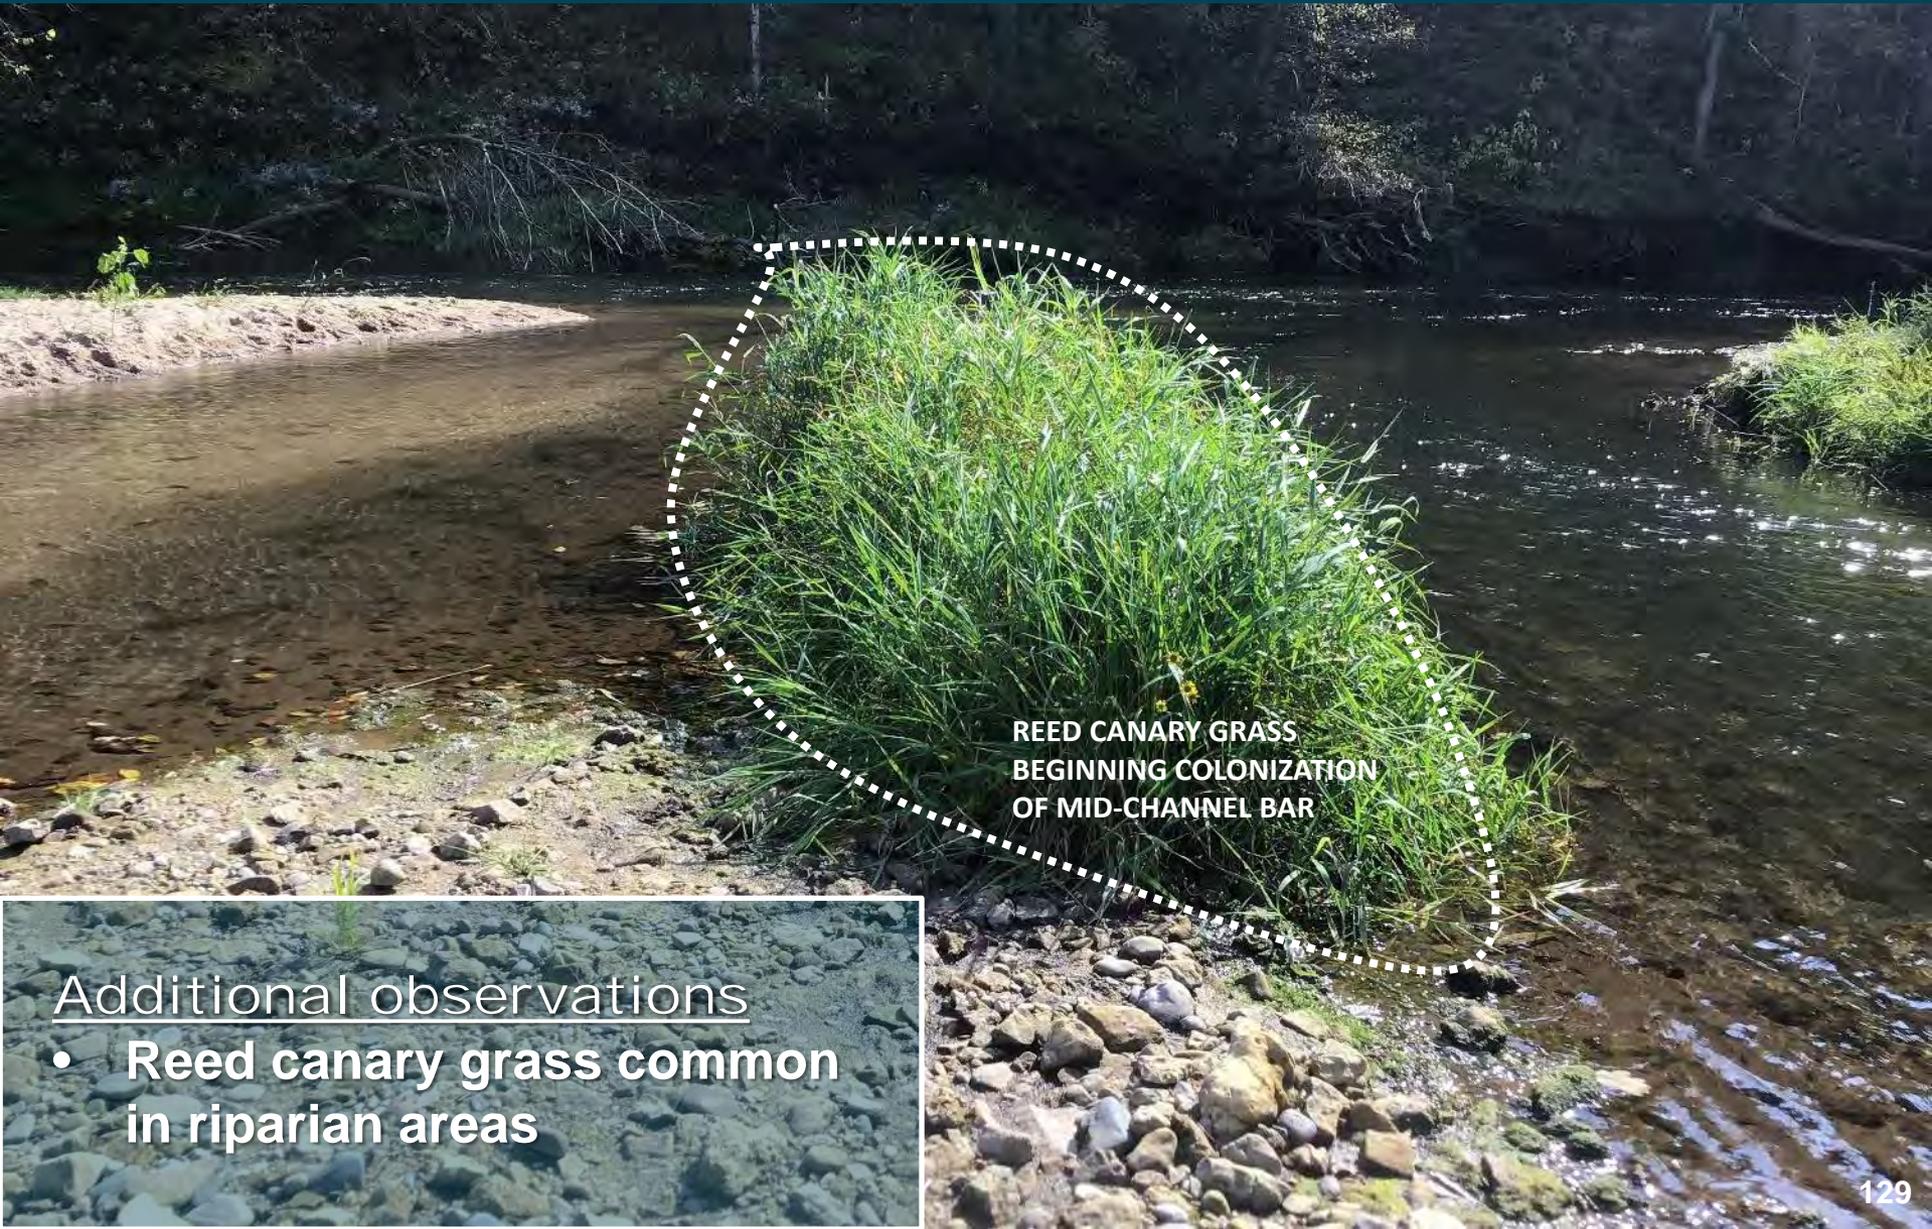
REED CANARY GRASS
BEGINNING COLONIZATION
OF MID-CHANNEL BAR

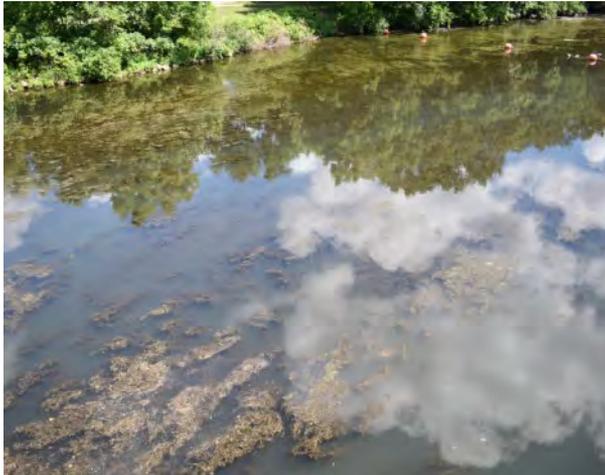
Focal Point: Lake George (16 acres)

- Walking path
- Maintained lawn, street lamps, benches
- Kayak/boat take-out
- Fishing pier
- Parking lot (7 spaces)

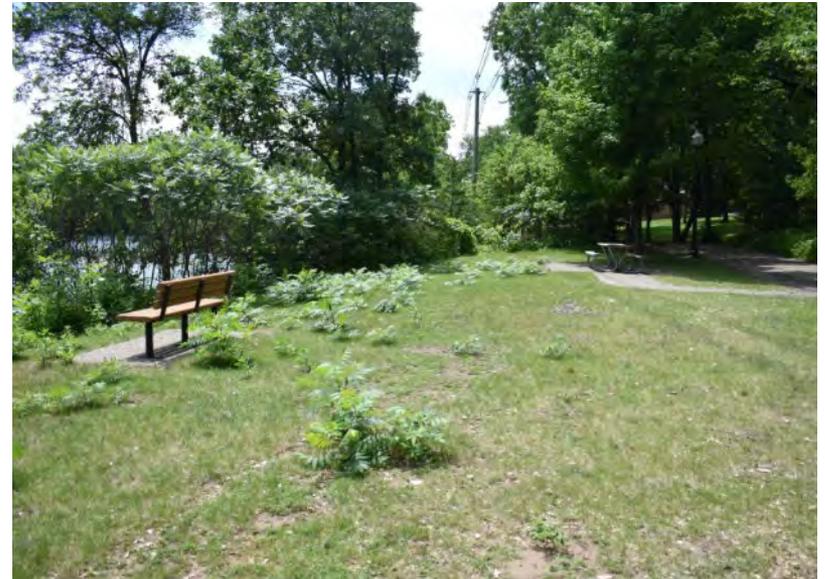
Conditions

- Weedy/areas of dense algae
- Overall well-maintained pathway and associated amenities
- No bathrooms/toilets
