**RE: River Falls Hydroelectric Project, FERC Project No. 10489
Updated Study Report Meeting Summary**

**RIVER FALLS HYDROELECTRIC PROJECT, FERC No. 10489
INTERESTED PARTIES MAILING LIST**

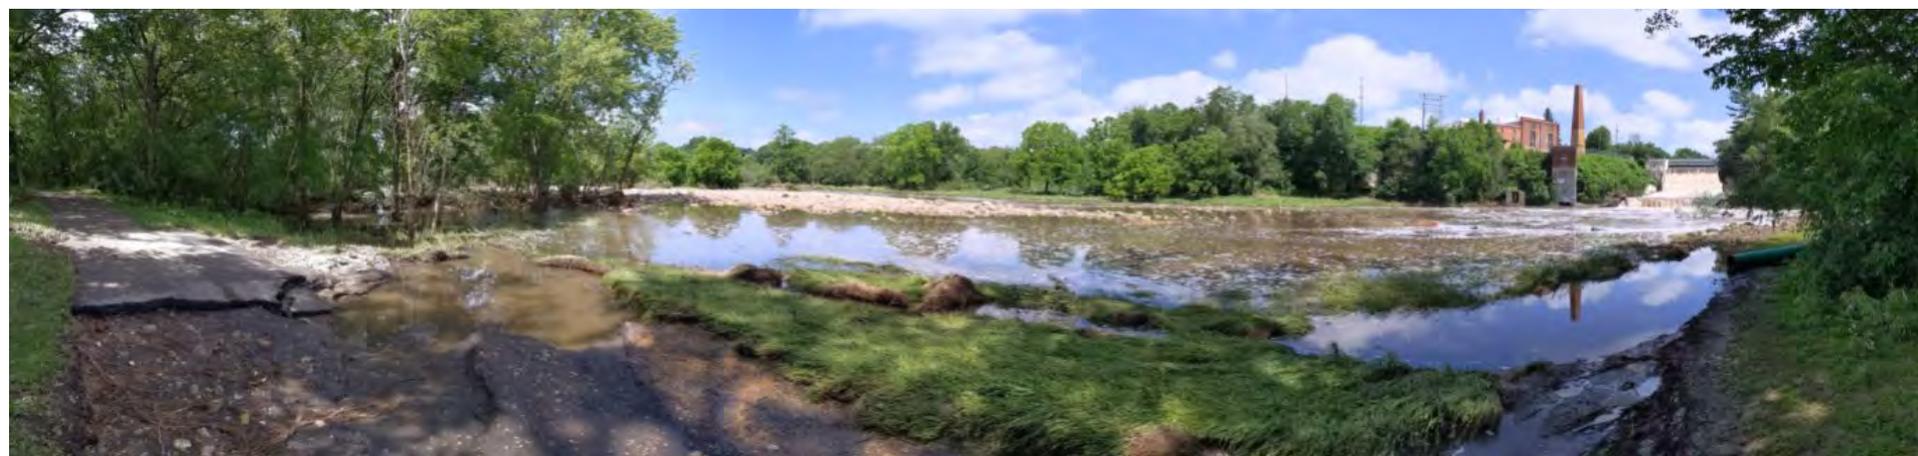
Conditions

- Paved trail in good condition
- Pre- and post-flood conditions drastically different at base of Junction Falls Dam

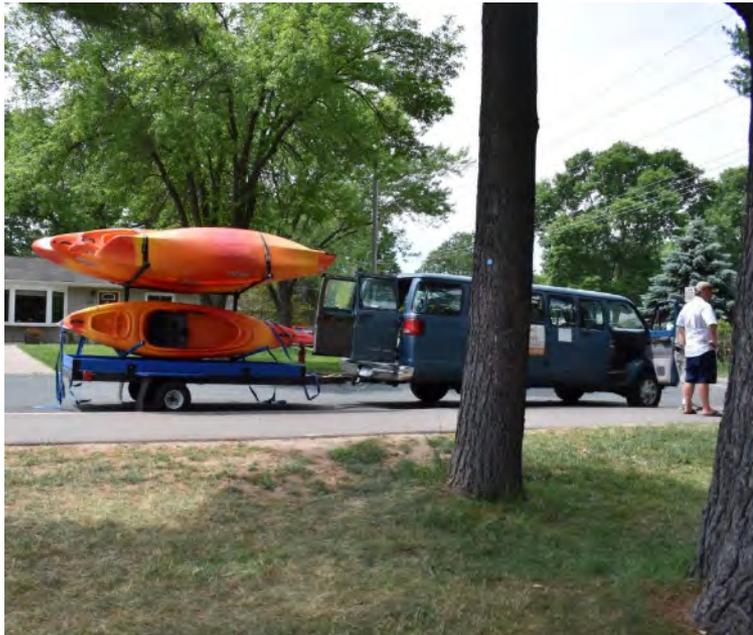
Amenities

- Kayak launch
- Hiking trails
- Kayak staging area with picnic tables

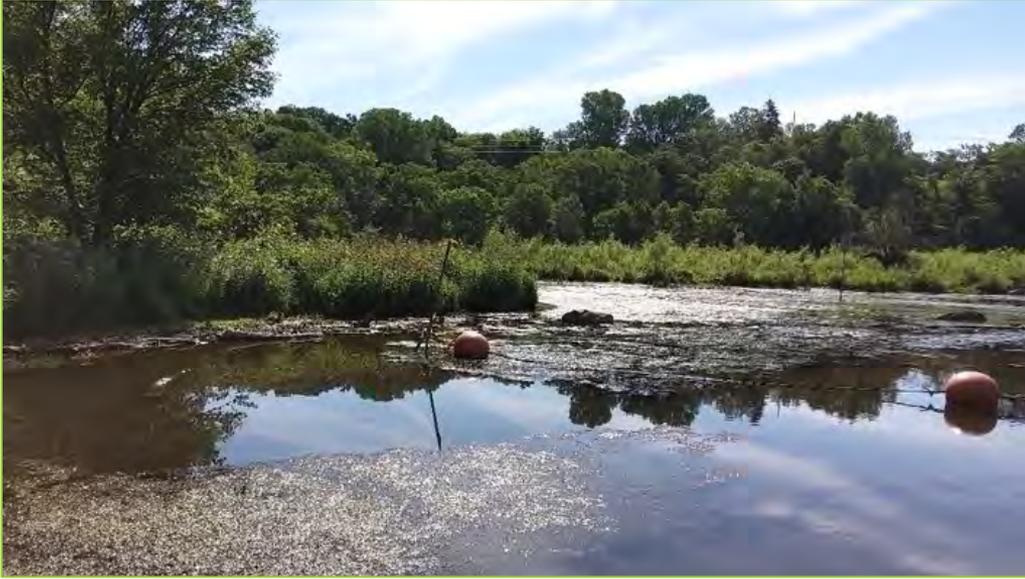
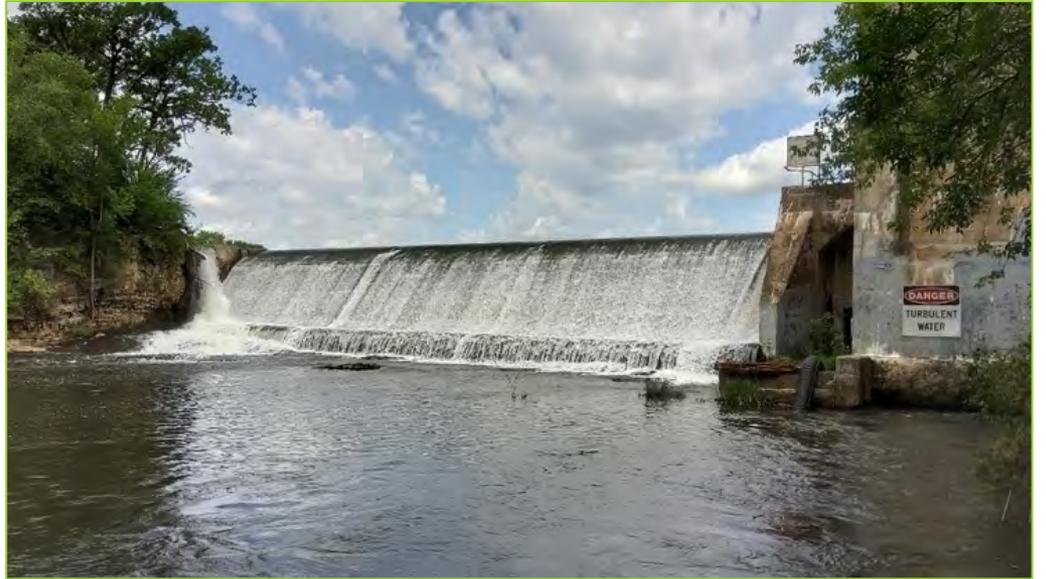
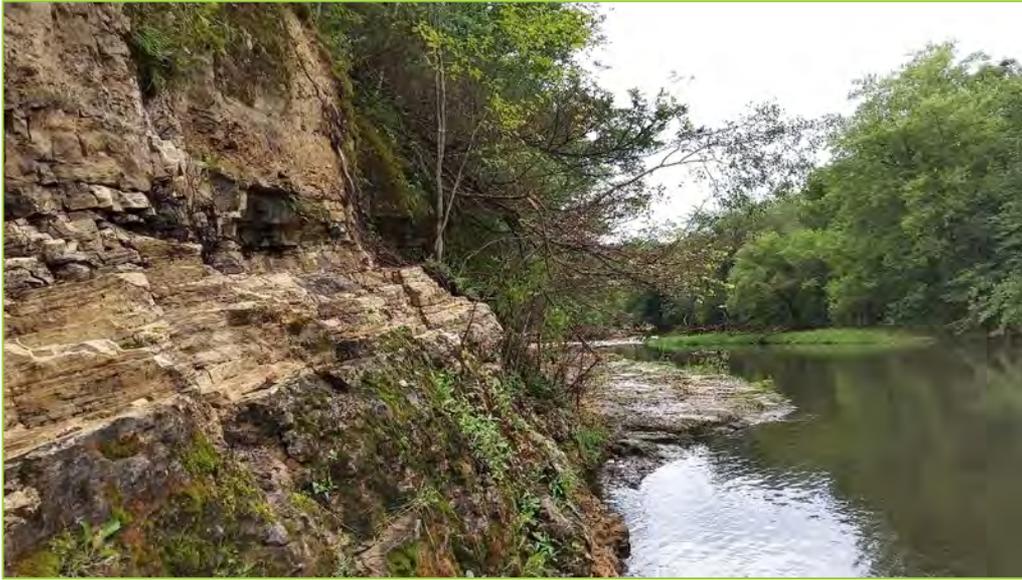
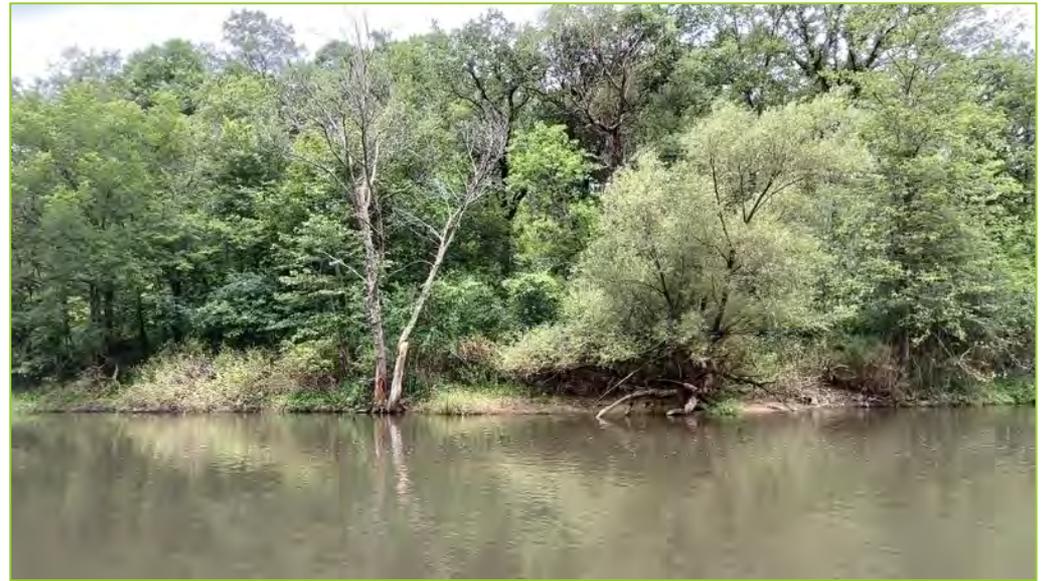
Shoreline Review

- **Junction Falls**
 - Visual inspection of the shoreline did not encounter any areas of erosion, the shoreline appears to be well vegetated and stable;
 - Shovel testing did not encounter any subsurface archaeological artifacts or deposits;
 - **Nothing was found and no additional archaeological work is recommended until that stipulated by the Historic Resources Management Plan (HRMP).**
- **Powell Falls**
 - Visual inspection of the shoreline did not encounter any areas of erosion, the shoreline appears to be well vegetated and stable;
 - Shovel testing did not encounter any subsurface archaeological artifacts or deposits;
 - **Nothing was found and no additional archaeological work is recommended for this Project.**

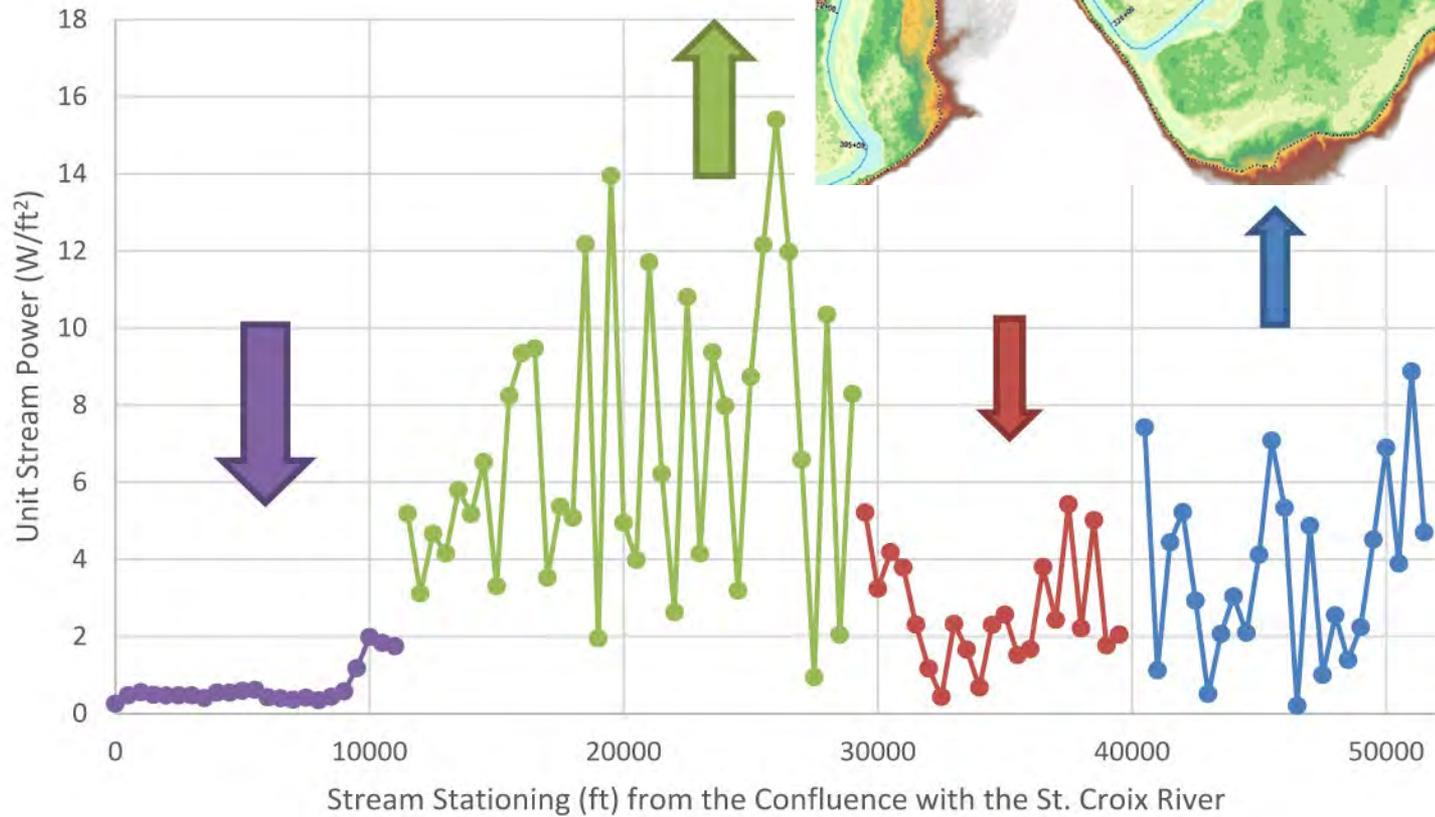
—●— Reach 1 —●— Reach 2 —●— Reach 3 —●— Reach 4

- Four geomorphologically similar reaches were found
- Stationing numbered per hydraulic engineering convention from mouth of river and heading upstream
- Same reaches as in other studies except the upstream Reach 4 in this study was split into two reaches in the habitat study.

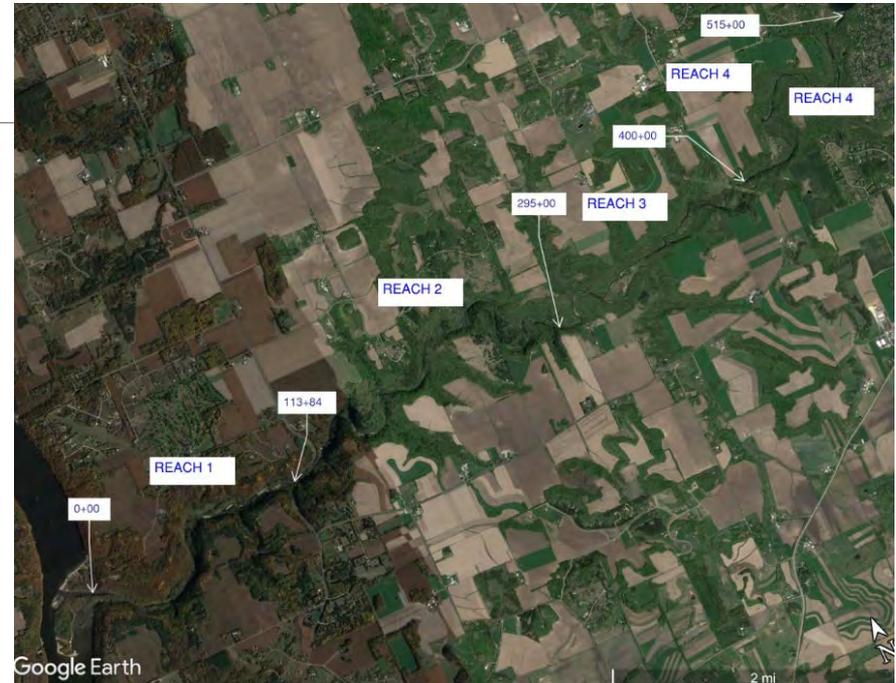
Existing channel morphology

Channel Slope (ft/ft)	Valley Slope (ft/ft)	Avg Unit Stream Power (Watts/ft ²)	Bankfull Width (ft)	Valley Width (ft)	Alluvial Channel Type
Reach 1	0.0007	0.0008	0.68	73	469	Dune - Ripple / Pool - Riffle
Reach 2	0.0031	0.0035	6.86	57	242	Pool - Riffle
Reach 3	0.0027	0.0032	2.53	48	464	Pool - Riffle
Reach 4	0.0031	0.0035	3.86	52	359	Pool - Riffle

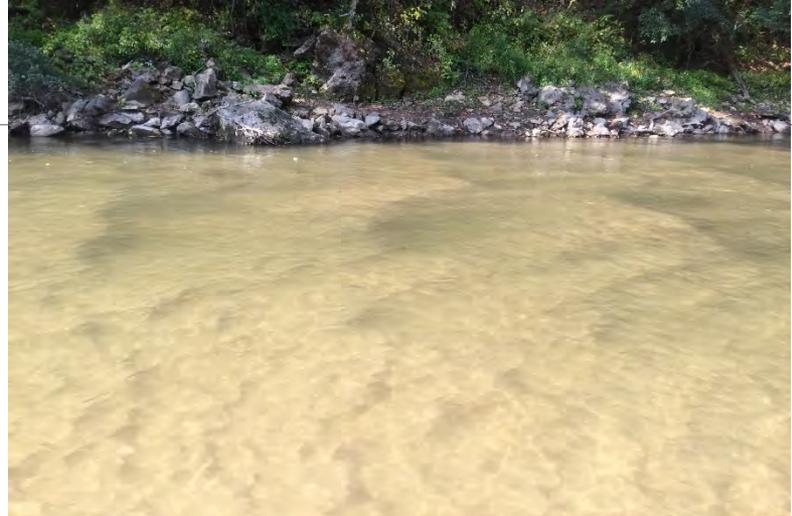
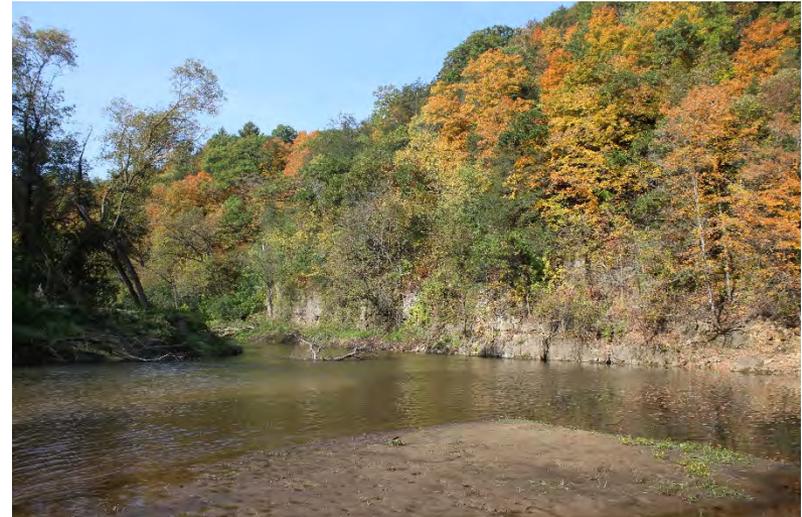
Summary of Sediment Capacity: Reach 1

- ❑ This reach is downstream near mouth of Kinnickinnic River
- ❑ Dune-ripple planforms (sand bed, uniformity in channel, and generally less ecological function and habitat heterogeneity than other reaches)
- ❑ Significant amounts of stored sand in channel and in overbank near delta
- ❑ Expected impacts after dam removal: **temporary deposition on top of dune bed and permanent deposition on overbanks.**

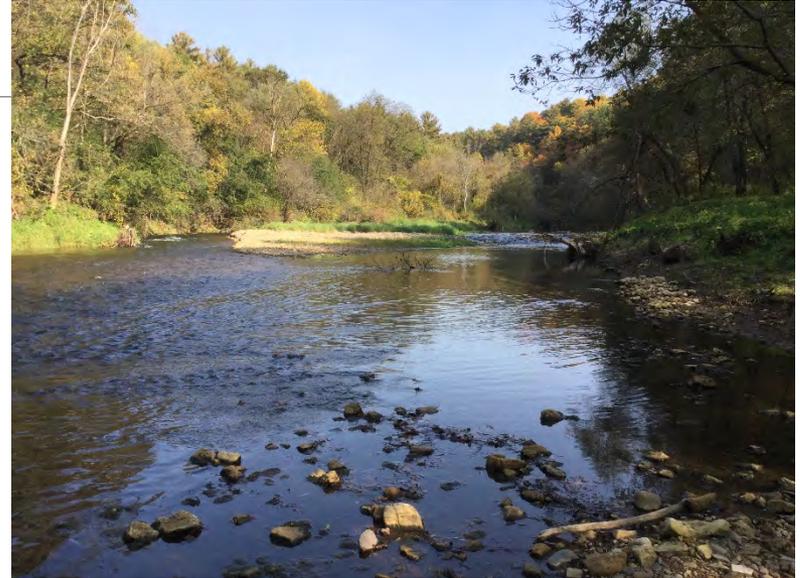
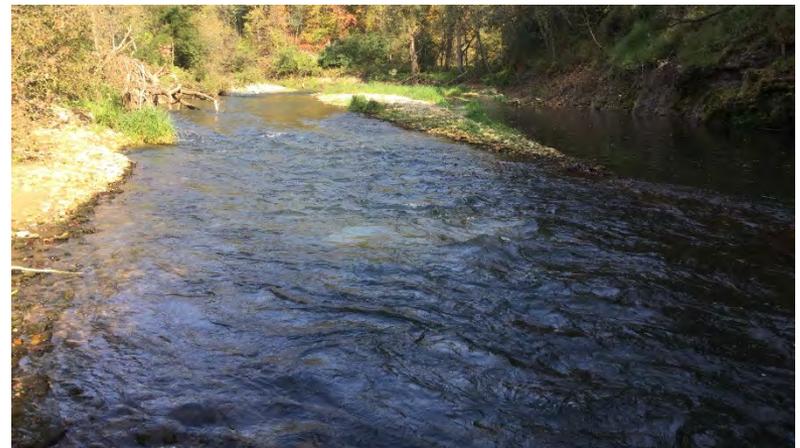
Summary of Sediment Capacity: Reach 2

- ❑ This reach is upstream of CTH F
- ❑ Reduced valley width and increased confinement
- ❑ Highest stream power between dam and St. Croix is in this reach
- ❑ Sand deposits from 2020 flood found in eddies and on point bars.
- ❑ Pool-riffle channel throughout
- ❑ Expected impacts after dam removal: **temporary pool filling but steep reach should flush pools faster than other reaches.**

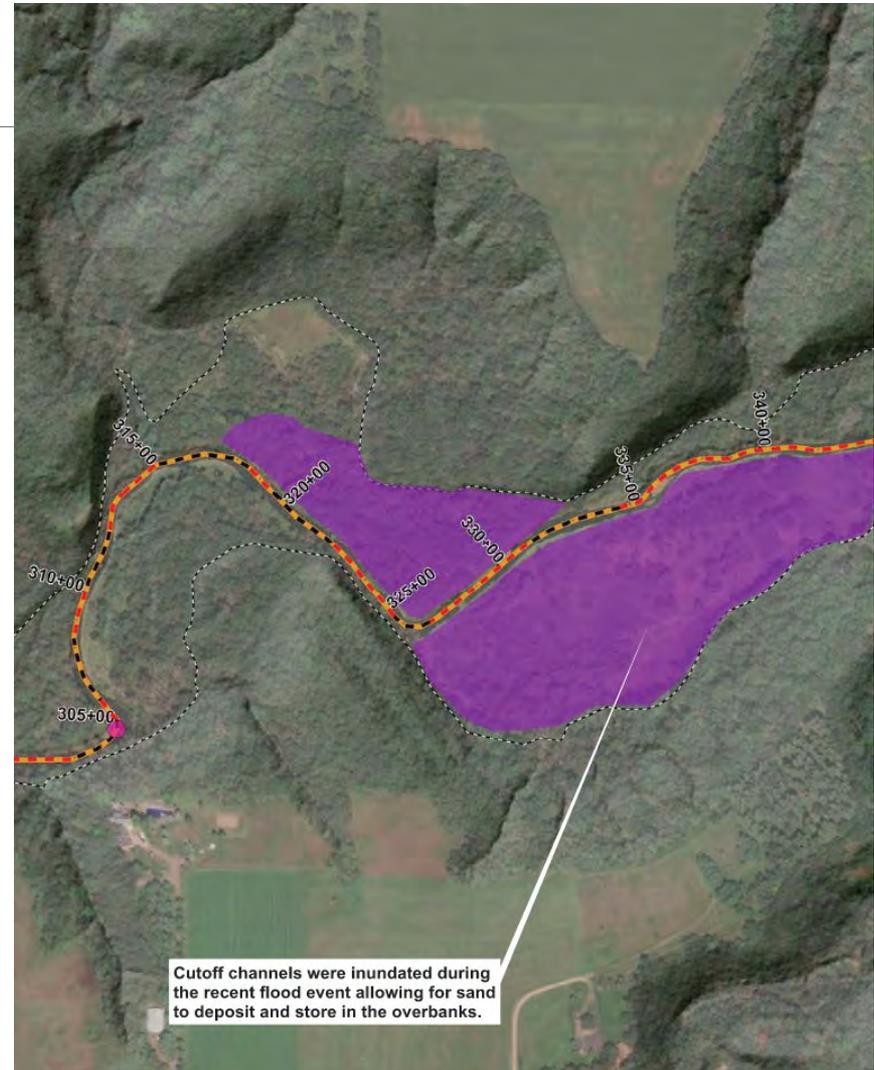
Summary of Sediment Capacity: Reach 3

- This reach is upstream of 1130th Street and continues upstream about 2 miles
- Confinement is less than for Reach 2, so the channel slope and stream power are also reduced.
- Wider valley margins and the confluence of two larger tributary channels dominate this reach.
- Expected impacts after dam removal: **permanent deposition on overbank during floods and temporary filling of pools during low flow periods.**

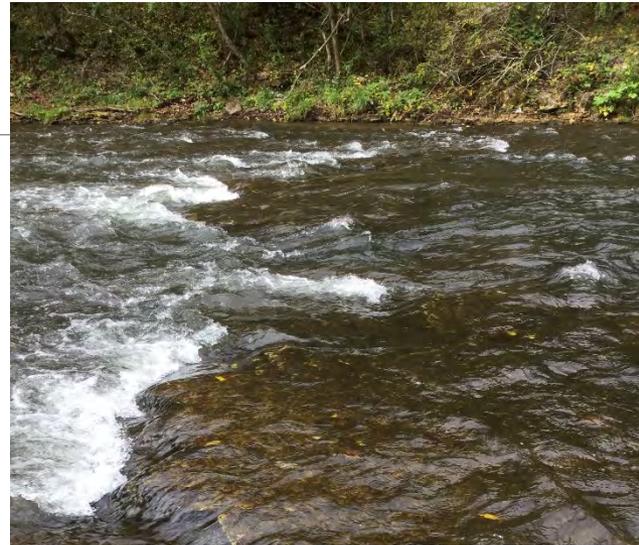
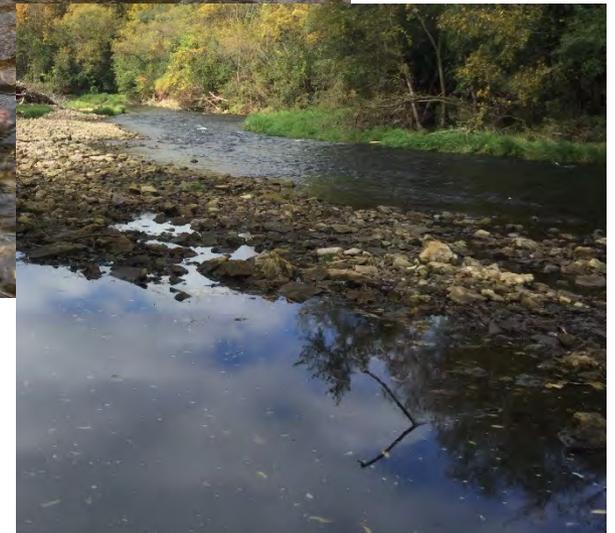
Summary of Sediment Capacity: Reach 4

- ❑ This reach is from the Powell Falls Dam to about 2.2 miles downstream.
- ❑ Riverbed has very little sand from 0 to 600 feet below Powell Falls, mainly exposed bedrock and cobble with some gravel. Some sand is stored on the overbanks, likely from the 2020 flood.
- ❑ Expected impacts after dam removal: **most changes of any reach, especially within 1000 feet of dam, including temporary filling of pools and possibly permanent changes from a bedrock thalweg below the dam to gravel thalweg and more sand bars between banks.**

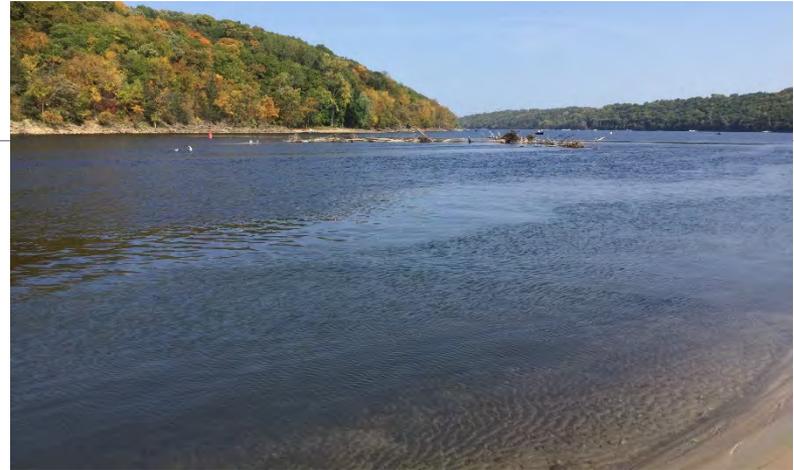
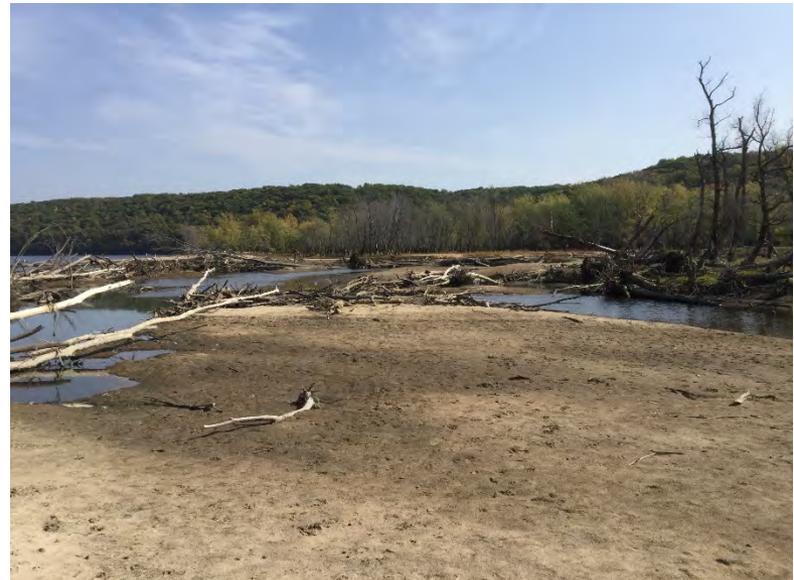
Dam Removal Impacts: St. Croix Effects

- ❑ Current Sediment Capacity:
 - ❑ 25,000 tons per year at St. Croix Falls (6240 sq. mile watershed)
 - ❑ More than 30,000 tons per year at Prescott (8570 sq. mile watershed)
 - ❑ Volume of sand stored in the “delta bar” and bank at the mouth of the Kinnickinnic greatly exceeds the total volume of Lake Louise sediment (by 10x or more).
 - ❑ The 2020 flood and dam removal sediment releases will likely have similar impacts to the St. Croix.
Permanent impacts are expected to include expansion of the delta bar and thicker channel dunes.

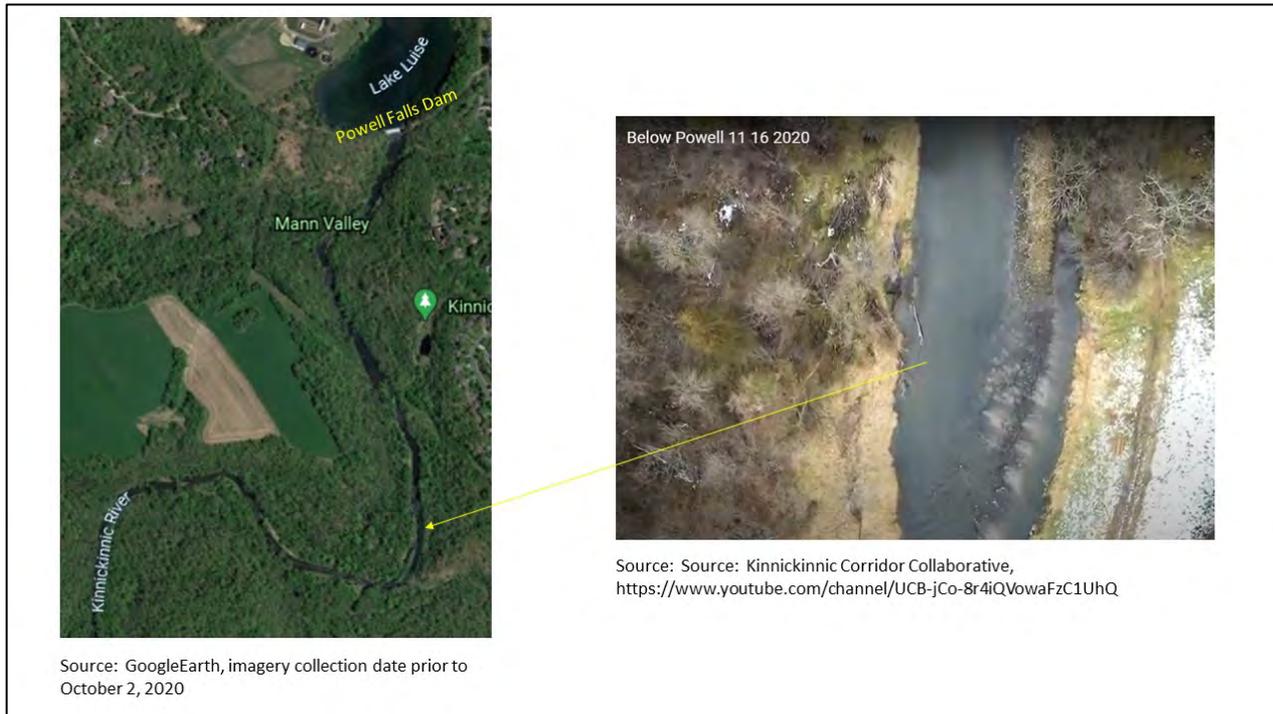
- Pool depth decrease by fine sediment deposition immediately downstream of Powell Falls
- Riffle features maintained

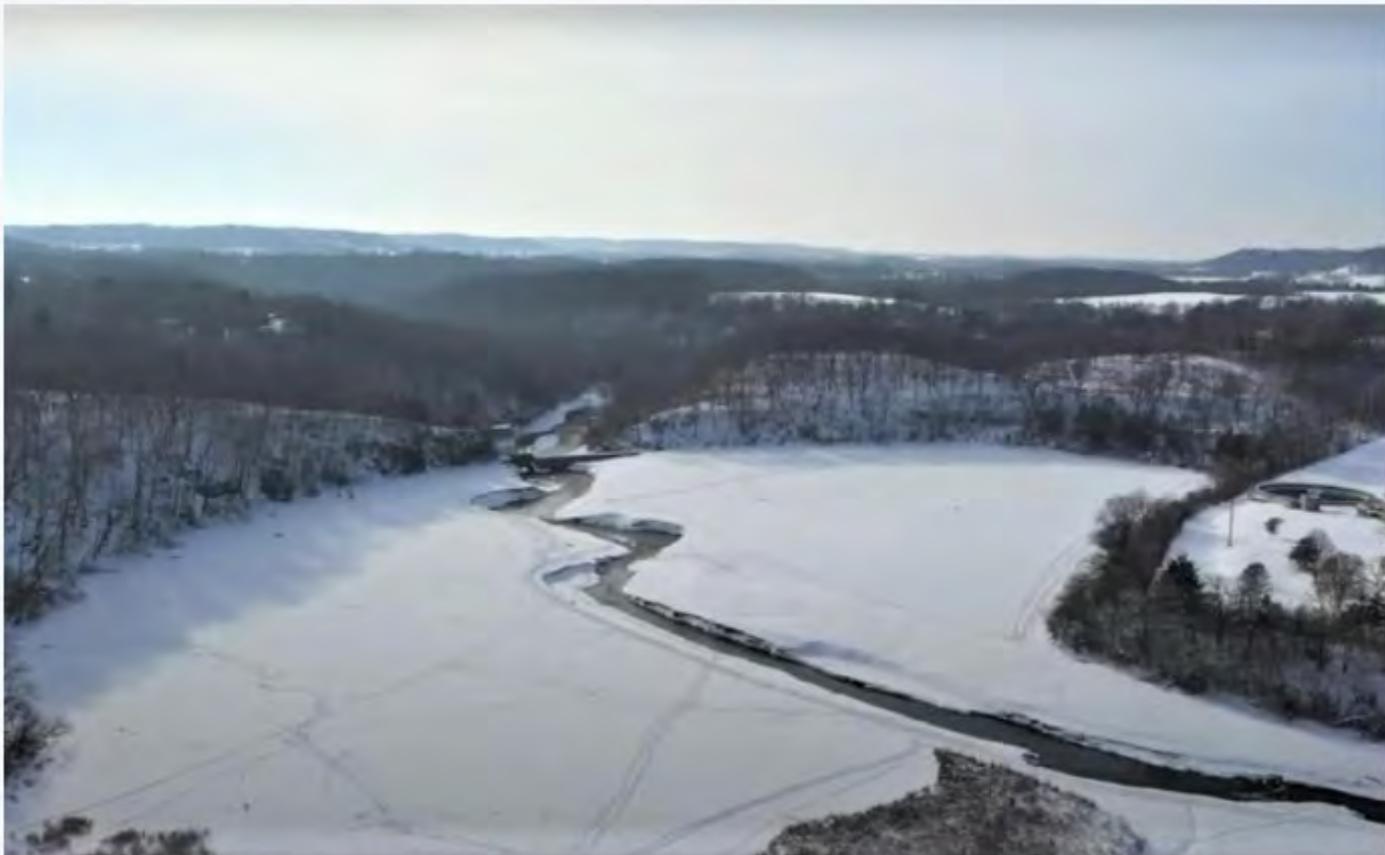
- 6) Restoration of riverine habitat in reservoir area
 - Primary benefit of dam removal

A screenshot of drone footage shows the Lake Louise riverbed on Jan. 1, 2021. Photo by Kinni Corridor Collaborative

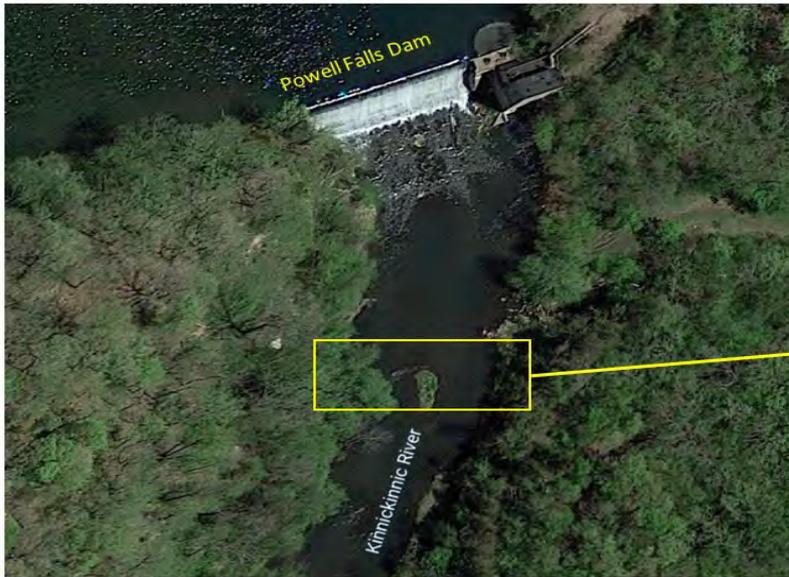
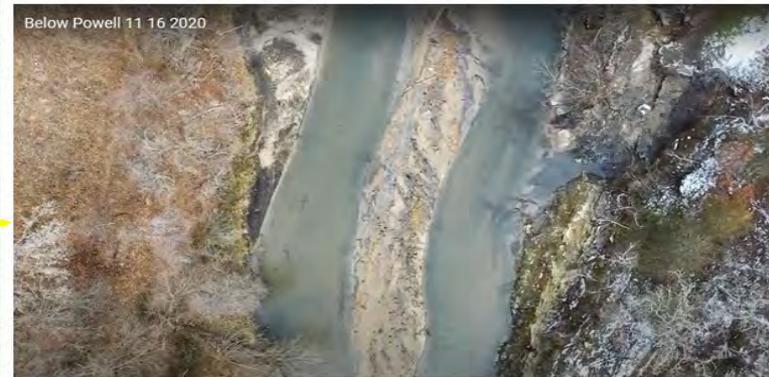
- 7) Restoration of riverine habitat dynamic processes
- a) physical habitat features
- bars, islands, large wood features, and side channel activation

Source: GoogleEarth, imagery collection date prior to October 2, 2020

Source: Source: Kinnickinnic Corridor Collaborative,
<https://www.youtube.com/channel/UCB-jCo-8r4iQVowaFzC1UhQ>

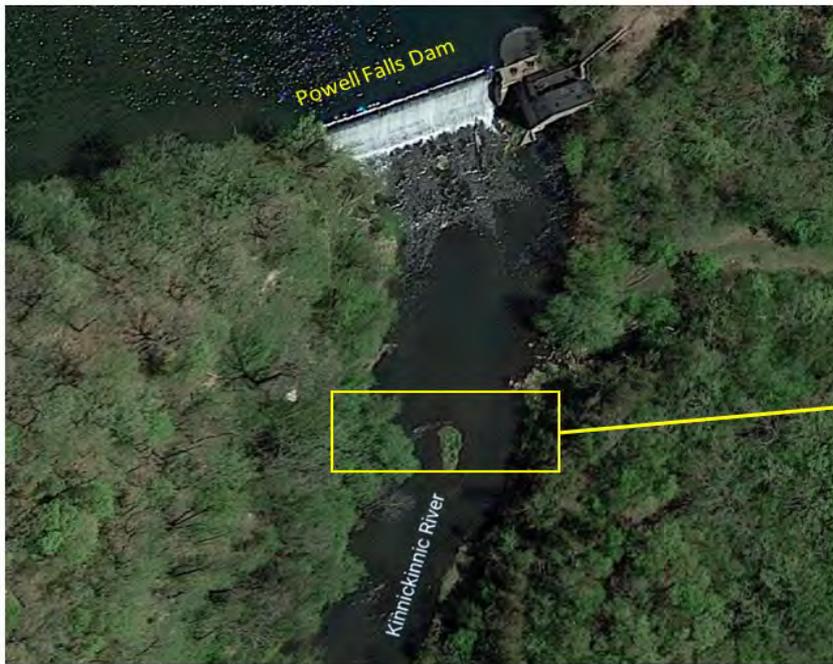
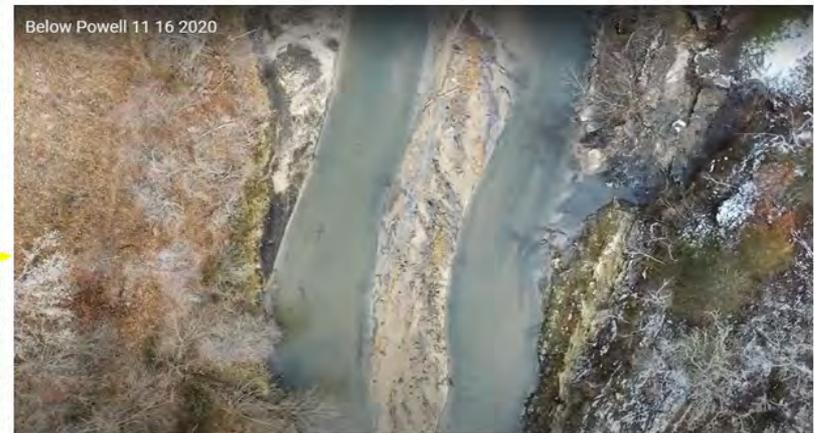
- Boat launch downstream of Powell Falls reduced depth

Source: GoogleEarth, imagery collection date prior to October 2, 2020

Source: Source: Kinnickinnic Corridor Collaborative,
<https://www.youtube.com/channel/UCB-jCo-8r4iQVowaFzC1UhQ>

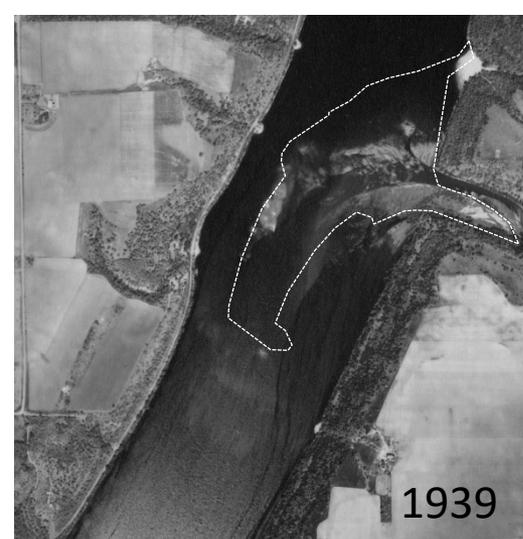
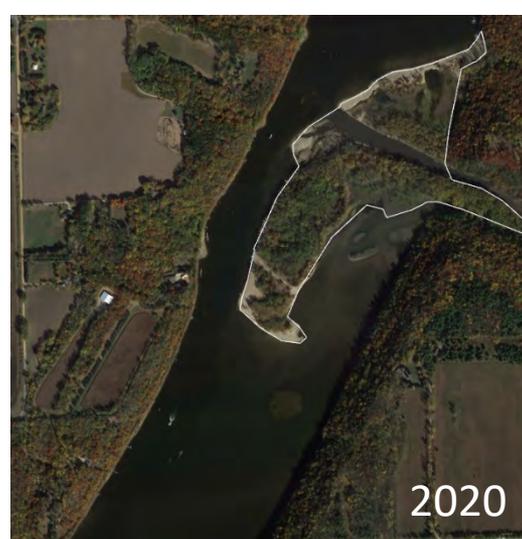
- ❑ Ayres found no published values for bed load in the Kinnickinnic
- ❑ However, bedload is usually the same magnitude as suspended load for Wisconsin streams – likely 5000 to 10000 tons per year at CTH F bridge.
- ❑ To put all this in perspective, the 66 acre “delta bar” contains more than a million tons of sediment.

□ The 66 acre “delta bar” likely contains between 600,000 and 1,500,000 cubic yards, which is well over 1,000,000 tons of sediment.

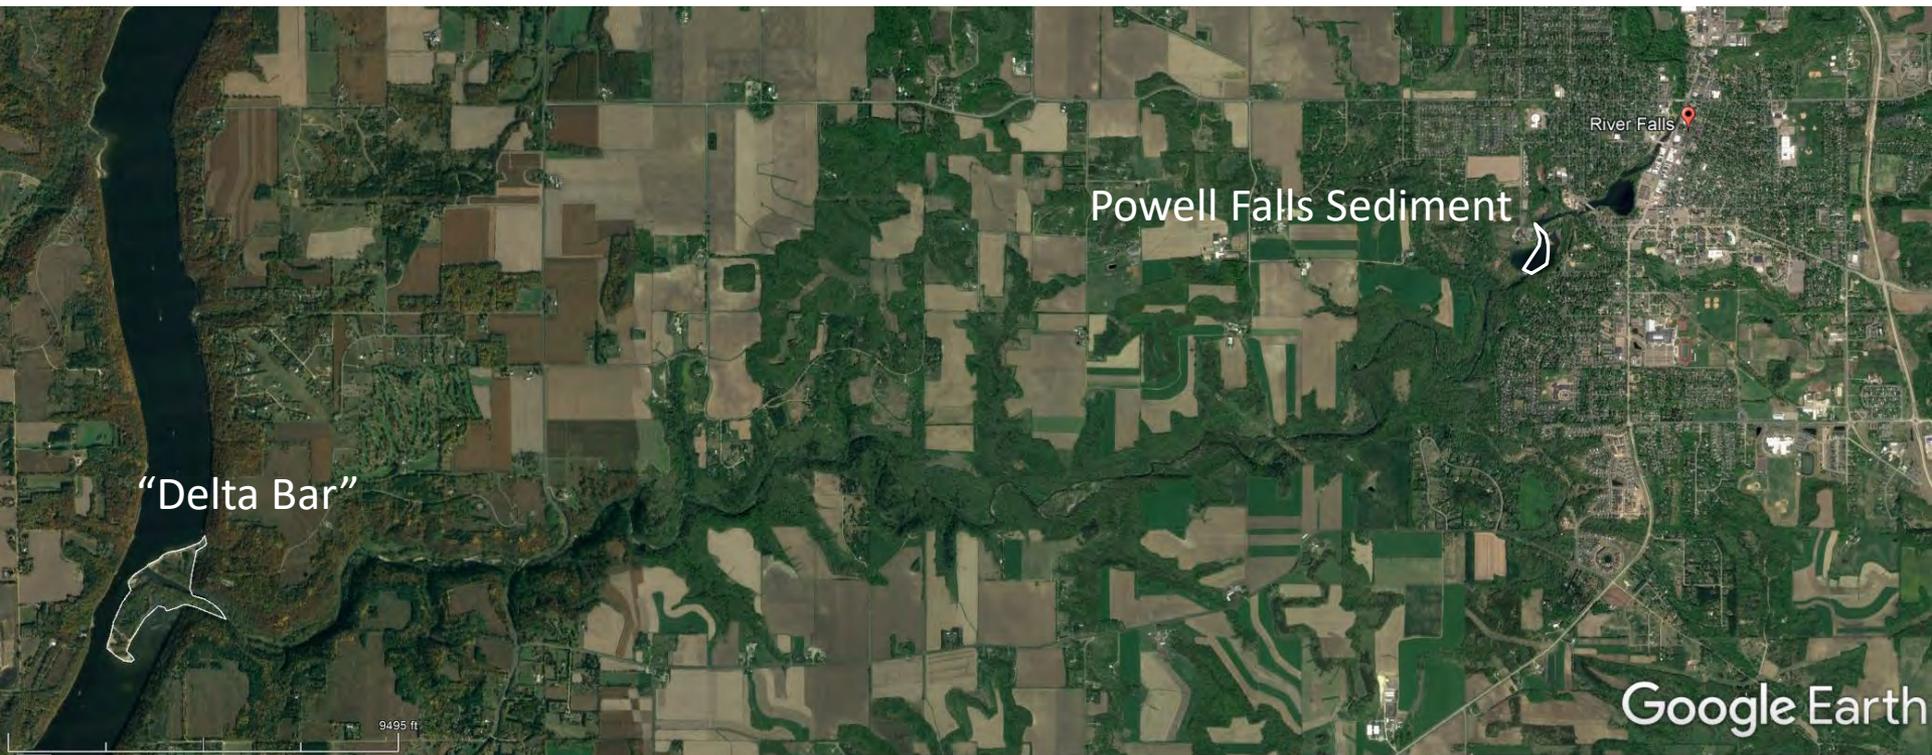
□ The maximum expected release from removal of Powell Falls Dam is 33,000 to 90,000 tons.

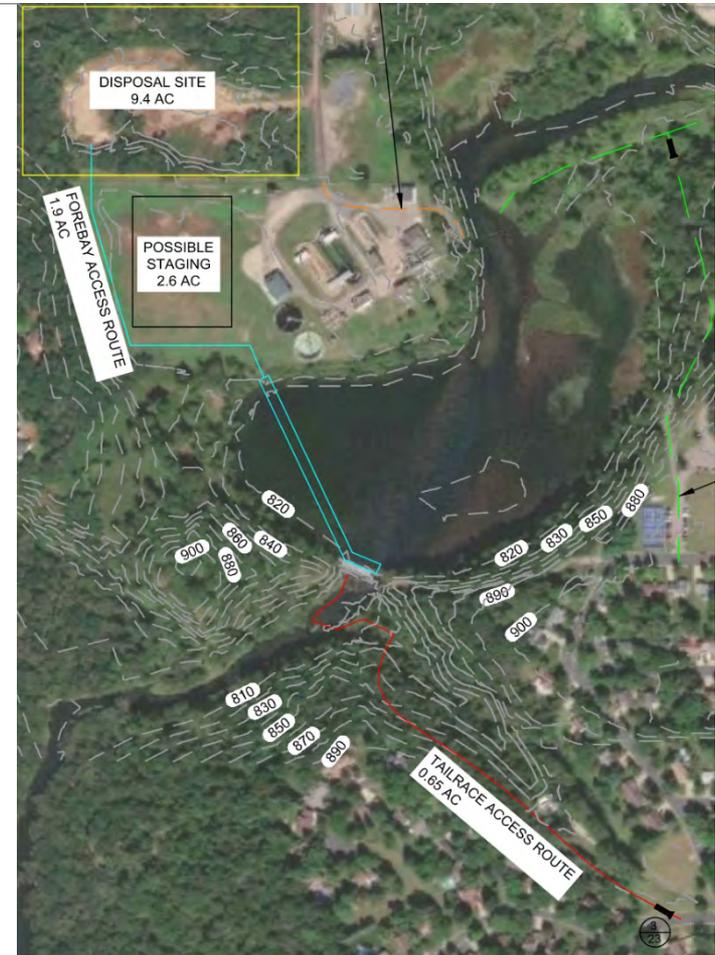
Decommissioning Plan: 2021 Activities Expected

- ❑ Manually seed lakebed and then aerially seed lakebed
- ❑ Permit applications for sediment management and license amendment request
- ❑ Construct access route to tailrace
- ❑ Sediment management in tailrace
- ❑ Naturally dewater lakebed sediments (up to a year process)

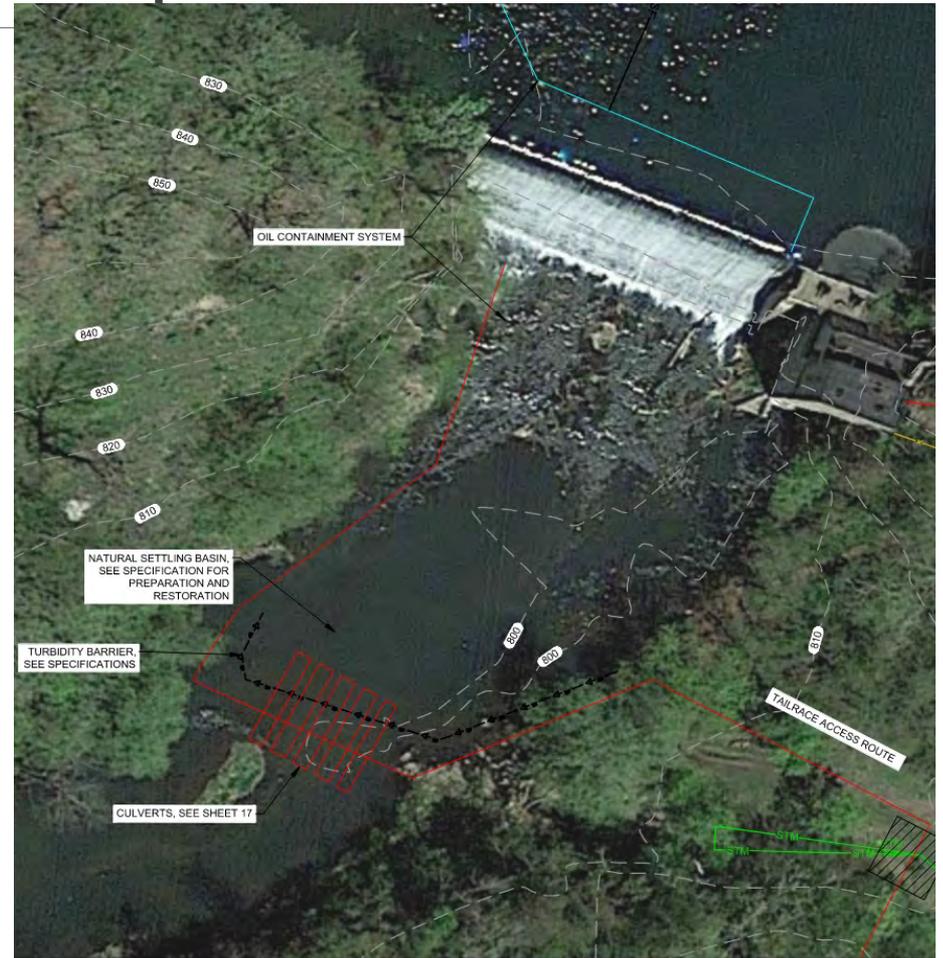
Decommissioning Plan: 2022 Activities Expected

- ❑ Monitor lakebed vegetation growth and invasive species
- ❑ Monitor and armor sanitary sewer infrastructure as necessary
- ❑ Sediment management in tailrace
- ❑ Naturally dewater lakebed sediments (up to a year process)
- ❑ Finalize dam removal drawings for anticipated WDNR submission
- ❑ Finalize lakebed restoration plan
